Instrumentation for Box Girder Tests Harrison Street Undercrossing

November 1962

State of California
Department of Public Works
Division of Highways
Materials and Research Department

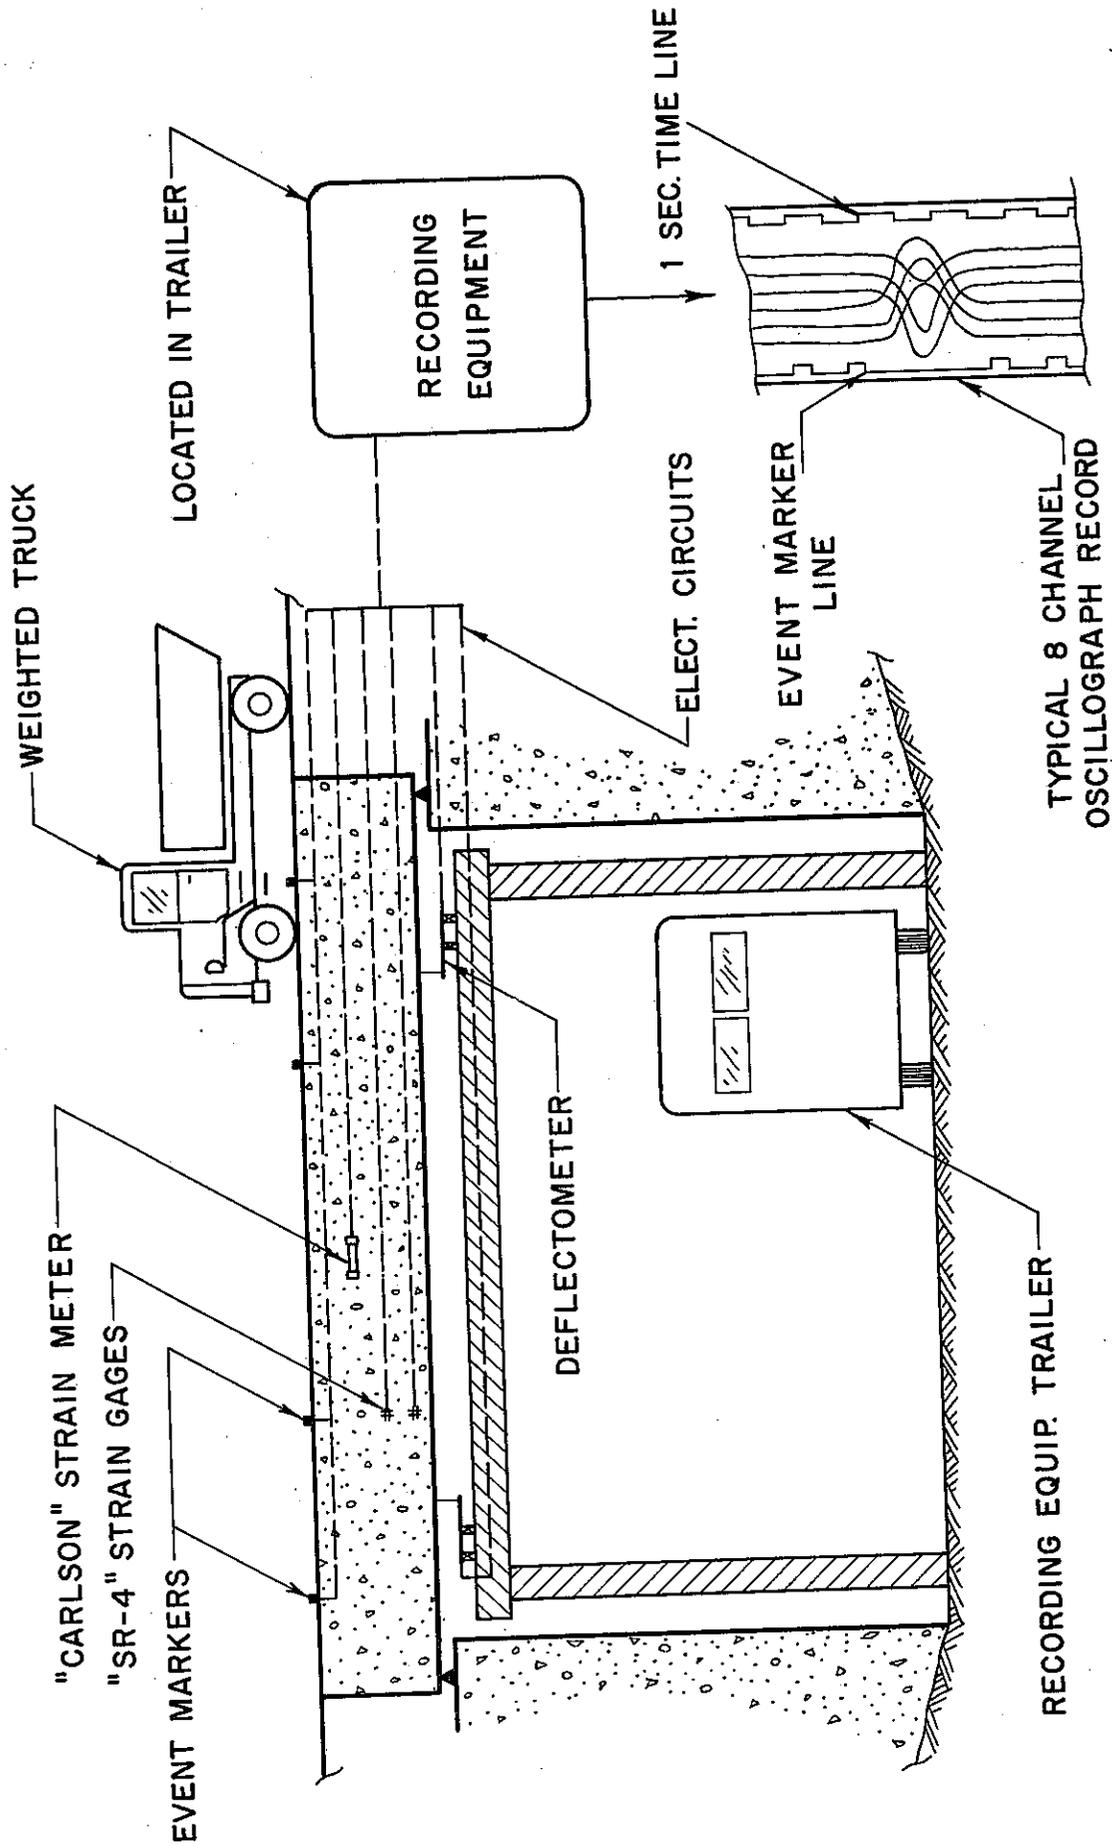
FIG. 1

— HARRISON ST. UNDERCROSSING —

The drawing, Figure 1, is a pictorial diagram of the dynamic test setup. The instrumentation was installed concurrently with the construction of the bridge. Construction of the bridge started in the first week of July 1960. The instrumentation consisted of 69 thermocouples, 158 strain gages premounted in the laboratory on reinforcing bars, 22 deflectometers, 30 Carlson strain meters, and 5 rosette strain gages. The pictorial diagram outlines some of the instrumentation, the truck used for the moving load tests, and a typical 8 channel oscillograph record. The recording equipment was housed in a trailer beneath the bridge. Final tests on the bridge were completed on December 10, 1960.

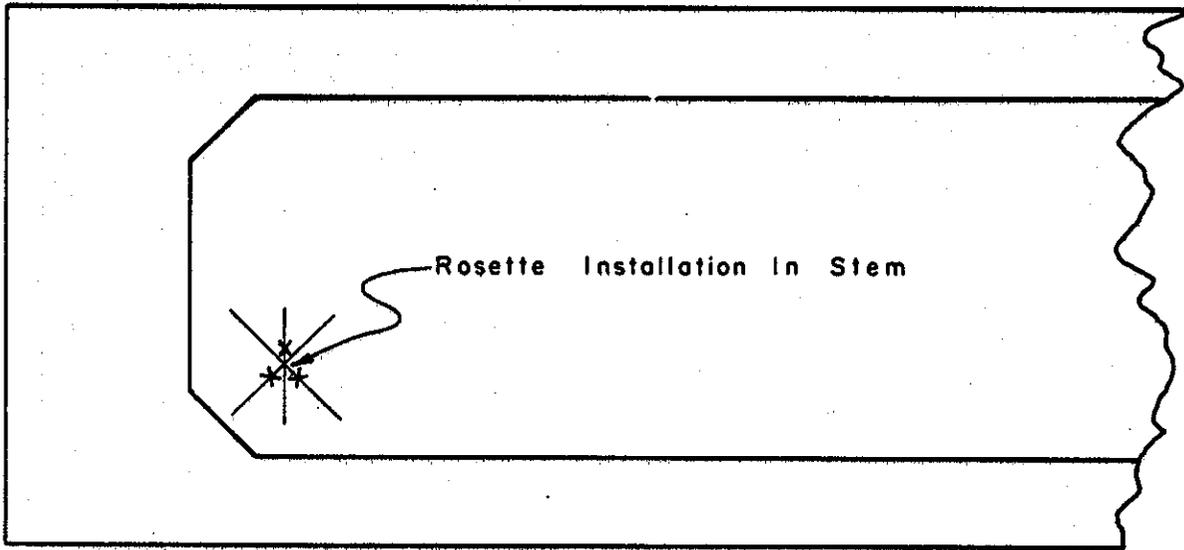
FIG. 1A

SIDE VIEW - End Section

After the soffit stem concrete had cured, the top roadway surface was placed. Figure 3 is a plan view of roadway surface instrumentation. Figure 4 is a plan view of the thermocouple and strain gage instrumentation in the stems at the lower 1/3 point and four strain gaged locations in the diaphragm. Side view -- end section of Figure 1A shows the rosette installation. There are five rosette installations.

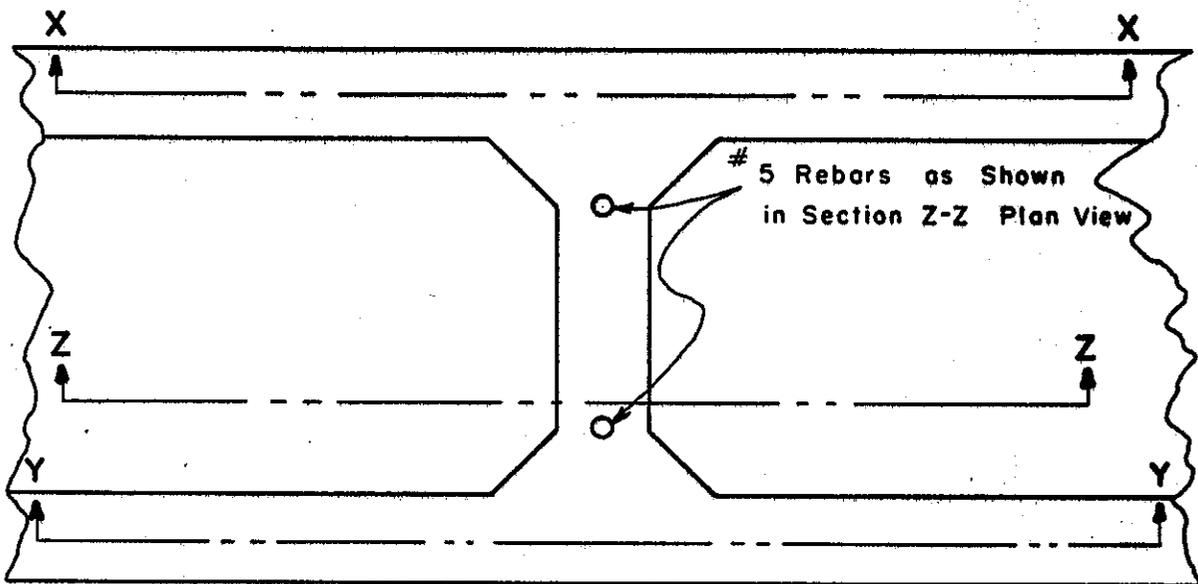
FIG. 1B

SIDE VIEW - Diaphragm

The Harrison Street Bridge superstructure was constructed in two stages. The bottom soffit and stems were constructed in the first stage. The roadway slab was constructed in the second stage. Instrumentation was installed in the bottom soffit stems and roadway slab. The instrumentation was installed concurrently with the two stages of construction. After a series of live load tests, the center diaphragm and curbs were poured. The diaphragm contained four strain gaged #5 rebars as shown in Figure 1B, Side View Diaphragm, and Figure 4. Figure 1B, Side View--Diaphragm, shows the X-Y-Z- planes of the following discussion.

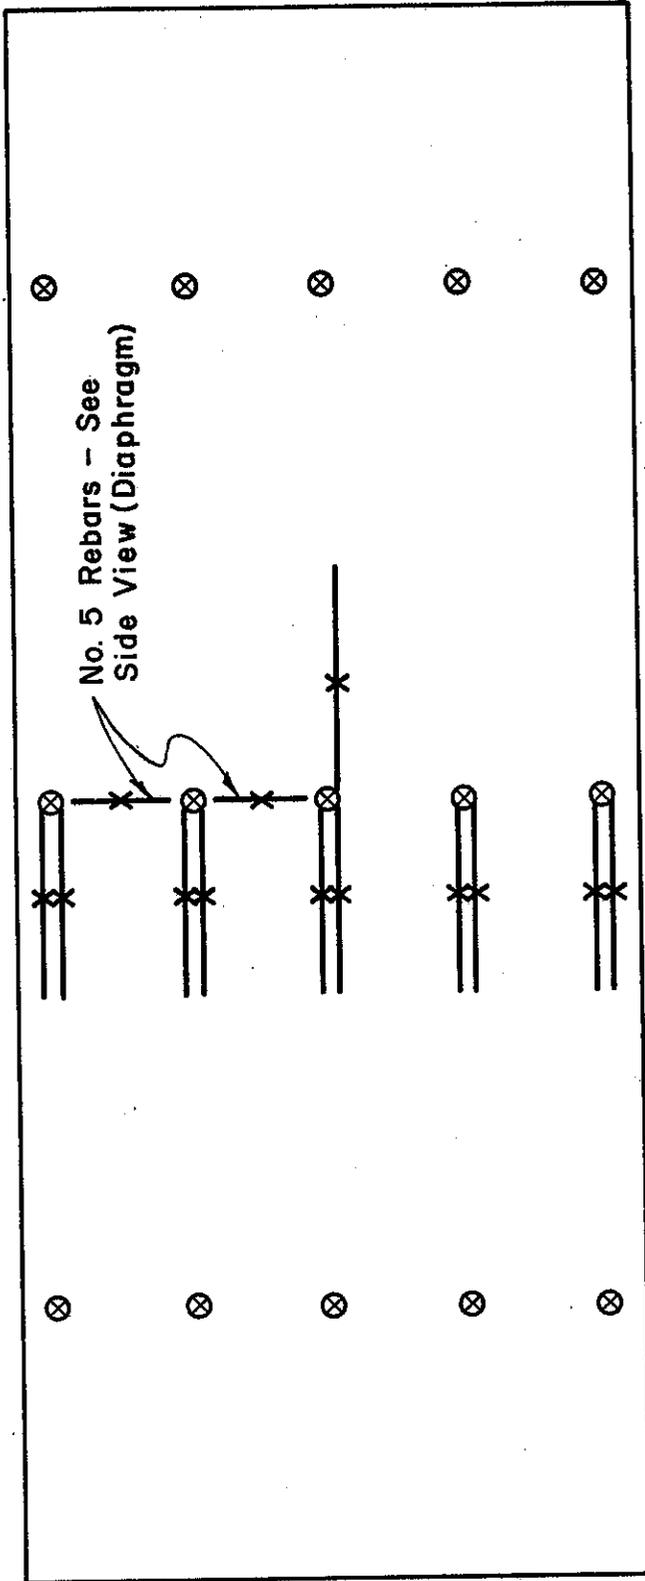
FIG. 2

SECTION Z-Z

PLAN VIEW - LOWER 1/3 POINT

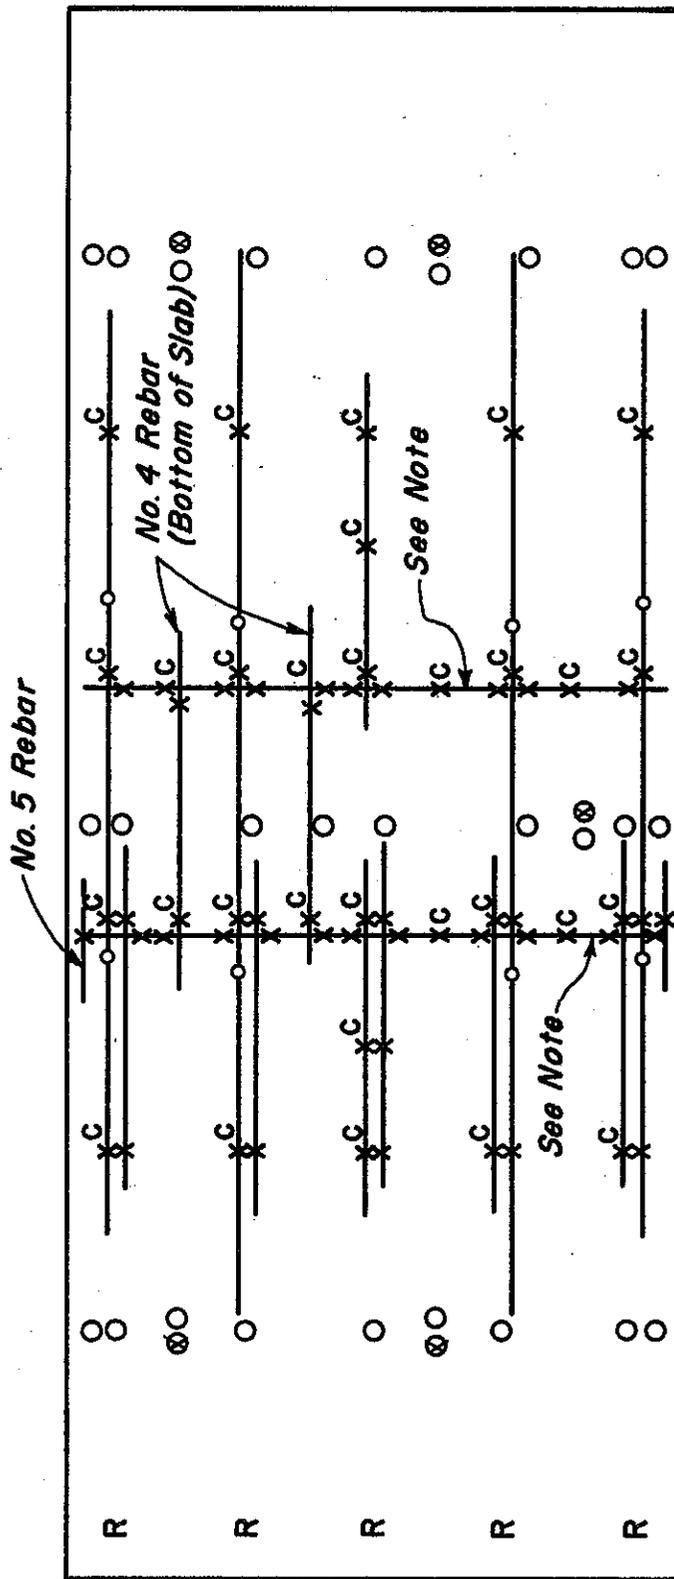
FIG. 4

NOTE: No. 5 Transverse Rebar - 2 Identical (1 Top & 1 Bottom of Roadway Surface Slab).

SECTION **X X**

PLAN VIEW - ROADWAY SURFACE

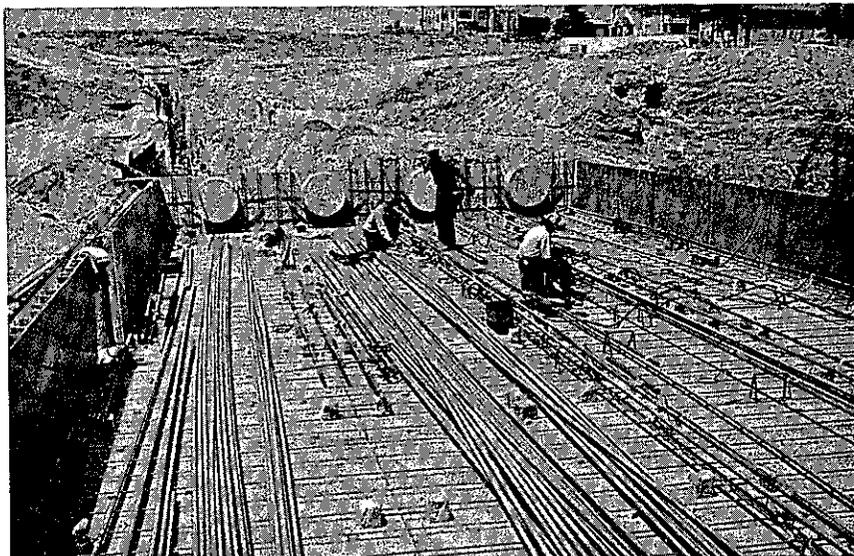
The #11 and #5 reinforcing bars that had been "strain gaged" at the laboratory replaced directly a portion of the normal bridge reinforcing bar installation. The total weight of #11 bars replaced was 5143 pounds and the total weight of #5 bars replaced was 532 pounds. Figure 5 shows the fabrication of the bottom soffit steel mat on the bottom forms. The welder is welding the strain gaged #11 reinforcing bar to the regular #11 bar. This will form a continuous length of #11 reinforcing bar sufficient to span the length of the bridge.

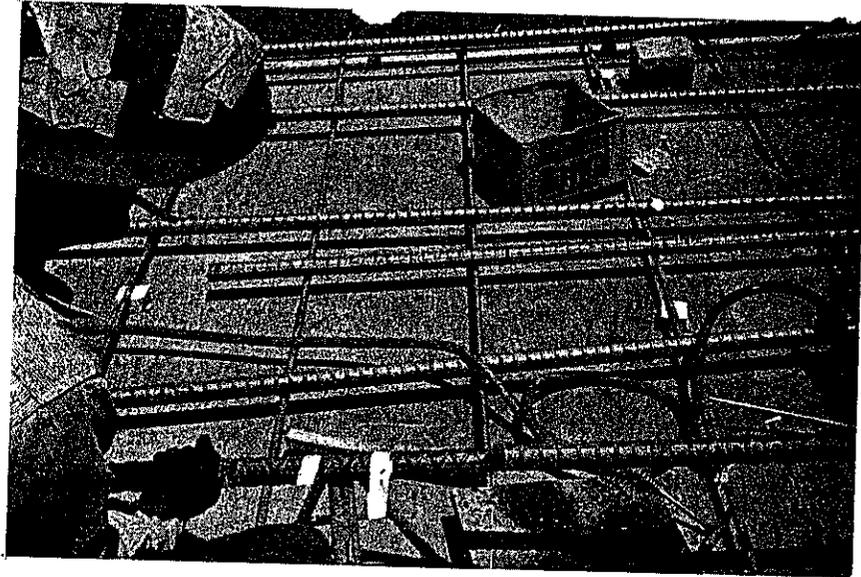
Figure 6

A view of the joints prepared for welding the #11 reinforcing bar being placed together prior to welding is shown in Figure 6.

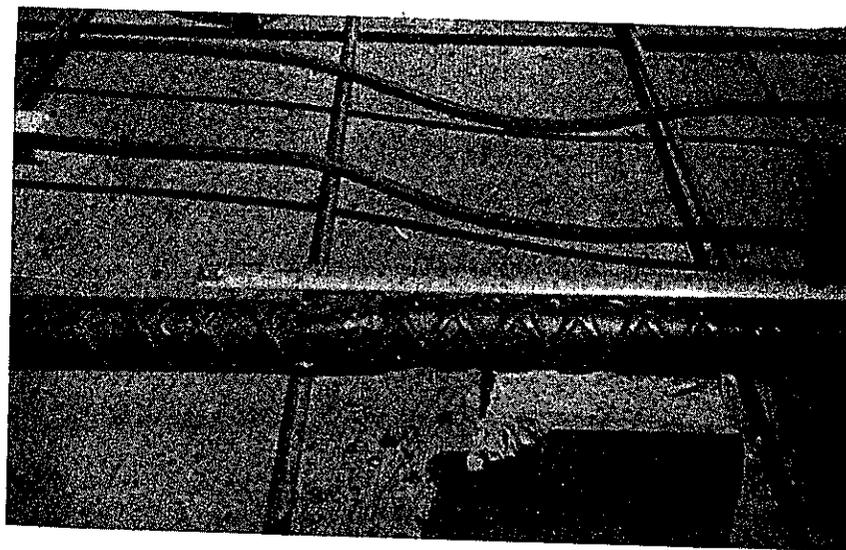
Figure 7 is a view of two #11 bars butt welded together. A total of 23 lengths of #11 bar with a total of 41 strain gaged locations was thus placed in the bottom soffit. All welds of the #11 bars were radiographed for soundness of weld.

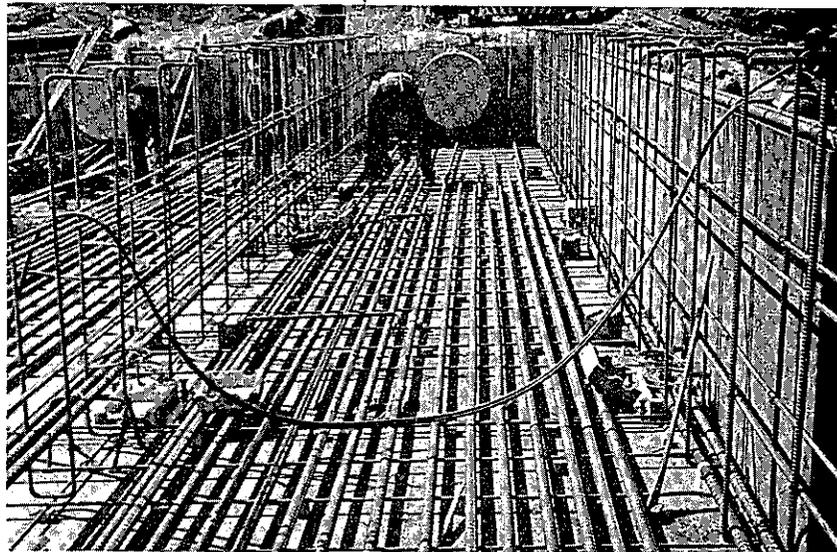
Figure 8 is a view of the bottom steel mat and stems.

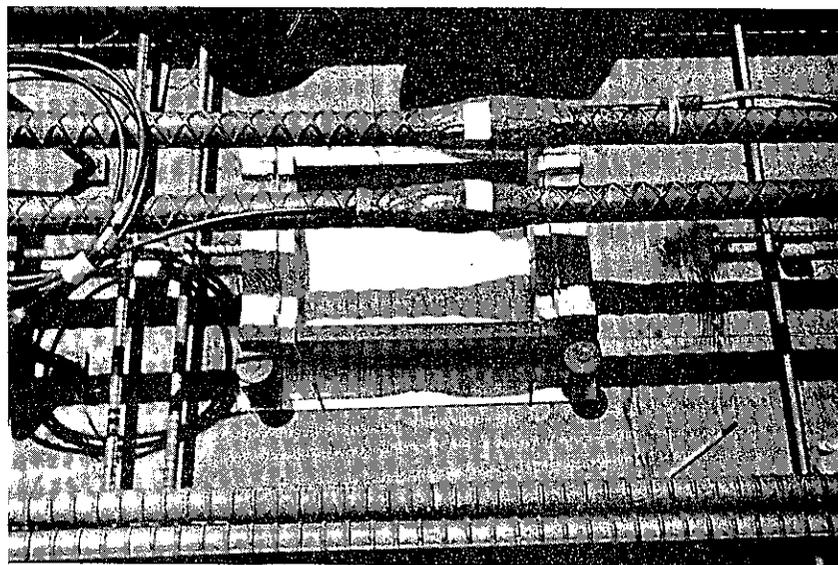
Figure 9

All of the gaged locations of the bottom #11 bars were boxed during construction so that they would be accessible from the exterior bottom of the bridge.
