Dynamic Tests of Five Breakaway Lighting Standard Base Designs

October 1968

State of California  
Transportation Agency  
Department of Public Works  
Division of Highways  
Materials and Research Department

Final Report

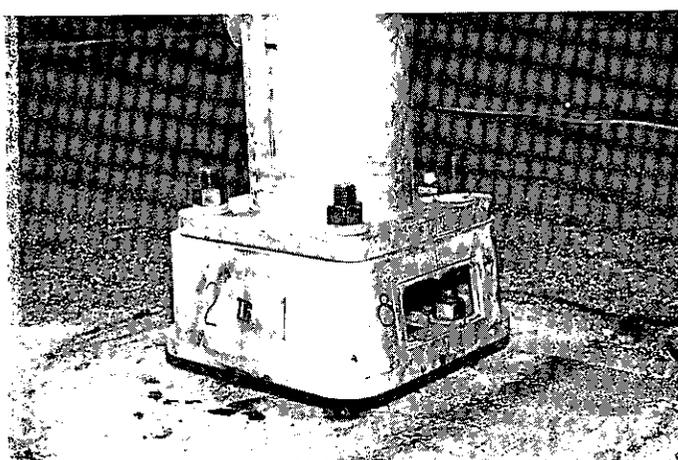
Test 182 was conducted at 40 mph on an unmodified cast aluminum insert with the hand hole facing away from the traveled way. See Figure 1A and Plate 13 in the Appendix for design details. As the base failed on impact the standard was kicked up and ahead of the test vehicle. (Fig. 1B)

The force of impact not only collapsed the front end of the test vehicle about 24 in. but the pole shaft was damaged beyond repair with a 30 degree bend at the point of contact. In addition the foundation anchor bolts were bent approximately 30 degrees away from the direction of impact.

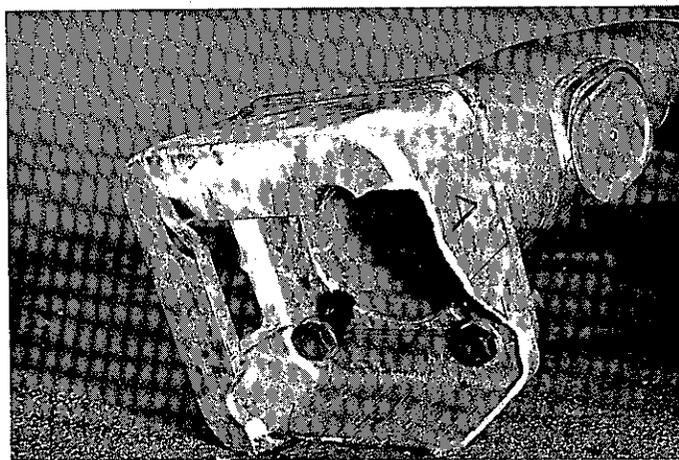
Figure 1B

The lower portion of the pole shaft hit the roof as the test vehicle progressed under it. The top of the pole shaft came to rest about 30 ft beyond the foundation.

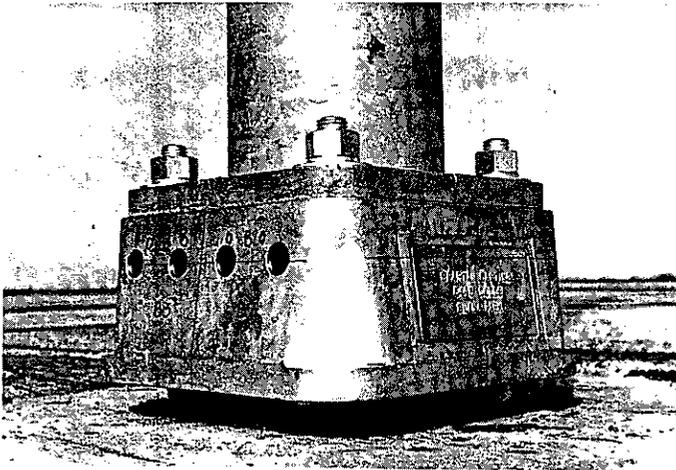
Test 183 was conducted at 40 mph on a cast aluminum insert modified by drilling a series of four one-inch diameter holes at  $2\frac{1}{2}$  in. centers in each of the three side walls (modification #1) and the hand hole was oriented toward impact. See Figure 2A and Plate 13 in Appendix for Design Details). It was anticipated that the base would fracture through this weakened cross section, thus reducing the impact resistance. However, upon impact, the base failed through the base flange in much the same manner as in the preceding test 182. There was no evidence of fracture through the weakened plane of the drilled holes. (Fig. 2B)

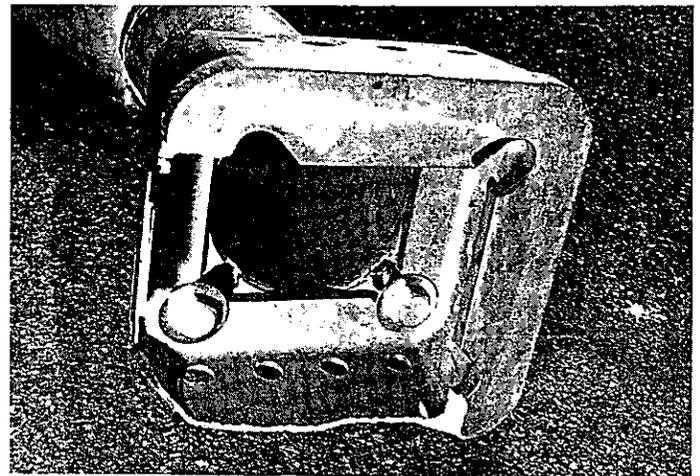
Figure 2B

The lighting standard was kicked ahead and up, clearing the vehicle by 3-ft as it passed through the impact zone. It settled to the pavement with the top approximately 35 ft beyond the anchorage. The shaft was bent to approximately 25 degrees at the point of first contact and was damaged beyond repair. The anchor bolts were bent approximately 30 degrees. Vehicle damage was much the same as sustained during Test 183 with 20-in. deformation to the front end.

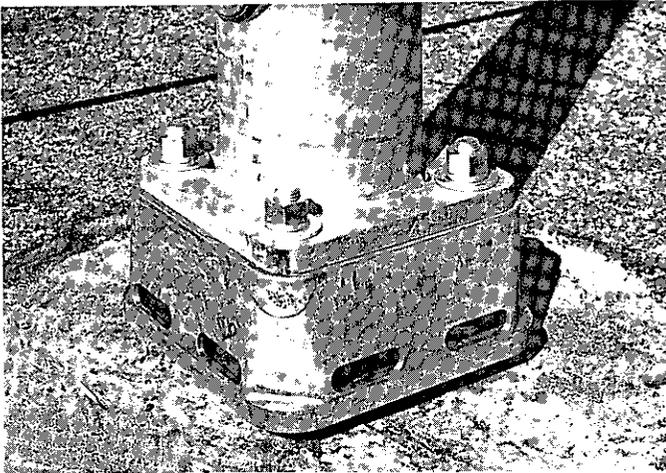
Test 191 was conducted at 48 mph on the cast aluminum insert mounted on the same anchorage as was used for Test 182 (the previously damaged bolts were repaired by straightening and welding on new studs). In a further effort to reduce the impact resistance noted in Tests 182 and 183, two 1-in. by  $3\frac{1}{4}$ -in. slots were milled through the three side walls near the base flange (modification #2) where the fracture occurred in the insert bases in the preceding two tests. See Figure 3A and Plate 13 in Appendix for Design Details. The hand hole was oriented facing away from the

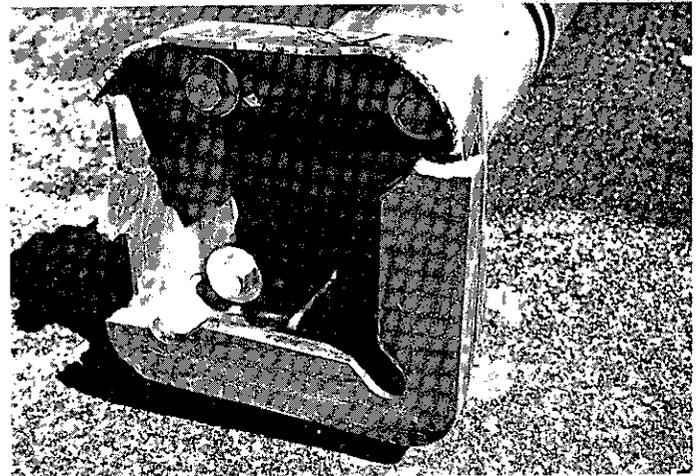
Figure 3B

traveled way. Upon impact, the aluminum insert again failed in a combination of shear and tension with the fracture taking place through the milled slots as anticipated. (Fig. 3B)

The two right hand bolts were bent 30 degrees and the two left hand bolts were sheared off at the surface of the concrete foundation. The lighting standard was kicked ahead and up, clearing the vehicle by 7-ft as it passed through the impact zone. The top of the pole settled to the pavement 25-ft beyond the anchorage. The shaft was dented 2-in. and was not considered salvageable. The vehicle sustained the least front end deformation (19-in.) observed in the three frangible aluminum insert tests.

The performance of the 6-in. cast aluminum insert with the second modification as in test 191 under moderate impact was satisfactory. However, due to concern over the loss of side wall cross section induced by the slots, it was concluded that this device should not be adopted as a design standard unless subsequent cyclic vibration tests are performed to insure that wind loads would not cause premature operational fatigue failure. Such tests were not within the scope of this research study.

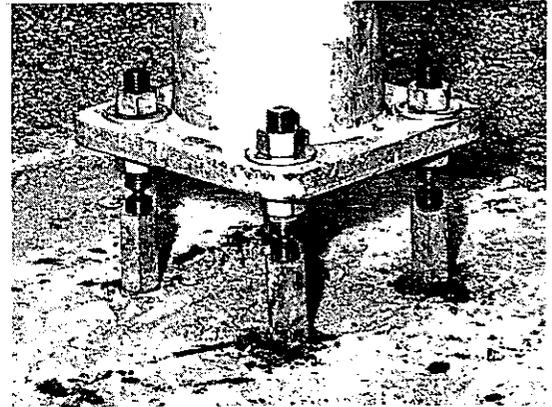
Figure 4

Test 181 was conducted on bolts heat treated at 950 F and tests 192 and 194 used bolts heat treated at 1050 F. Prior to heat treating a notch is machined in the bolt insert to reduce its diameter from the standard 1 in. to 7/16 in. See Plate 14 in the Appendix for exact details. The notched inserts are threaded into 3-in. long sleeve nuts which in turn are threaded onto the regular anchor bolt.

Test 181 was conducted at 40 mph on the assembly shown in Figure 4. No grout pad was placed around the insert assemblies as was done on the subsequent two tests to provide lateral support. Upon impact the lighting standard was kicked ahead and up and cleared the vehicle by 6-ft as it passed through the impact zone. The top of the pole came to rest 16-ft beyond the anchorage. Damage to the lighting standard consisted of a minor dent at the point of contact with the vehicle. Although the A-307 anchor bolts bent 30 degrees, they were successfully straightened for use in a succeeding test. Vehicle deformation (18-in.) was less than sustained during any of the frangible aluminum insert tests.

From the standpoint of impact resistance at 40 mph, the notched bolts performed efficiently and dummy driver decelerations were almost negligible. However, there is some concern as to the possibility of stress corrosion cracking occurring in this material in a 950° heat treatment condition after extended exposure to wind loading and accompanying vibration. It was therefore agreed that the heat treatment temperature should be increased to improve the fatigue characteristics. However, since an increase in treatment temperature also increases the impact resistance, a proof test was conducted using the revised heat treatment.

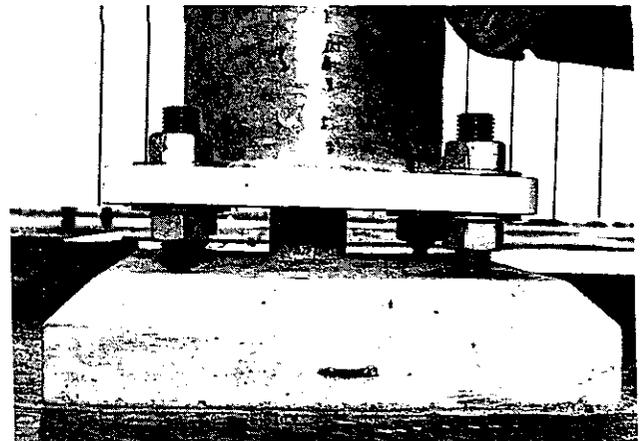
Figure 5

Test 192 was conducted at 40 mph on the same design notched insert bolts as were used for Test 181 with the following modifications: (1) heat treatment was increased from 950 degrees to 1050 degrees and (2) a three-inch grout pad was cast around the sleeve nuts and was epoxy bonded to the foundation (Figure 5). Upon impact the notched bolts failed as before and the standard was kicked ahead and up 4-ft over the vehicle as it passed through the impact zone. The standard came to rest with the top approximately 12 ft beyond the anchorage. The point of impact was off-center on the vehicle bumper and close to the supporting brackets. Consequently, the vehicle sustained only very minor damage consisting of a 1 1/2-in. dent in the bumper and a slight dent in the grill and hood. The light standard was bent 10 degrees and the steel pole base plate was deformed. The grout pad was damaged and broken out around the right sleeve nut. No discernible decelerations were recorded in the unrestrained dummy. Due to the off-center

point of impact by the vehicle on the reinforced section of the bumper, no valid correlation could be made between the results of tests 181 and 192 concerning the increase in impact resistance presented by the notched studs with the higher temperature treatment.

In the first notched bolt test (181) the vehicle experienced most of the damage, whereas the principal damage in Test 192 was sustained by the pole. Although the performance of this design when impacted at 40 mph was very satisfactory, a third test was considered necessary to determine the impact characteristics of the notched bolts at a lower speed under loading approaching a static condition.

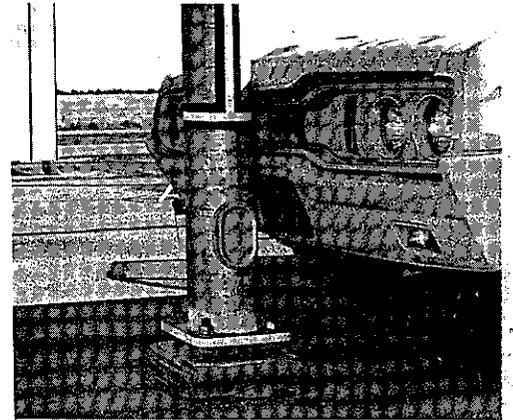
Figure 6

Test 194 was conducted on the same notched bolt design as was used for Test 192 (1050 degrees treatment and 3-in. grout pad around sleeve nuts) but with a 15 mph vehicle impact speed and the ignition cut off prior to contact (Figure 6). Upon impact, the bolts failed primarily in tension and the standard remained vertical and in contact with the car, "walking" for 6-ft before falling forward and to the left. The pole came to rest within 3-ft of the 18-ft offset line used to simulate the edge of pavement. The base of the standard remained under the front bumper 18-in. from the anchorage. The vehicle sustained extensive damage (21-in. deformation) but the lighting standard was only slightly dented. The test results from this 15 mph test indicate the performance of this device as a break-away design to be marginal under low speed impacts. Further research into the metallurgical properties of the ARMC0 17-4PH steel is necessary before this concept could be accepted as an effective breakaway device for the inevitably wide range of operational impact conditions.

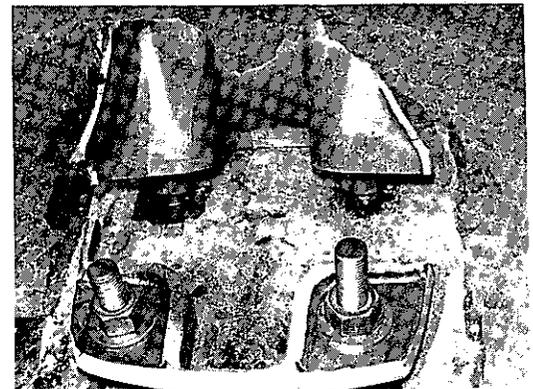
Figure 7B

In this test the lighting standard consisted of a tapered, welded aluminum pole fitted and epoxy cemented to an 18-in. high cast aluminum insert sleeve shoe base (Figure 7A.) The base extends 12-in. inside the aluminum pole. This serves not only as an effective structural connection but also reinforces the pole to resist collapse on impact and to more effectively transmit the impact load into the frangible base. See Plate 15 in the Appendix for design details.

The vehicle impacted the pole head-on at 40 mph. Upon contact the pole collapsed and bent to an angle of approximately 90 degrees at a point 35-in. above the concrete foundation. As the cast aluminum base failed (See Figure 7B) the car bumper was deformed 19-in. into and back under the vehicle. The collapse and bending of the pole caused it to hang up under the bumper and remain in contact with the vehicle for a relatively long period of time. However, after releasing from the car, the pole cleared the vehicle by 4-ft and the top of the pole came to rest about 25 ft beyond impact. Vehicle decelerations were low and dummy decelerations were negligible. With the 22-inch bumper height (typical of most American passenger vehicles now in operation and production), the pole was contacted above the reinforced section. Consequently, as the pole collapsed, the load was transmitted to the base primarily in bending rather than in shear. The Texas Transportation Institute reported a more favorable breakaway action in a test on this base design using a 1958 model test vehicle with a 14-in. bumper height.

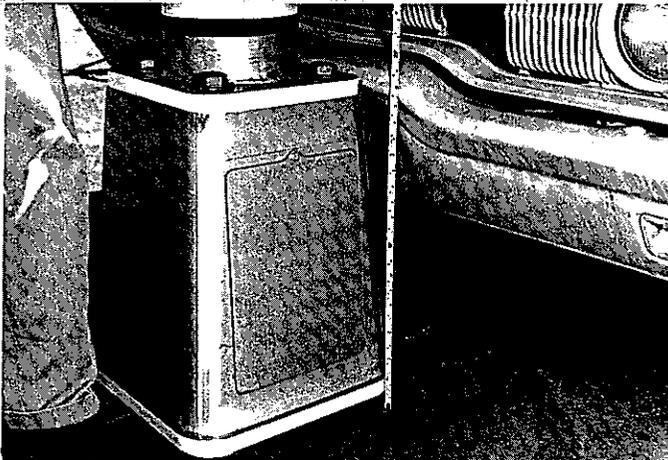
The 20-in. high tapered cast aluminum alloy transformer base tested conforms to the requirements of ASTM Designation: B-108, alloy SG70A, heat treated to a T-6 temper. The top of the base accepts the 11-1/2 in. bolt circle steel lighting standard base and the bottom requires a 15-in. bolt circle. See Figure 8A and Plate 16 in the Appendix for Design Details.

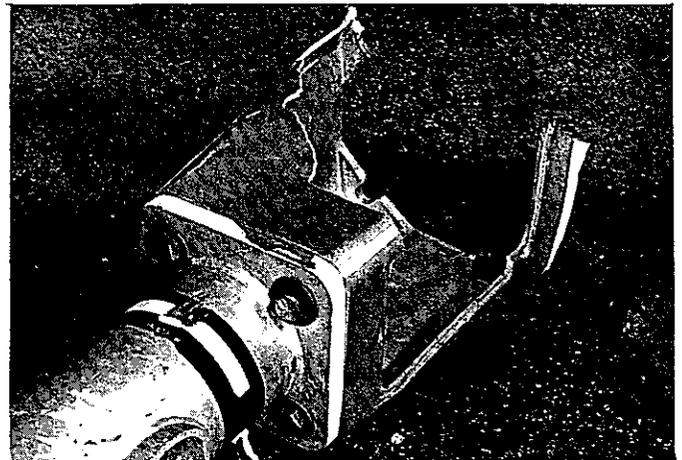
Figure 8B

The vehicle impacted near the top of the transformer base at a speed of 15 mph. The impact side of the base fractured but remained hung up on the anchor bolts. The remainder of the base (See Figure 8B) and lighting standard remained in contact with the vehicle and was pushed along in the vertical position for about 10-ft before falling ahead and to the left of the vehicle. A portion of the pole and the entire mast arm protruded 16-ft. beyond the 18-ft offset simulating the edge of the traveled way. This test, as did that on the notched bolt insert design, illustrates the significant increase in impact resistance that might be expected with any frangible system as the impact velocity is decreased from the 40 mph to the 15 mph range.

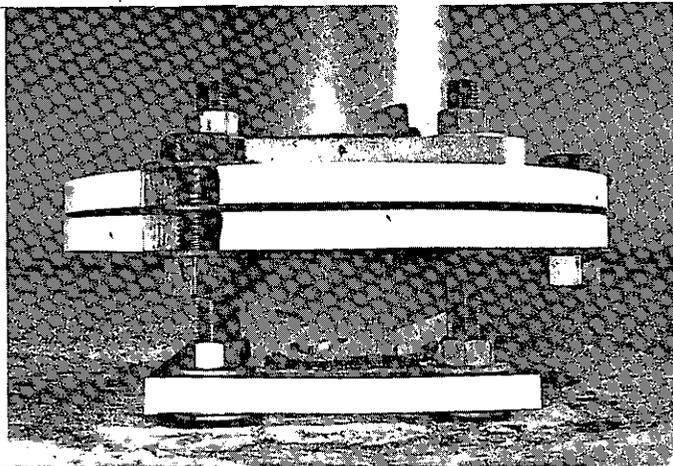
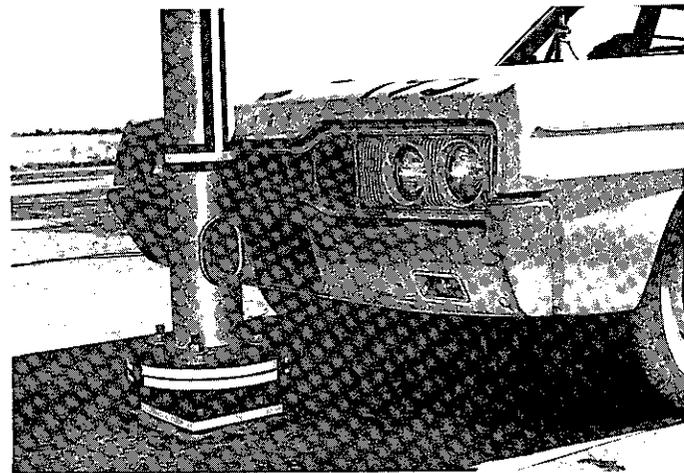
The two 18-1/4-in. diameter 1-in. thick mild steel plates on the slip base were held together with three 1-1/4 in. black bolts conforming to ASTM Designation A-307 (Figures 9 and 10.) Bolt torque was approximately 50 ft-lb which is equivalent to about 2000 lbs. bolt tension. Each of the top washers was pinned to the upper 1" plate with two 1/8" shear pins to prevent the bolts from walking out of the slots due to wind vibration.

Test 195 was a 40 mph head-on impact. Upon contact, the base parted instantaneously and the pole kicked up and ahead, clearing the vehicle passing underneath by 5-ft. The luminaire broke loose from the mast arm and fell directly over the foundation. While falling the mast arm rotated 180 degrees in the clockwise direction and the pole came to rest approximately on line 25-ft beyond impact. Vehicle damage was mild with only a 9-in. penetration into the hood and bumper.

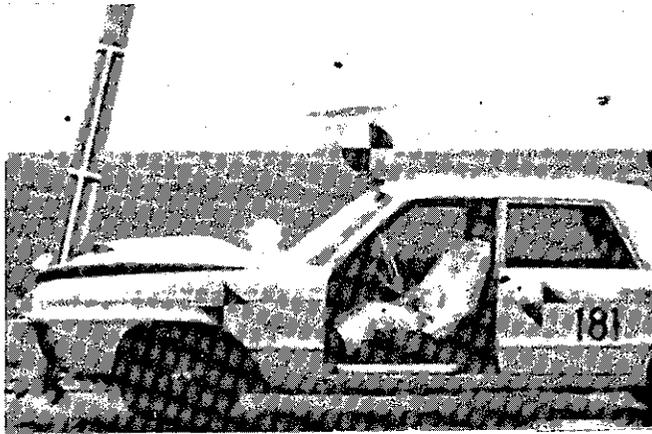
IMPACT + 0.08 Sec

DATE . . . . . 2-8-68  
 TYPE OF LIGHT STD. . . . . Steel Type XV  
 BASE (outside diameter) LIGHT STD. . . . . 7 3/4"  
 MOUNTING HEIGHT . . . . . 30"  
 LENGTH OF MAST ARM . . . . . 12'-0"  
 BREAKAWAY DEVICE . . . . . Notched Bolts  
 ARMCO 17-4 PH Steel Heat Treat 950°F

TEST NO. . . . . 181  
 VEHICLE . . . . . 1966 Dodge  
 VEHICLE WEIGHT . . . . . 4540 lbs.  
 (W/DUMMY & INSTRUMENTATION)  
 IMPACT SPEED . . . . . 40 mph.  
 IMPACT ANGLE . . . . . Head on  
 DUMMY RESTRAINT . . . . . None

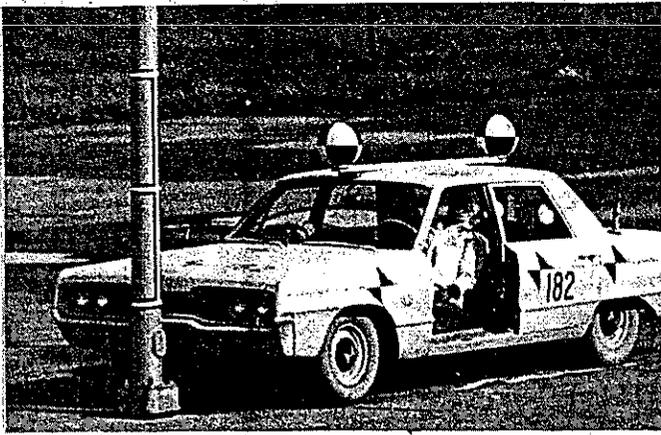
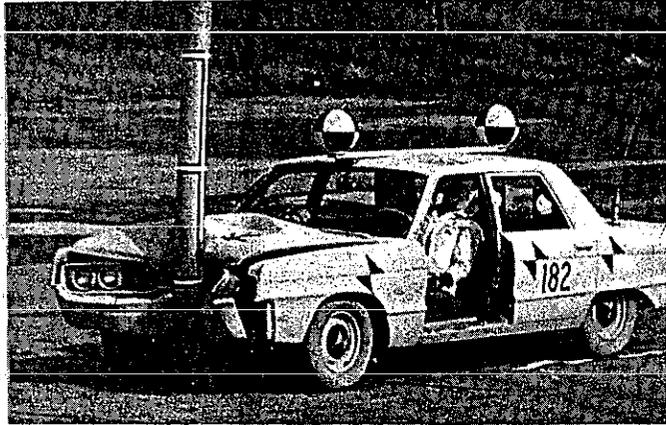
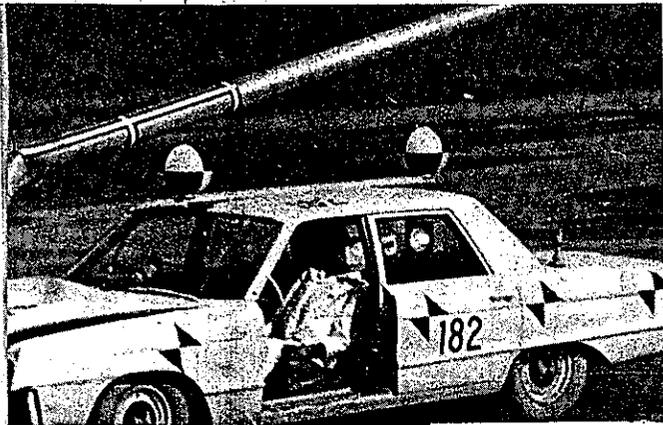
Plate 2

TEST NO. . . . . 162  
 VEHICLE . . . . . 1966 Dodge  
 VEHICLE WEIGHT . . . . . 4540 Lbs.  
 (W/DUMMY & INSTRUMENTATION)  
 IMPACT SPEED . . . . . 39.7 mph.  
 IMPACT ANGLE . . . . . Headon  
 DUMMY RESTRAINT . . . . . None

DATE . . . . . 2-15-68  
 TYPE OF LIGHT STD. . . . . Steel Type XV  
 BASE (outside diameter) LIGHT STD. . . . . 7 3/4"  
 MOUNTING HEIGHT . . . . . 30'-0"  
 LENGTH OF MAST ARM . . . . . 12'-0"  
 BREAKAWAY DEVICE . . . . . 6" Frang. Al. Base Insert

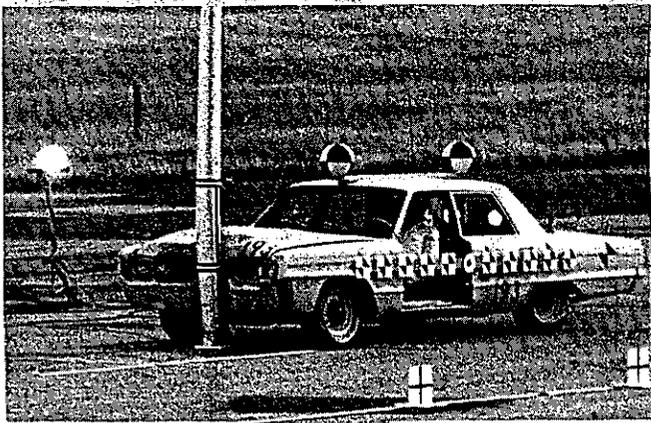
DATE . . . . .	6-7-68	TEST NO. . . . .	192
TYPE OF LIGHT STD. . . . .	Steel Type XV	VEHICLE . . . . .	1966 Dodge
BASE (outside diameter) LIGHT STD. . . . .	7 3/4"	VEHICLE WEIGHT . . . . .	4540 Lbs.
MOUNTING HEIGHT . . . . .	30'-0"	(W/DUMMY & INSTRUMENTATION)	
LENGTH OF MAST ARM . . . . .	12'-0"	IMPACT SPEED . . . . .	39.9 mph.
BREAKAWAY DEVICE . . . . .	Notched Bolts	IMPACT ANGLE . . . . .	Headon
ARMCO 17-4 PH Steel Heat Treat 1050°F		DUMMY RESTRAINT . . . . .	None

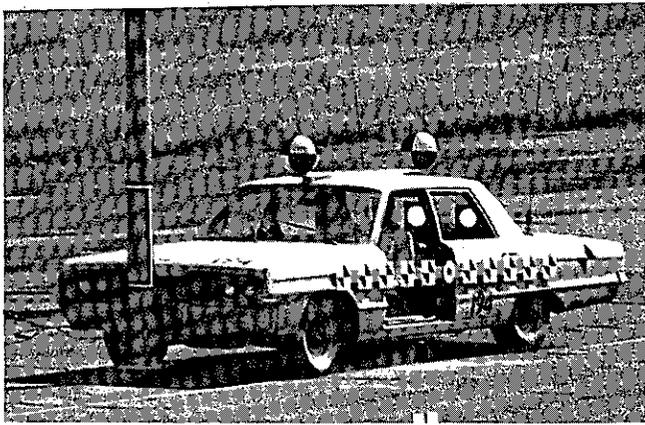
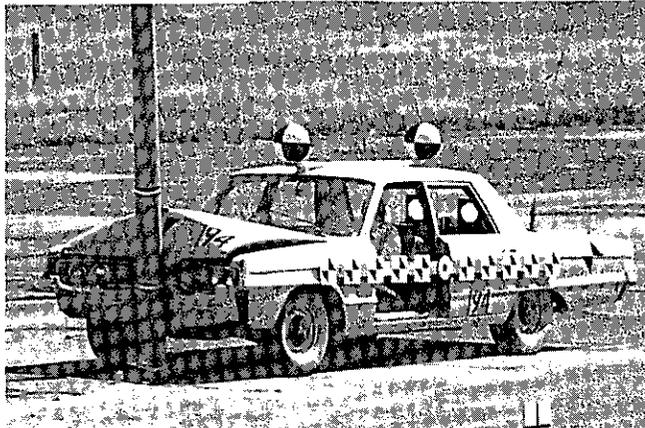
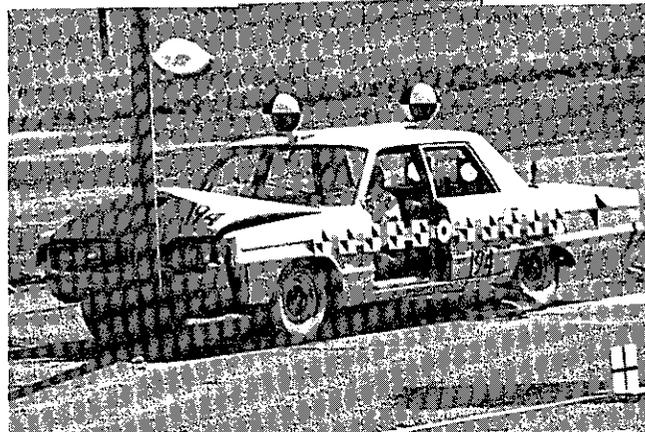
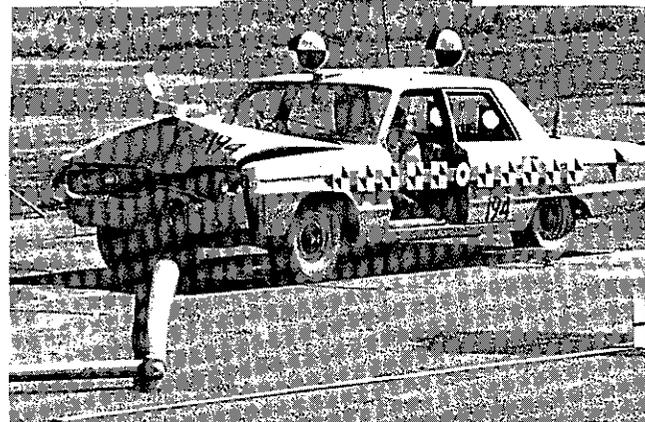
DATE . . . . . 6-12-68  
 TYPE OF LIGHT STD. . . . . Tapered Al.  
 BASE (outside diameter) LIGHT STD. . . . . 9"  
 MOUNTING HEIGHT . . . . . 30'-0"  
 LENGTH OF MAST ARM . . . . . 12'-0"  
 BREAKAWAY DEVICE . . . . . Cast Al. Base

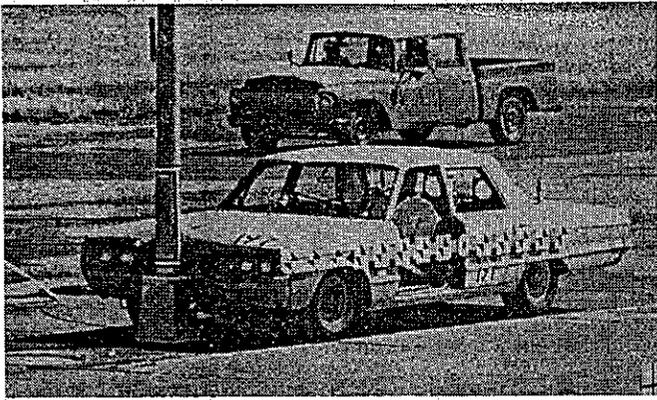
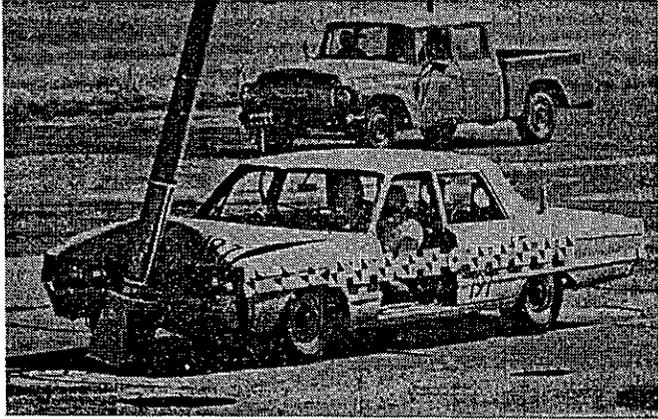
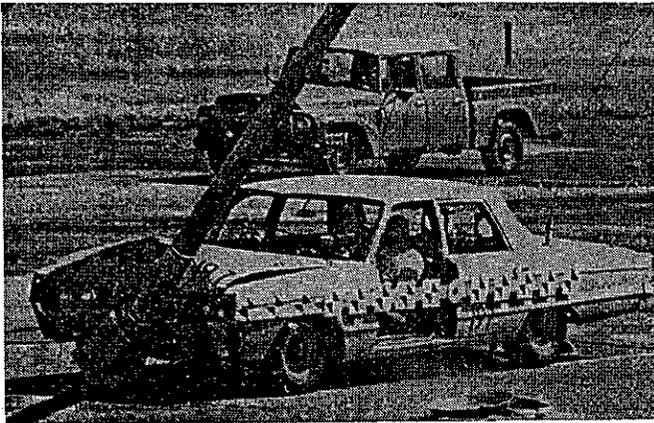
DATE . . . . . 7-11-68  
 TYPE OF LIGHT STD. . . . . Steel Type XV  
 BASE (outside diameter) LIGHT STD. . . . . 7 3/4"  
 MOUNTING HEIGHT . . . . . 30'-0"  
 LENGTH OF MAST ARM . . . . . 12'-0"  
 BREAKAWAY DEVICE . . . . . (T.T.I.) Texas Slip Base

TEST NO. . . . . 196  
 VEHICLE . . . . . 1966 Dodge  
 VEHICLE WEIGHT . . . . . 4540 lbs.  
 (W/DUMMY & INSTRUMENTATION)  
 IMPACT SPEED . . . . . 15.8 m.p.h.  
 IMPACT ANGLE . . . . . Head on  
 DUMMY RESTRAINT . . . . . None

As in the previous test, the pole again parted instantaneously on impact with very little damage to the front of the test vehicle (3-in. bumper penetration). However, because of the low impact speed, the pole did not kick up high enough to clear the test vehicle and fell back on top of it as it passed under, denting the roof and cracking the windshield. As the car continued under the pole, the pole base struck the rear part of the roof shattering the rear window. Judging by the minor extent of roof denting and by the broken glass, injuries to occupants of the vehicle

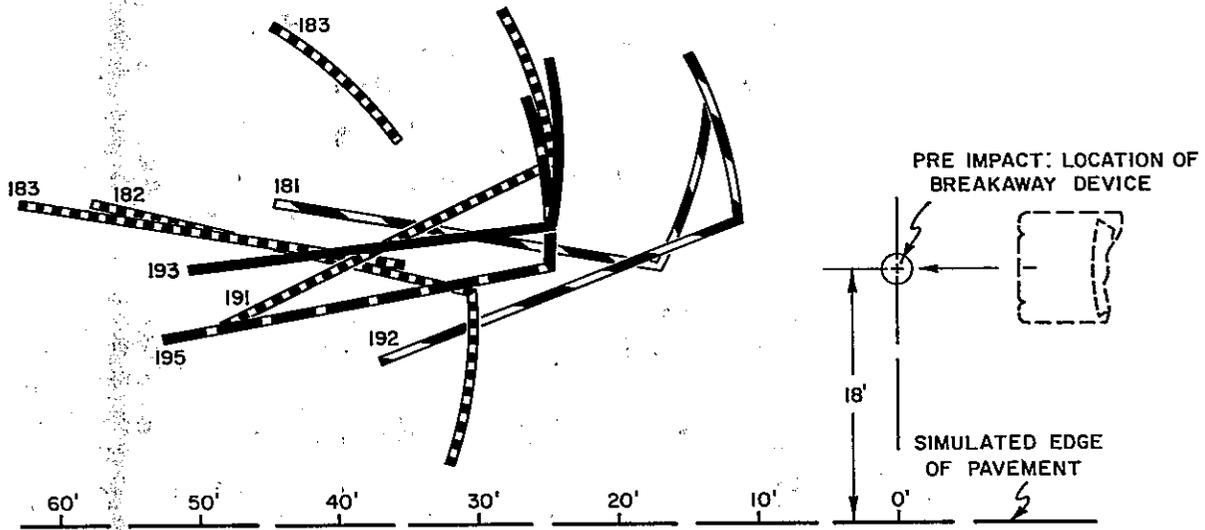
40 MPH TESTS

TEST NO.	BREAKAWAY DEVICE
181.....	NOTCHED BOLTS H-950°F
182.....	6" FRANGIBLE AL. INSERT
183.....	6" FRANGIBLE AL. INSERT (MODIFICATION#1)
191.....	6" FRANGIBLE AL. INSERT (MODIFICATION#2)
192.....	NOTCHED BOLTS H-1050°F
193.....	AL. SLEEVE BASE WITH AL. POLE
195.....	TEXAS SLIP BASE

Caution should be used in locating any breakaway lighting standard close to the traveled way. Pole trajectories after impact indicate that the problem of pole encroachment into the traveled way is minimized with the T.T.I. slip base design. Even at a 15 mph impact speed, the slip base was carried approximately 40 ft beyond the foundation and in the direction of impact, resulting in the least encroachment toward the traveled way of the three designs tested at that speed.

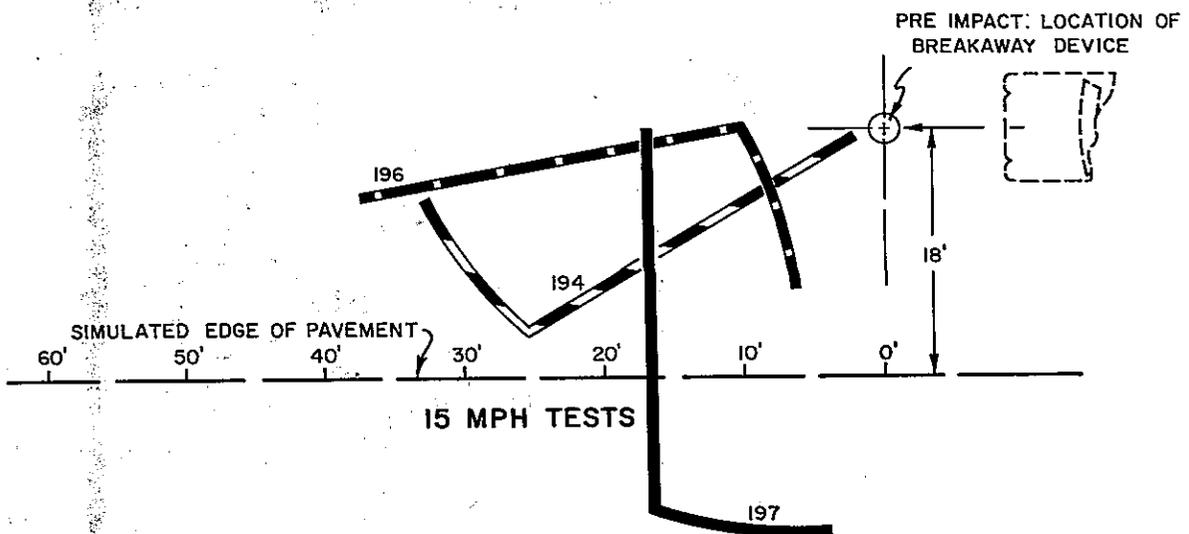
15 MPH TESTS

TEST NO.	BREAKAWAY DEVICE
194.....	NOTCHED BOLTS H-1050°F
196.....	TEXAS SLIP BASE
197.....	AL. TRANSFORMER BASE

It was significant to note that with an 18 ft. setback from the edge of pavement, just one of the three standards tested at low speeds would have fallen into the traveled way (Plate 12). In general, the pole reactions in this test series correlate well with work by other researchers with mathematical models, dynamic tests, and field performance.<sup>2,3,4</sup> Of particular significance is the post-impact position of the lighting standard supported on the slip base design for the 15 mph impact.
