Dynamic Tests Of An Energy Absorbing Barrier Employing Sand-Filled Frangible Plastic Barrels

# HIGHWAY RESEARCH REPORT

## DYNAMIC TESTS OF AN ENERGY ABSORBING BARRIER EMPLOYING SAND-FILLED FRANGIBLE PLASTIC BARRELS

**MATERIALS AND RESEARCH DEPARTMENT**  
**RESEARCH REPORT**  
**NO. M&R HRB 636405-4**

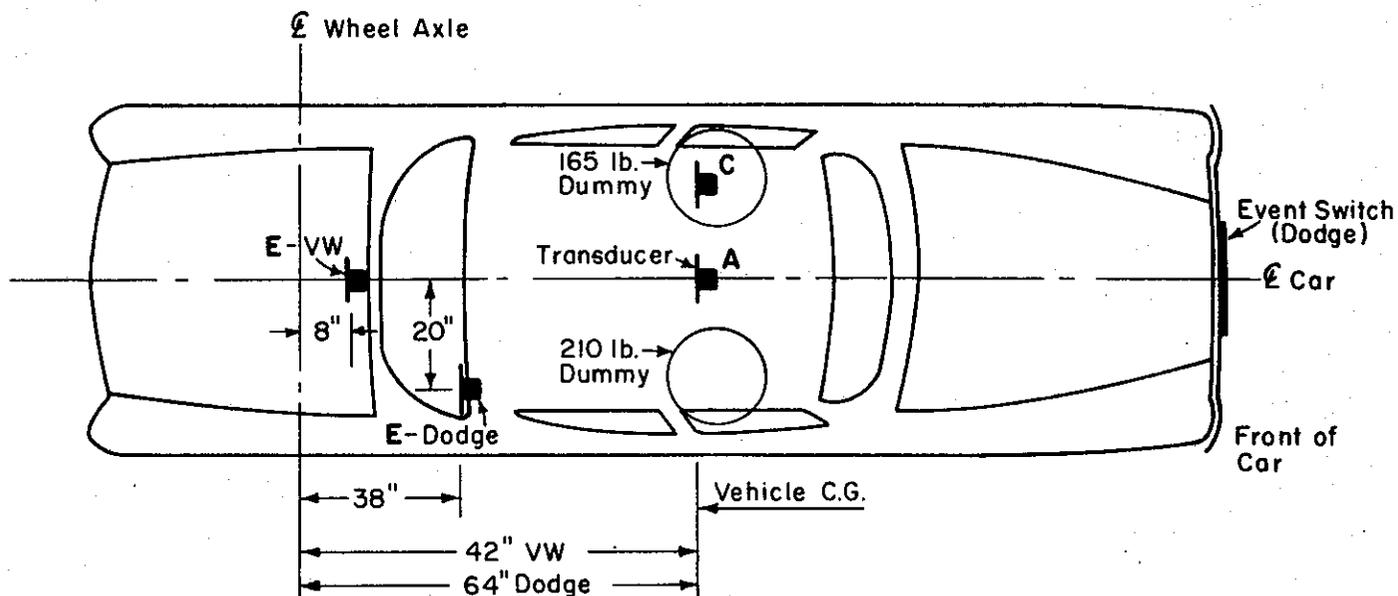
Plate 1  
 CALIFORNIA DIVISION OF HIGHWAYS  
 VEHICLE INSTRUMENTATION

Tests 241 & 243  
 (Dodge)

CHANNEL NO.	LOCATION <sup>1</sup>	DESCRIPTION
1	C	Longitudinal accelerometer - head.
2	C	Lateral accelerometer - head.
3	C	Vertical accelerometer - head.
4	C	Longitudinal accelerometer - chest.
5	A	Longitudinal accelerometer.
6	A	Lateral accelerometer.
7	E	Longitudinal accelerometer.
8	E	Lateral accelerometer.
9	C	Seat belt transducer - lap belt.
13	L	Event switch mounted across front bumper.
	E	Impact-O-Graph with mechanical stylus.

<sup>1</sup> A and E on vehicle floor; C on back of dummy's chest cavity and back of dummy's head cavity.

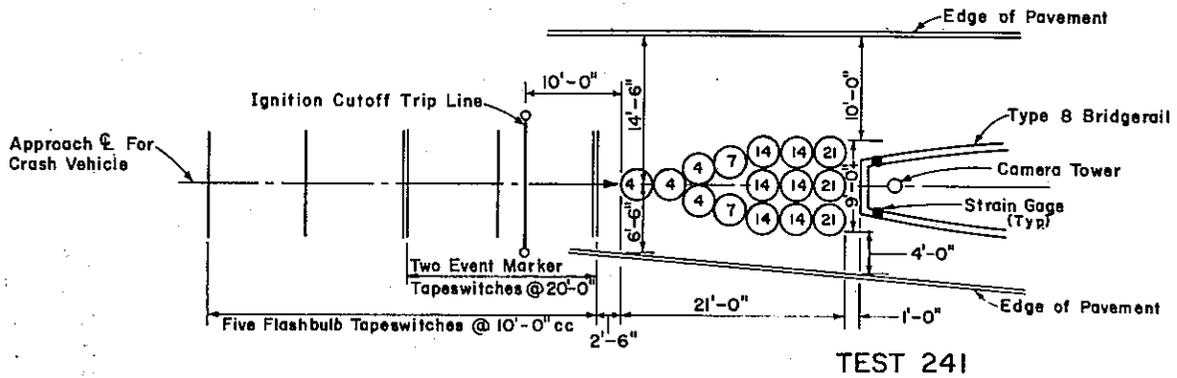
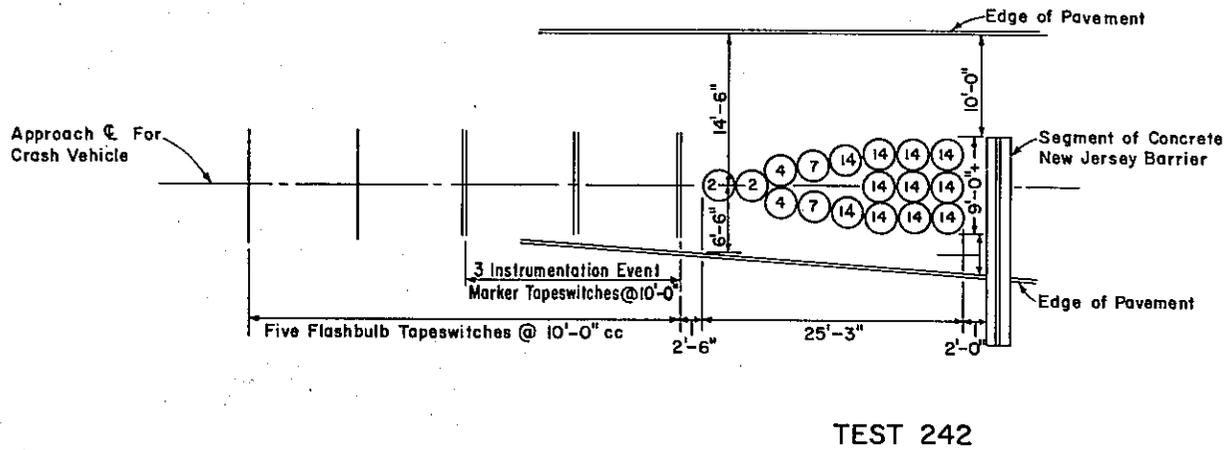
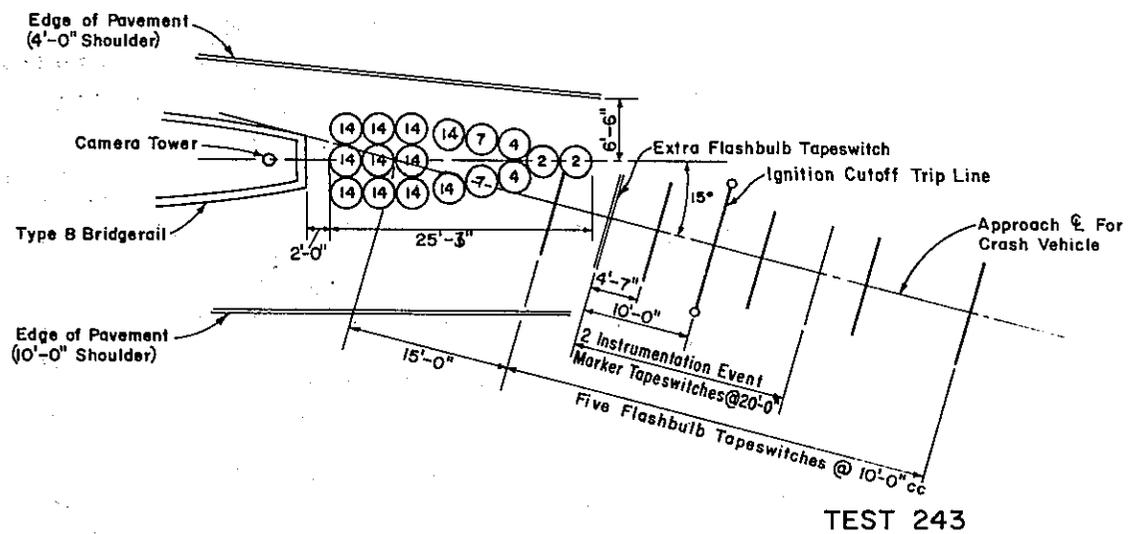
### BARRIER INSTRUMENTATION

- - Strain gage on top surface of upper and lower rails, 8 in. behind nose of bridgerail-total 3
- ⊙ - Barrels with nominal wt. of sand in hundreds of pounds.

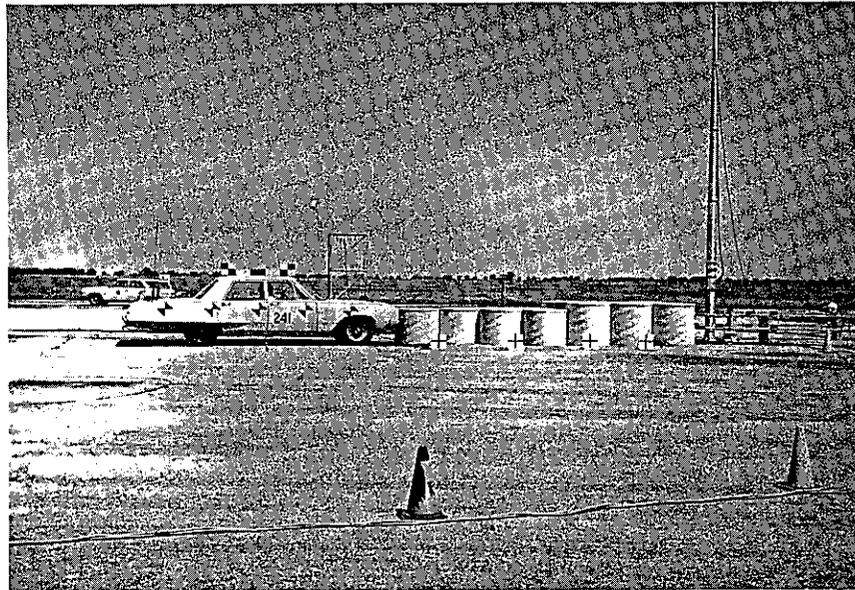
FIGURE 1

The test barrier for Test 241 was composed of an array of frangible plastic barrels containing varied amounts of sand and was placed in front of a California Type 8 Bridge Approach Guardrail (BAGR - see Figure 1 and Exhibits 1 and 2). Deceleration of the impacting vehicle was obtained through a transfer of momentum from the vehicle to the sand. The foamed plastic used for the barrels was frangible so the sand was relatively unconfined when the modules were subjected to an impact-type load. Thus the barrier design was based on the conservation of momentum with adjustments so that standard barrel sizes could be used. The over-all barrier length for the first test was 21 ft  $\pm$ . An additional 1 ft gap was left between the rear of the barrier and the nose of the BAGR to provide some additional deceleration distance and to minimize the accumulation of sand against the BAGR (might provide a ramp for the vehicle).

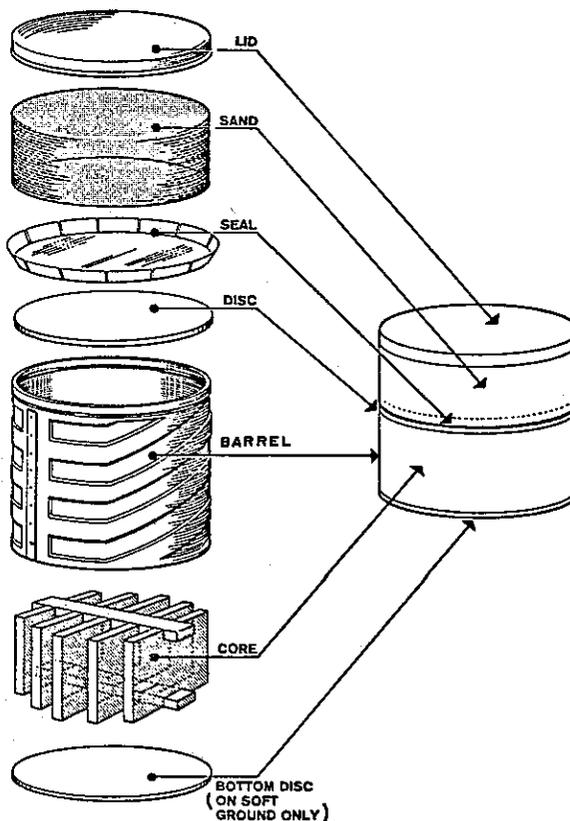
FIGURE 2

Several components were used to construct each barrel (Figure 2). Frangible, high density polyethylene plastic was used as the barrel

material and a thin flexible plastic was used for the lids. A round plastic disc was available to place at the bottom of the barrel on soft ground; however, it was unnecessary for the test barrier. An interlocking group of seven polystyrene (plastic) boards served as a core to support the sand at the proper height in the barrel. Covering the core was a thin, hard, circular, high impact polystyrene (plastic) disc. A flexible clear plastic circular seal with upturned edges was seated on top of the disc to prevent the sand from spilling down to the ground. The sand was poured into the barrel to obtain the desired weight and then a lid was riveted to the barrel in three or four places. Core heights available from the manufacturer permitted nominal sand weights (based on a sand density of 100 pcf) of 200, 400, 700, and 1400 lbs.; a full barrel (with no core) contained 2100 lbs. of sand. The barrels holding 1400 and 2100 lbs. of sand were 3' in diameter and 3' high; all other barrels were 3' diameter and 2'-6" high.

### BARREL COMPONENTS

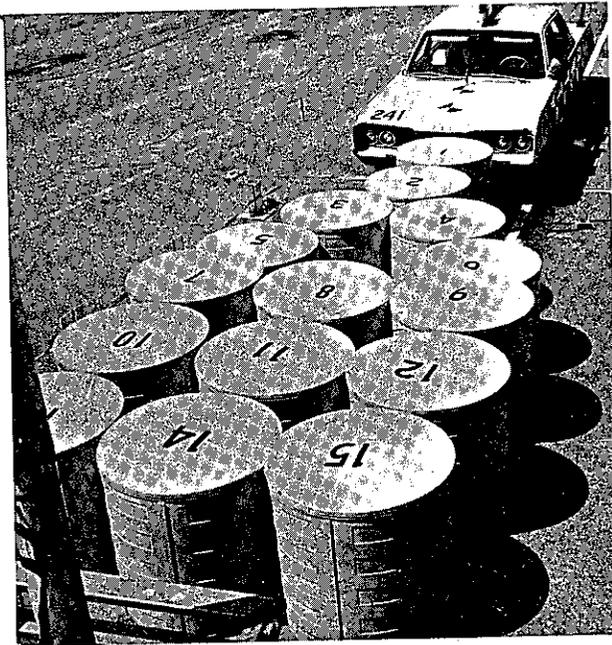
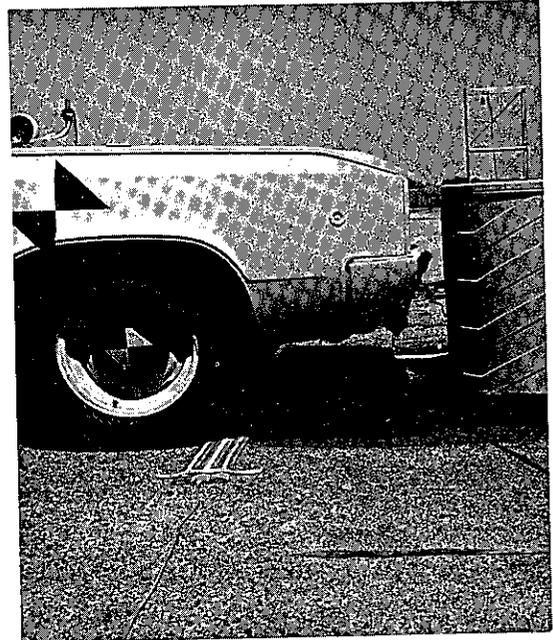
The initial barrier (Test 241) was constructed using barrels containing 400 lbs. of sand at the nose and 2100 lbs. of sand at the rear (see Exhibit 1 and Figures 3 and 4). This mass distribution was designed to obtain a relatively uniform rate of deceleration during impacts. The barrier had a width of 3 ft (one barrel) at the nose and was tapered out to a width of 9 ft (three barrels) at the rear.

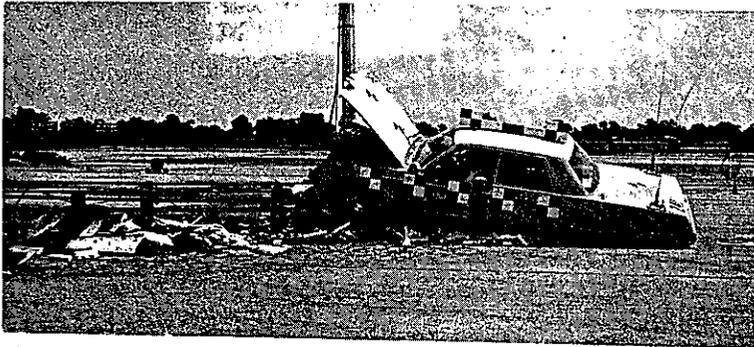
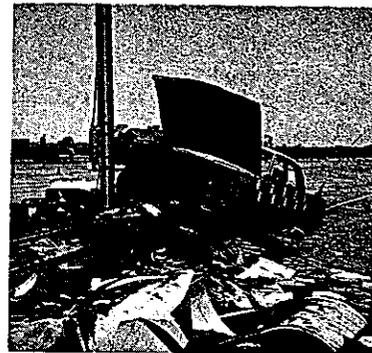
See Plate 3, page 15, for a summary of the test results. The vehicle, traveling 58 mph, impacted the barrier head-on and plowed through the entire barrier (Figures 5 and 6). The vehicle axis was one ft. to the left of the barrier axis at the time of impact. About 3-4 feet in front of the bridge railing, the vehicle ramped up on barrier debris and came to rest on the bridge rail just in front of the camera tower 24 ft behind the nose of the barrier. As it ramped up, the vehicle tilted sharply in a counterclockwise direction, since the left front wheel was off the bridge rail, and almost turned over (Figure 7) before returning to its final position. The left rear fender was flush with the ground when the vehicle came to rest.

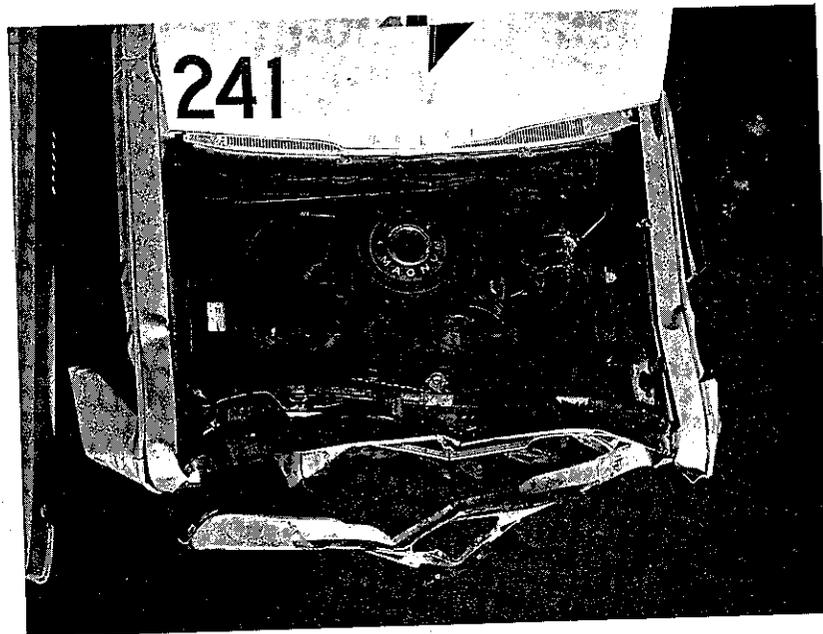
FIGURE 8

Damage was confined mainly to the front end. Maximum significant crush at the center of the vehicle forestructure was 1'-8". The crush was fairly uniform across the front of the vehicle but slightly less on the left side (see Figure 8 and Exhibit 3). The lower frame member, bumper, and front fenders were all severely buckled and the radiator was shoved back against the engine. On the passenger side, the front windshield was cracked where the sun visor came down and was struck by the dummy's head. No crimp in the roof over the doorpost was observed. The doorpost on the driver's side was torn loose from its roof connection and displaced back  $\frac{1}{2}$ ". Immediately after impact, the hood flew open. However, it sustained no damage, mainly because the level of the hood was higher than the 2'-6" high barrels at the nose of the barrier. The steering wheel deformation was 2 $\frac{1}{2}$ "; the collapsible steering column was foreshortened 0.7" when the jackknifing dummy hit it.

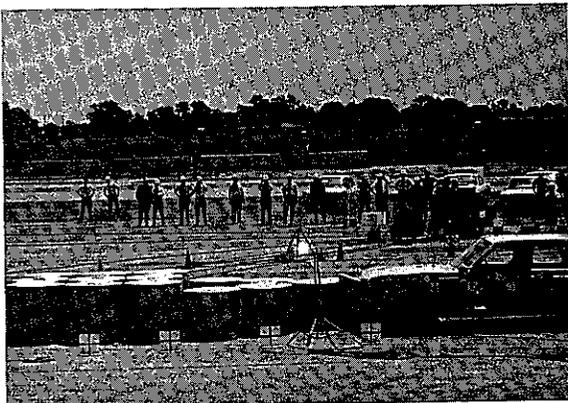
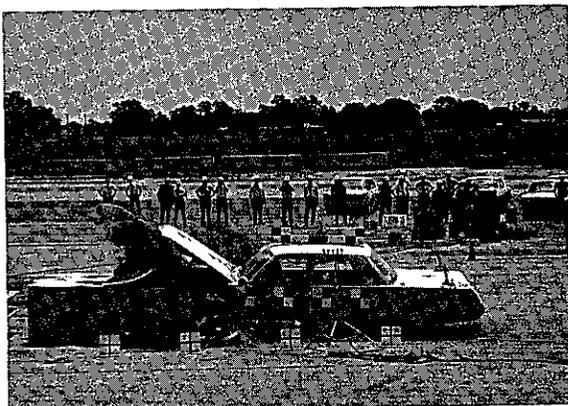
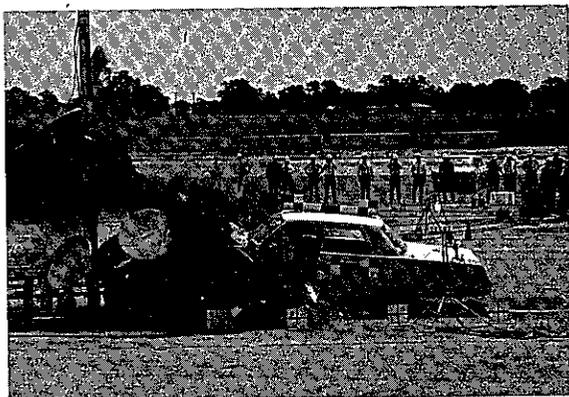
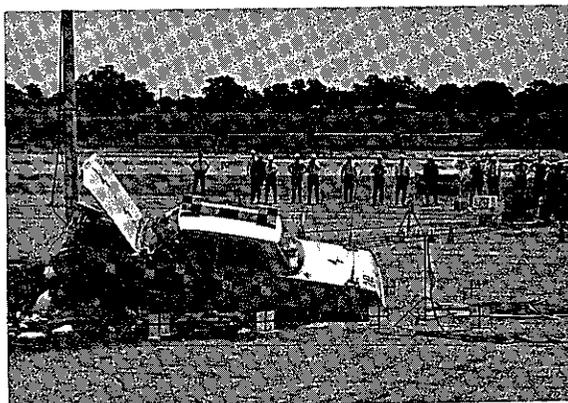
Impact + 0.027 Sec.

Impact + 0.231 Sec.

Impact + 0.435 Sec.

Impact + 2.373 Sec.

Test No. 241  
Date of Test May 21, 1970  
Vehicle 1968 Dodge  
Vehicle Weight (w/dummies and instrumentation) 4690 lb.  
Impact Velocity ( $V_0$ ) 58.0 mph  
Impact Angle Head-on  
Dummy Restraint Lap Belt  
Barrier Depth 21'-10"  
No. of Plastic Barrels 15

Deceleration Distance of Passenger Compartment 24'-0"  
Maximum Vehicular Deformation at Forestructure 1'-8"  
Passenger Compartment Deceleration - Highest 50 ms. avg. - accelerometer record, 100 Hertz 10.7 G's  
Vehicular Deceleration - Avg. value based on  $V_0^2 = 2as$  where  $s = 24.0'$  (stopping distance) 4.7 G's  
Gadd Severity Index (Dummy's head) 185

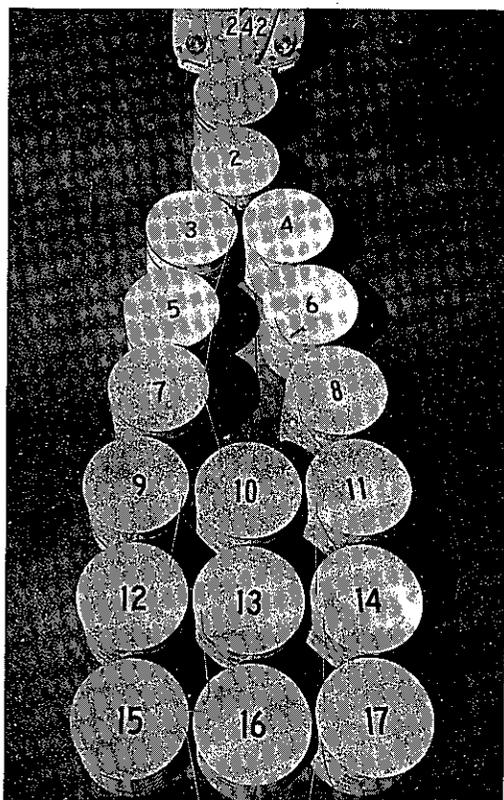
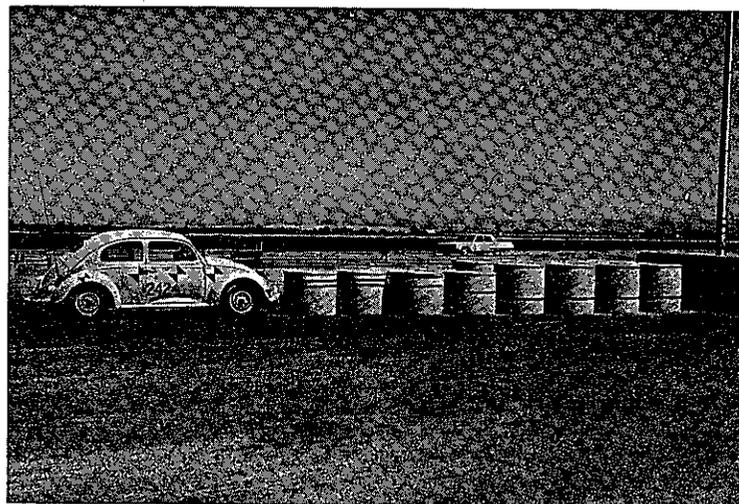
The test barrier consisted of 17 plastic barrels filled with varied amounts of sand ranging from 200 lbs. at the nose of the barrier to 1400 lbs. at the rear (see Exhibit 1 and Figures 9 and 10). The black tape on the barrels shows the bottom level of sand in the rear barrels and top and bottom levels in the front barrels. The above weights are nominal for an assumed sand density of 100 pcf. Since it was determined that the actual (moist) sand density for Test 241 was only 80 pcf, sand that had been run through a dryer just prior to delivery was used for Test 242. This sand had a higher density of 88 pcf (moisture content of 0.4%). The plastic barrel components were all identical to those used for Test 241.

The barrier was lengthened from 21 ft (Test 241) to 24 ft (nominal) and the barrel weights were decreased at the nose to provide a softer impact. Also, the rear barrels were changed from 2100 lbs. to 1400 lbs. and the void space at the rear increased from 1 ft to 2 ft in an attempt to lessen the accumulation of sand and debris against the fixed object which had caused ramping in Test 241. A section of New Jersey concrete median barrier was used as the fixed object instead of the bridge rail because of the location of the ground anchors for the cable tow system used in this test.

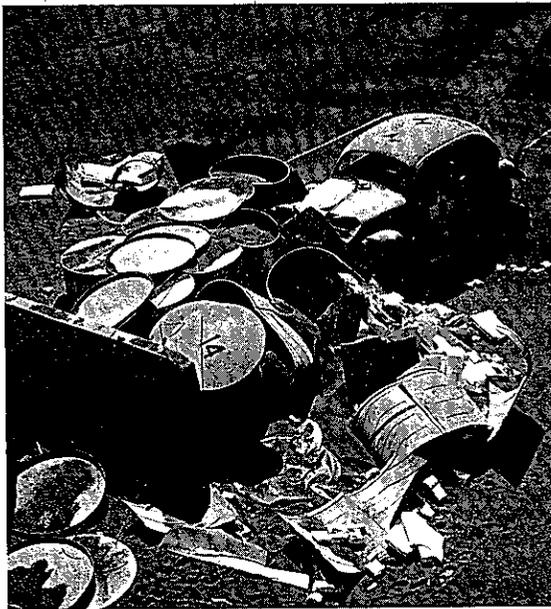
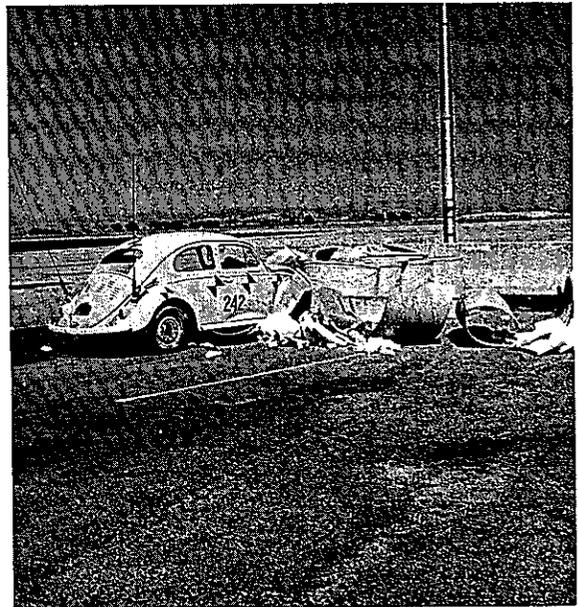
See Plate 5, page 21, for a summary of the test results. The VW hit the barrier nose head-on with its axis about 9 in. to the left of the barrier center line. The impact velocity was 59 mph. The vehicle came to rest 19 ft beyond the nose of the barrier with all its wheels on the ground (Figures 11 and 12). During impact there was a 1'-4" rise at the rear of the vehicle (measured at a target on the right rear fender).

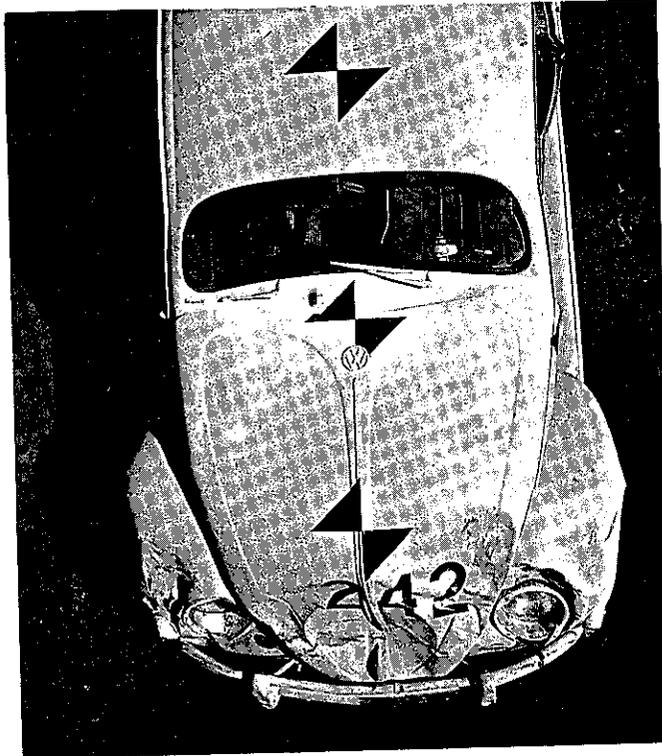
FIGURE 13

The front trunk lid remained closed and was moderately buckled, as were the front fenders. Maximum crush at the forestructure was

only 8 in. (see Exhibit 3 and Figure 13). The entire windshield popped out due to the impact from the dummy's head. The substitution of a pulley for the standard VW steering wheel (required for radio control of the VW) prevented measurement of any steering wheel deformation.

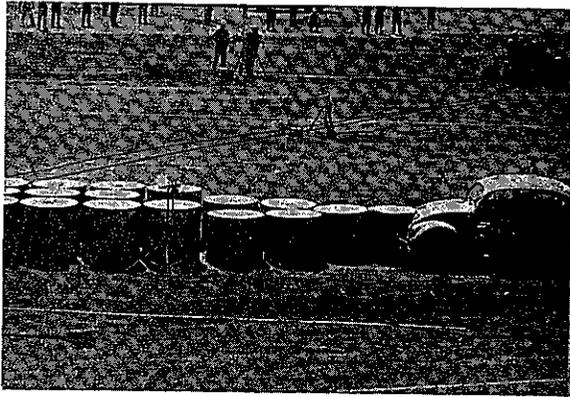
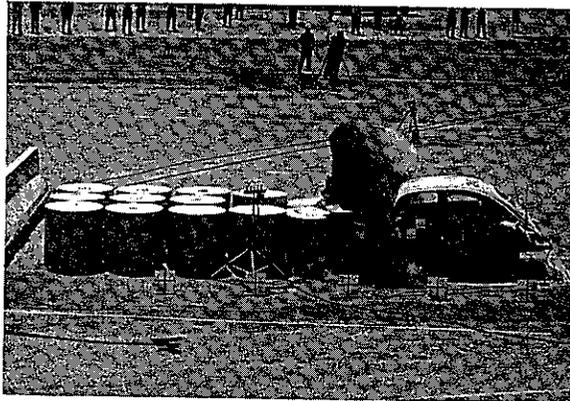
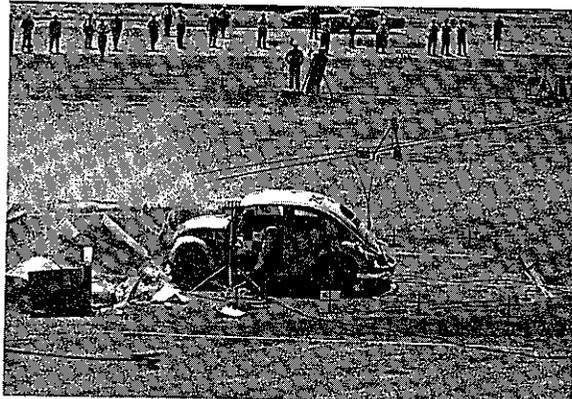
Impact + 0.022 Sec.

Impact + 0.163 Sec.

Impact + 0.586 Sec.

Impact + 4.536 Sec.

Deceleration Distance - Passenger Compartment  
 Maximum Vehicular Deformation at Forestructure  
 Passenger Compartment Deceleration -  
 Highest 50 ms. avg. - Accelerometer  
 Record, 176 Hertz  
 Vehicular Deceleration = Avg. value  
 based on  $V_0^2 = 2as$  where  $s = 19.0'$   
 (stopping distance)  
 Gadd Severity Index (Dummy's head)

19'-0"  
 8"  
 8.7 G's  
 6.1 G's  
 1280

Test No. 242  
 Date of Test September 4, 1970  
 Vehicle 1957 Volkswagen Sedan  
 Vehicle Weight 1940 lbs.  
 (w/dummy & instrumentation)  
 Impact Velocity ( $V_0$ ) 59.0 mph  
 Impact Angle Head-on  
 Dummy Restraint Lap belt  
 Barrier Depth 25'-3"  
 No. of Plastic Barrels 17

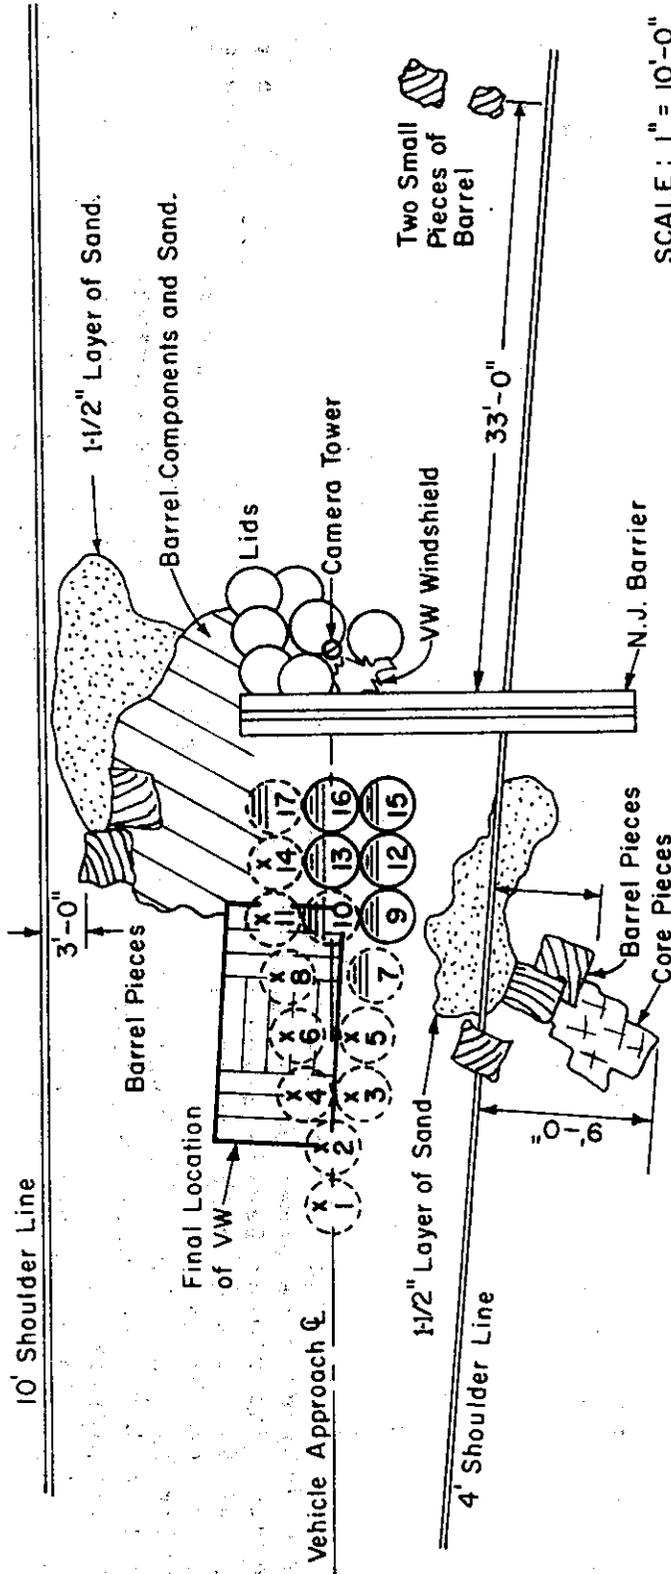
Plate 6, page 22, shows the location of the barrier debris. A small number of barrel core pieces were under the VW but there was no other debris under or behind it. There was no debris outside the 10 ft shoulder line but a small amount extended 9 ft beyond the 4 ft shoulder line. There was no sand covering the front of the VW. Very little debris was found beyond the back of the barrier. The lids all remained attached to the cotton rope and were clustered near the rear of the barrier. At least nine of the barrels were totally destroyed; four or five barrels were compressed but unbroken so they could have been reused; however, some of their inner foam plastic cores were crushed; three barrels were undamaged and undisturbed. The compressed barrels had moved forward during impact; it is unknown whether they could have been dragged on the ground and repositioned without breaking the plastic barrels and cores or spilling the sand.

1. Barrels 9, 12, 13, 15, & 16 were all intact with lids on; two were slightly compressed. No. 16 was 9" from N.J. Barrier.
2. Barrels with an (X) were broken and thrown out of position.
3. All lids remained tied together.
4. Small number of core pieces under car.
5. All 4 wheels of VW on ground.
6. Barrels 7 & 10 were compressed but unbroken, lids were off.
7. Barrel 17 was compressed, unbroken, lid off, leaning against N.J. Barrier.

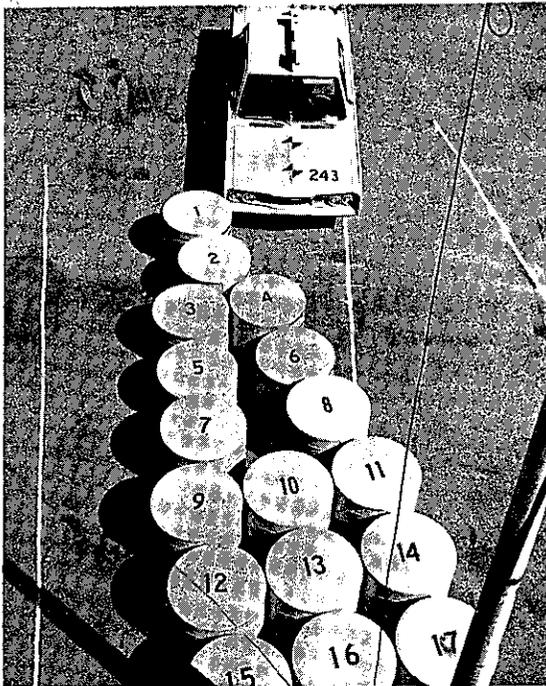
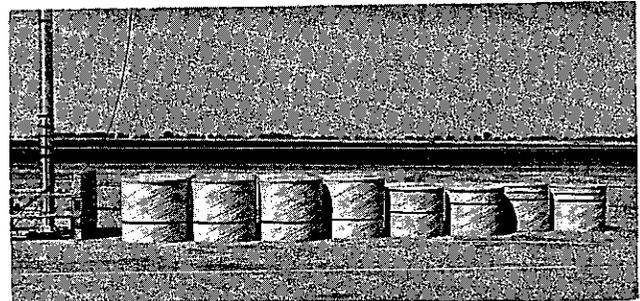
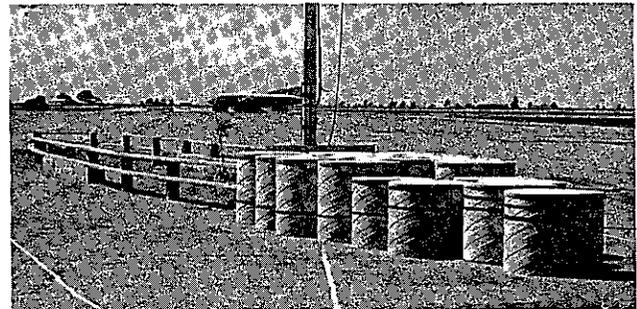
The test barrier had the same size, number, and configuration of barrels as was used for Test 242 (Figures 14-16). As in Test 242, the sand was dried prior to delivery. It had a density of 89.2 pcf and a moisture content of 0.8%.

Lids were attached to the barrels with four equidistant pop-rivets according to the manufacturer's directions. Three extra rivets were added in a short row next to one of these four rivets. This row of rivets was randomly located and was not on the same side of all the barrels. It was hoped that these extra rivets would provide a hinge effect and minimize the wide scattering of lids that occurred during Test 241.

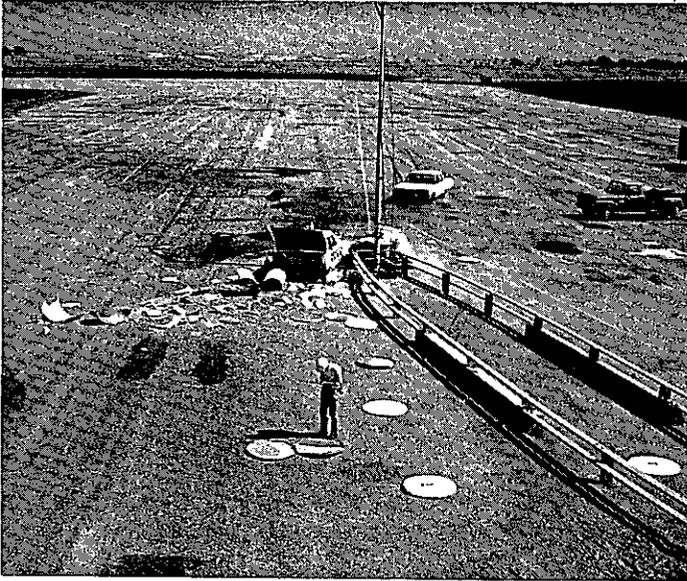
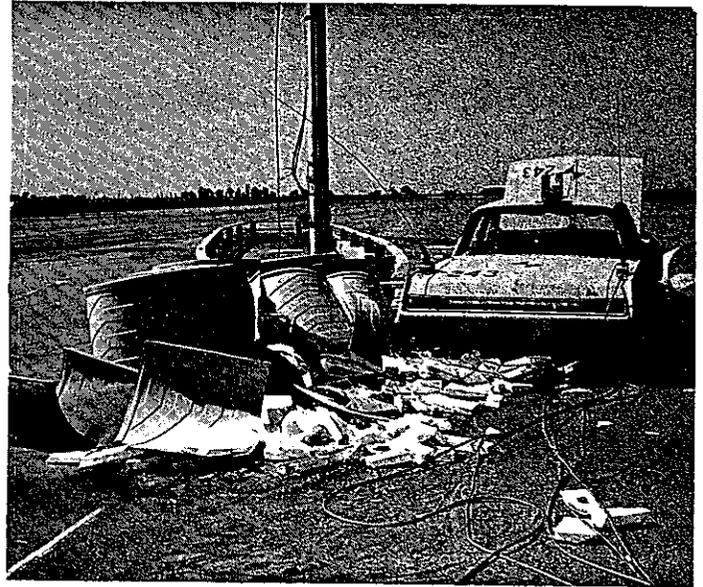
See Plate 7, page 26, for a summary of the test results. The crash vehicle hit the nose of the barrier about a foot to the right of the planned point of impact at a speed of 57 mph and angle of  $15^\circ$  with the barrier axis. It ramped up midway into the barrier and continued on over and through it, narrowly passed by the right corner of the Type 8 bridge approach guardrail nose, and stopped

with the rear of the vehicle even with the last row of barrels in the barrier. It came to rest with all wheels on the ground on a thin layer of sand (Figures 17 and 18).

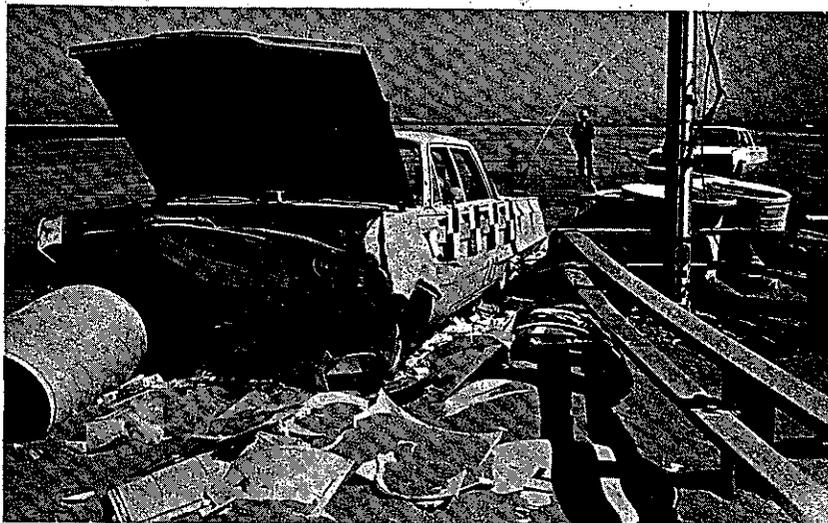
FIGURE 19

Damage to the vehicle forestructure was quite severe (Figure 19). The front end, including fenders, was uniformly crushed back against the engine. The maximum crush was 1'-9" (Exhibit 3). The engine was not displaced. The lower longitudinal front frame members and the bumper were sharply buckled down to the ground and back against the front wheels. The hood was undamaged due to the relatively low 30 in. height of the first four rows of barrels. A

crimp in the roof was observed on the driver's side above the door post. The rest of the car was undamaged. Maximum deformation of the steering wheel was 2-3/4 in. The collapsible steering column was foreshortened 0.75 in. due to impact by the dummy.

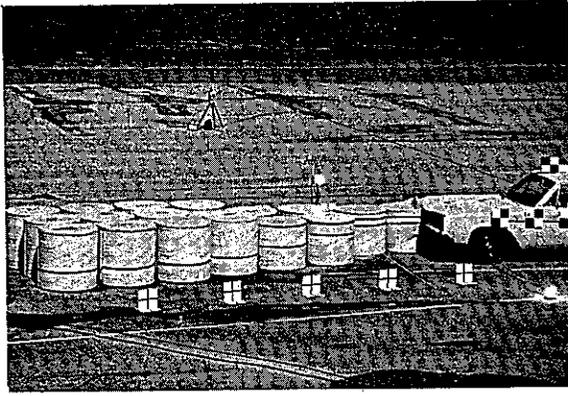
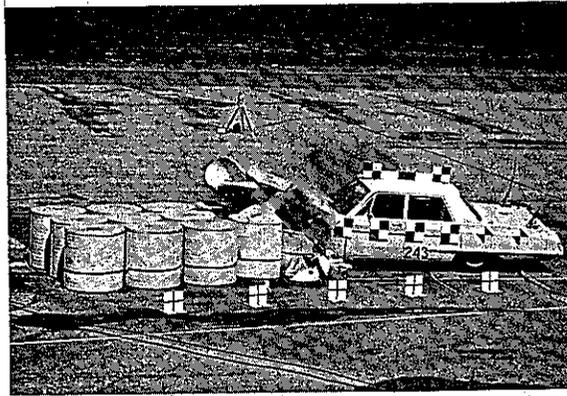
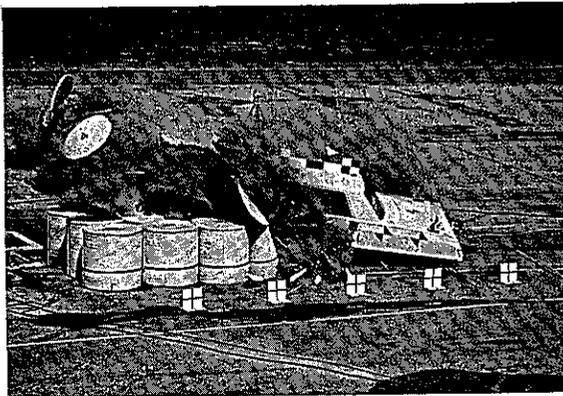
Impact + 0.012 Sec.

Impact + 0.180 Sec.

Impact + 0.348 Sec.

Impact + 8.880 Sec.

Test No. 243  
 Date of Test September 24, 1970  
 Vehicle 1968 Dodge  
 Vehicle Weight 4770 lbs.  
 (w/dummy & instrumentation)  
 Impact Velocity ( $V_0$ ) 57 mph  
 Impact Angle 15° nose  
 Dummy Restraint Lap belt  
 Barrier Depth 25'-3"  
 No. of Plastic Barrels 17

Deceleration Distance - Passenger Compartment 39'-0"  
 Maximum Vehicular Deformation at Forestructure 1'-9"  
 Passenger Compartment Deceleration - 7.9 G's  
 Highest 50 ms. avg. - accelerometer record, 176 Hertz  
 Vehicular Deceleration - Avg. value based on  $V_0^2 = 2as$  where  $s = 39'-0"$  (stopping distance) 2.8 G's  
 Gadd Severity Index (Dummy's head) 580

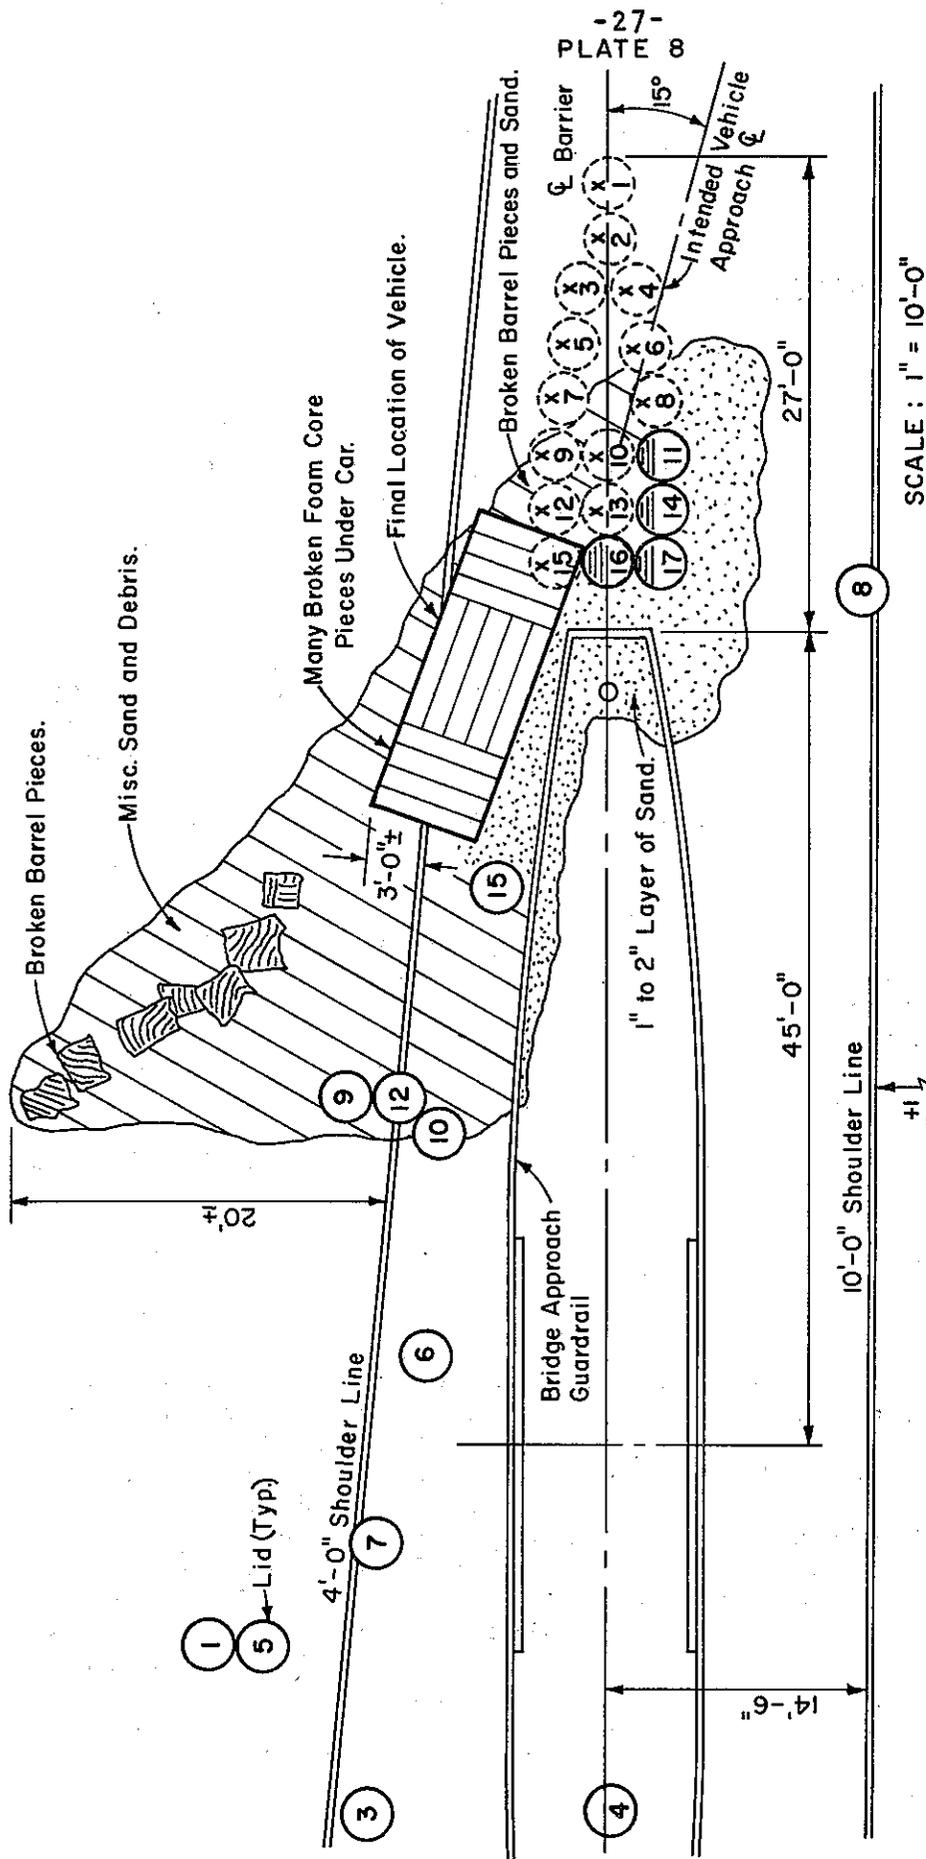
1. Many small, broken foam core pieces blown in all directions by wind.
2. Barrels 11, 14, 16 & 17 still upright, but squashed out of shape with lids still on.
3. Vehicle struck barrier 1 foot to right of intended vehicle approach centerline.
4. x indicates barrel was demolished.
5. Shoulder width measured at last row of barrels.

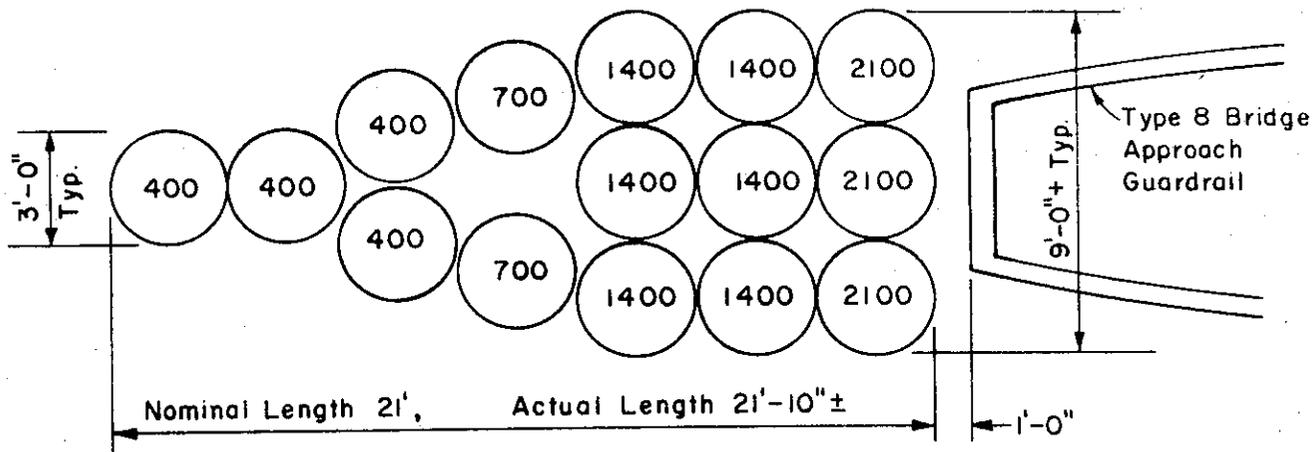
TEST NO. 241 PLAN VIEW

Shaded area shows location of sand inside barrels.

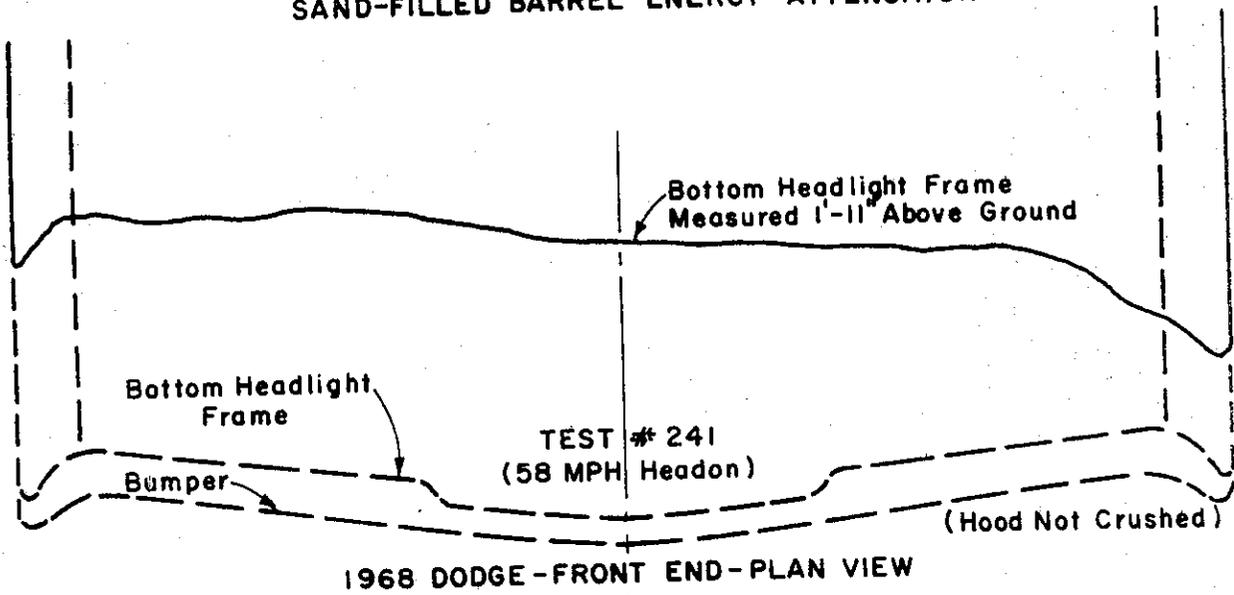
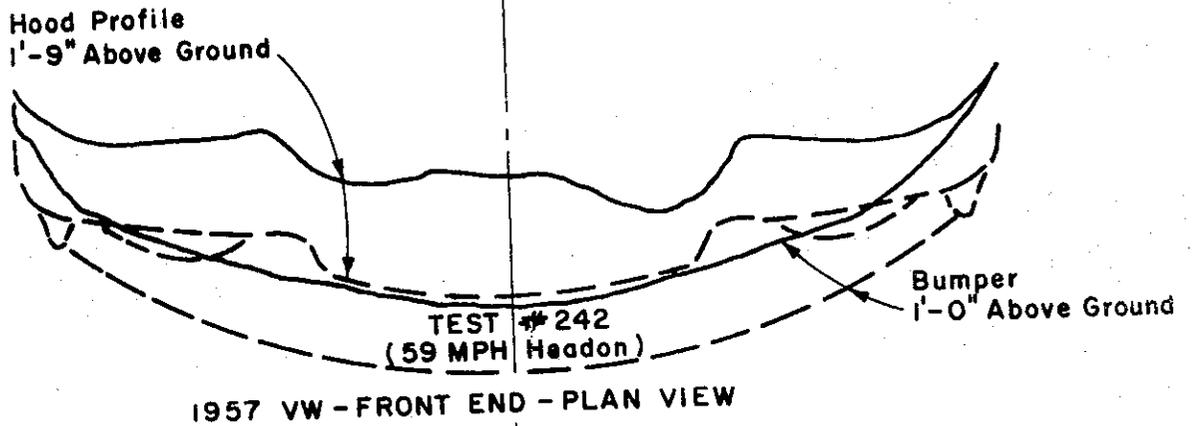
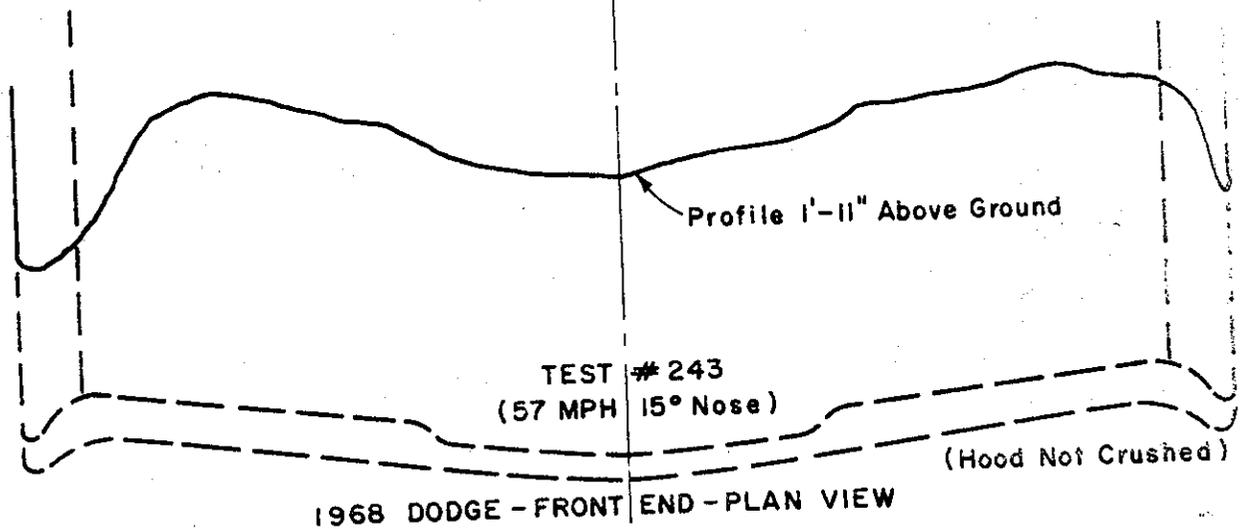
# VEHICULAR CRUSH SAND-FILLED BARREL ENERGY ATTENUATOR

Dashed lines show precrash profiles.
