RECENT EXPERIMENTAL PCC PAVEMENTS IN CALIFORNIA

INTERIM REPORT

RESEARCH REPORT

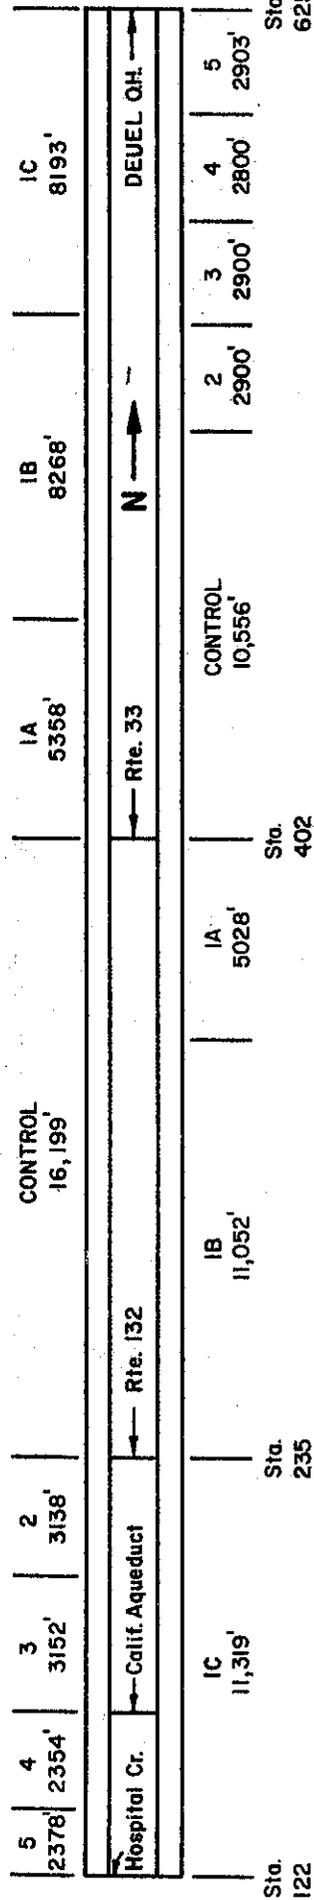
Figure 1

LAYOUT OF TEST SECTIONS

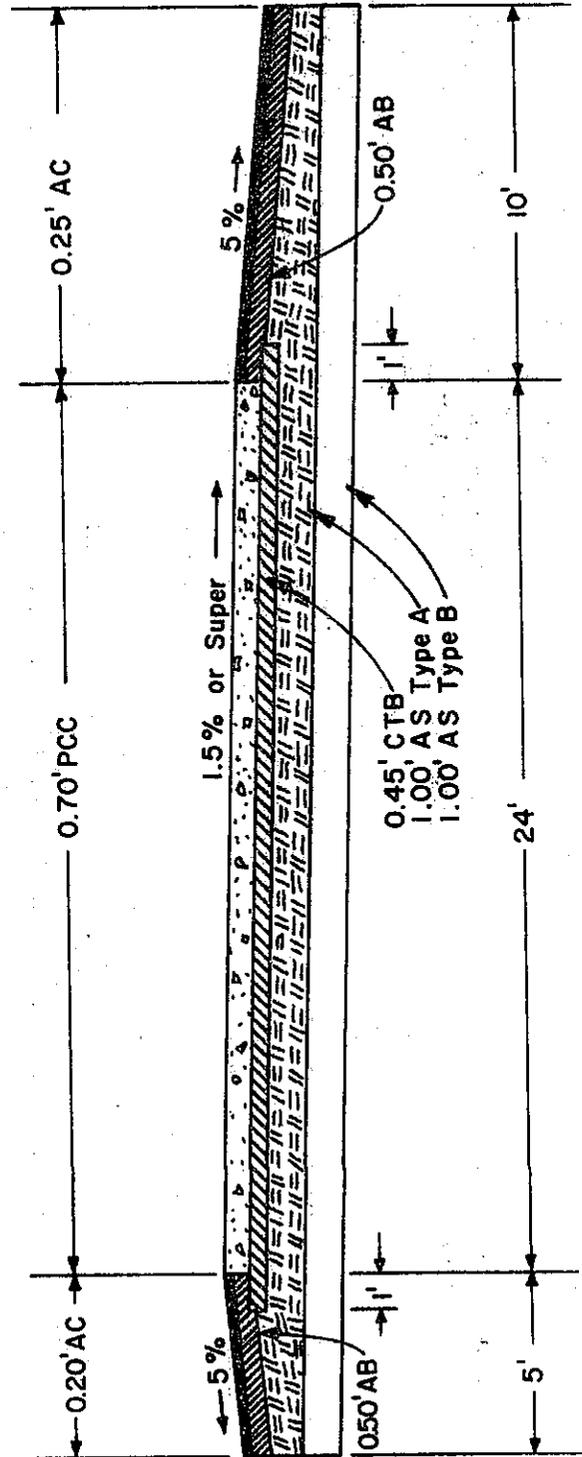
Figure 2

TYPICAL HALF SECTION
CONTROL AND SHORT JOINT SPACING

The structural design thicknesses for the various layers in the control sections were: 0.70-ft. PCC, over 0.45-ft. Class A cement treated base (CTB), over 1.00-ft. Class 4 aggregate subbase (AS), Type A, over 1.00-ft. Class 4 AS Type B over the imported borrow embankment. The shoulder consists of 0.25-ft. asphalt concrete over 0.50-ft. aggregate base over the AS. (The major difference between Type A and Type B AS is in the resistance value (R-value) requirement; Type A must have a minimum of 55, and Type B, 15.)

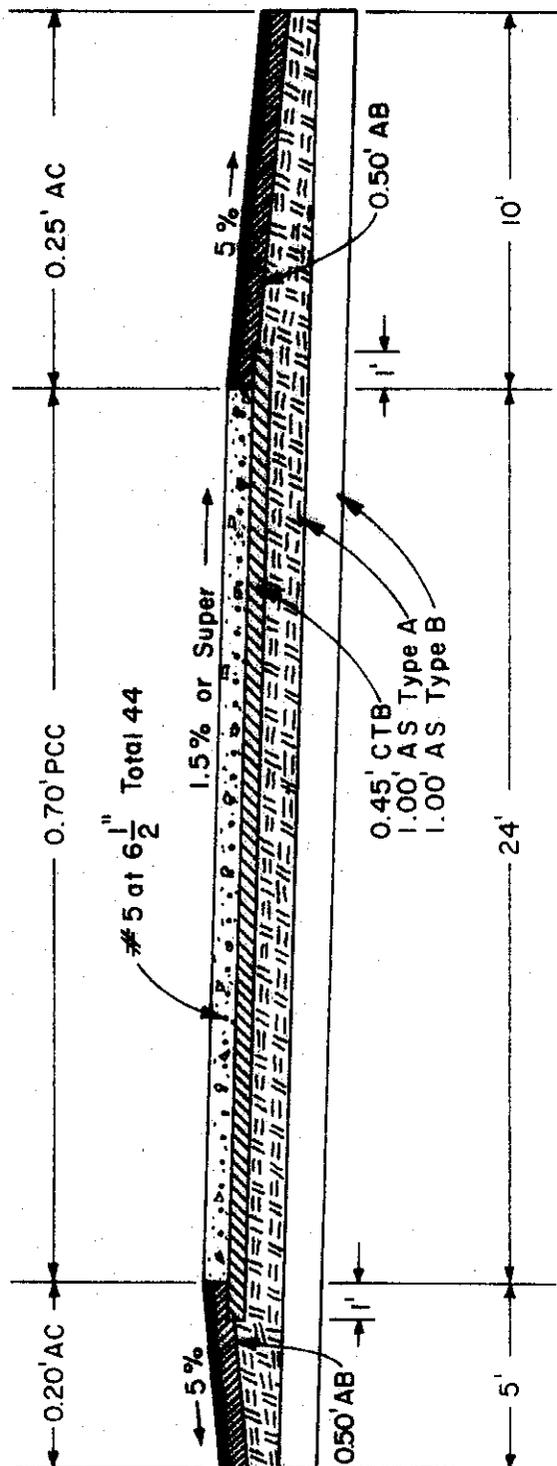
Figure 3

TYPICAL HALF SECTION
REINFORCED: LONGITUDINAL BARS ONLY

The thickness designated for CRCP was 0.70-ft., the same as that used for the control. Longitudinal reinforcement was 0.56% of the theoretical cross-sectional area, to be located 0.25 to 0.35-ft. from the top surface. Where longitudinal bars only were used (1-A), the reinforcement consisted of 44 No. 5 round deformed bars spaced at 6-1/2 inches in the 24-ft. slab width. For Section 1-B, longitudinal reinforcement was the same as in 1-A, but transversely, No. 4 bars spaced at 60 inches longitudinally were added. Transverse bars were set to the proper grade by placing on metal chairs, with longitudinal bars tied on top.

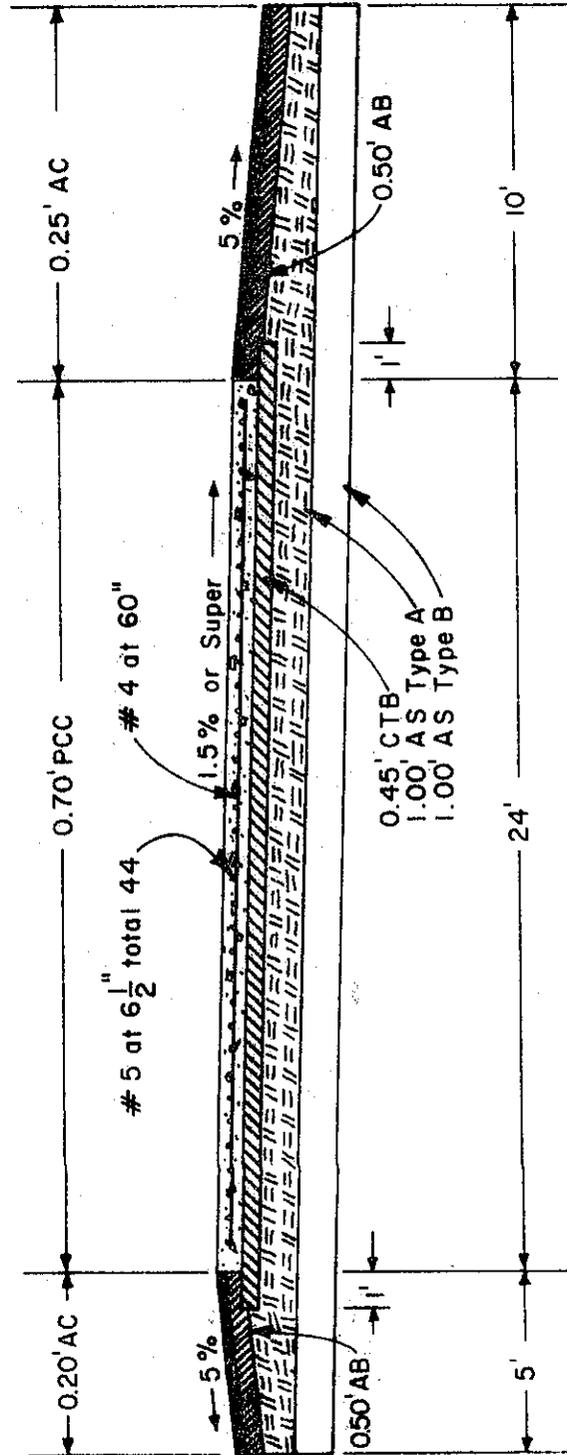
Figure 4

TYPICAL HALF SECTION
 REINFORCED: LONGITUDINAL AND TRANSVERSE BARS
 SYMBOLS & ABBREVIATIONS

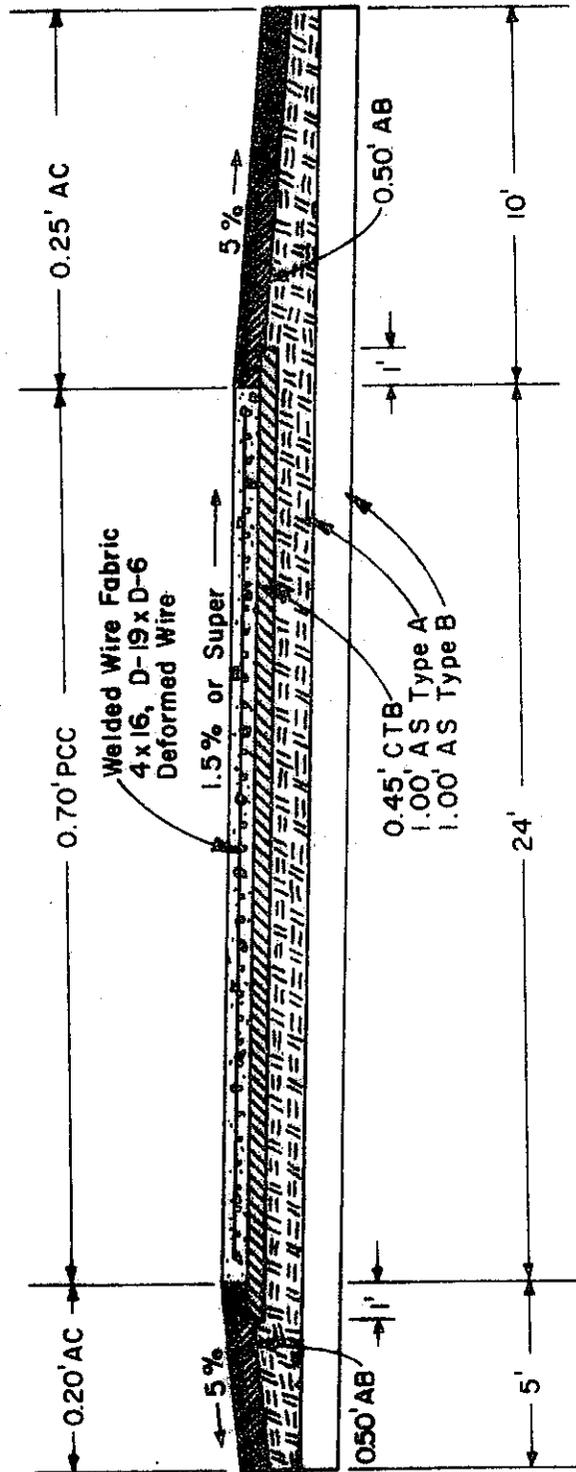
Figure 5

TYPICAL HALF SECTION
REINFORCED: WELDED WIRE FABRIC

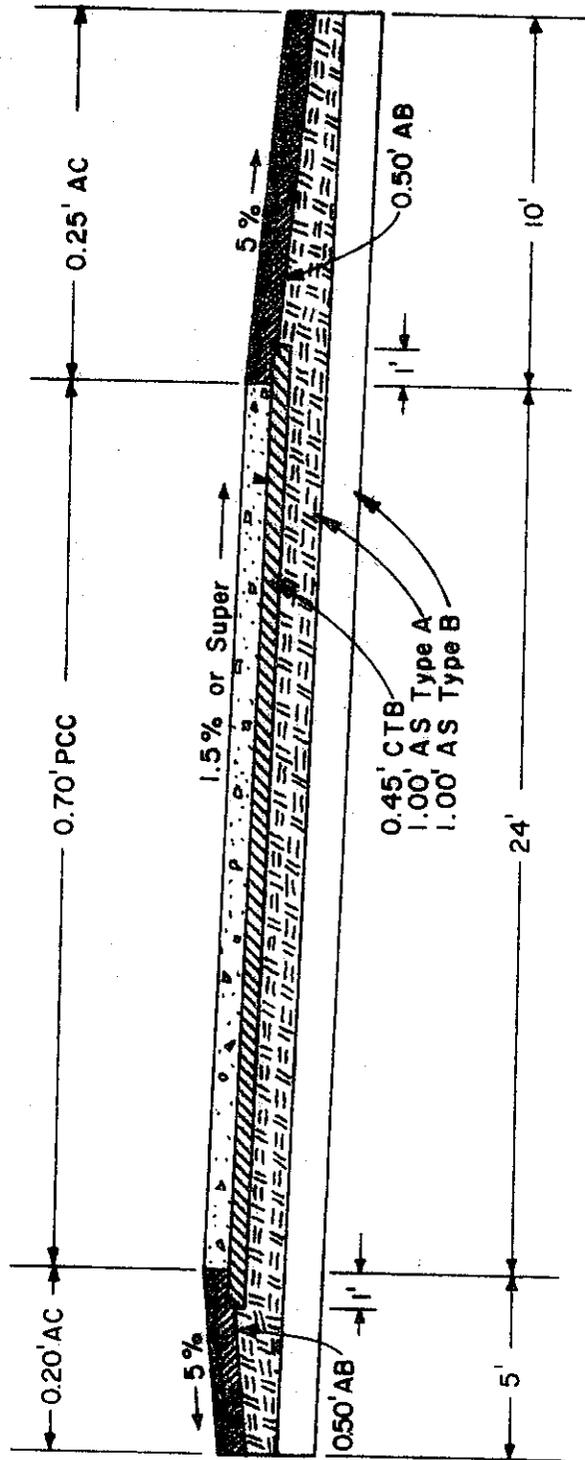
Figure 6

TYPICAL HALF SECTION
HIGHER CEMENT CONTENT

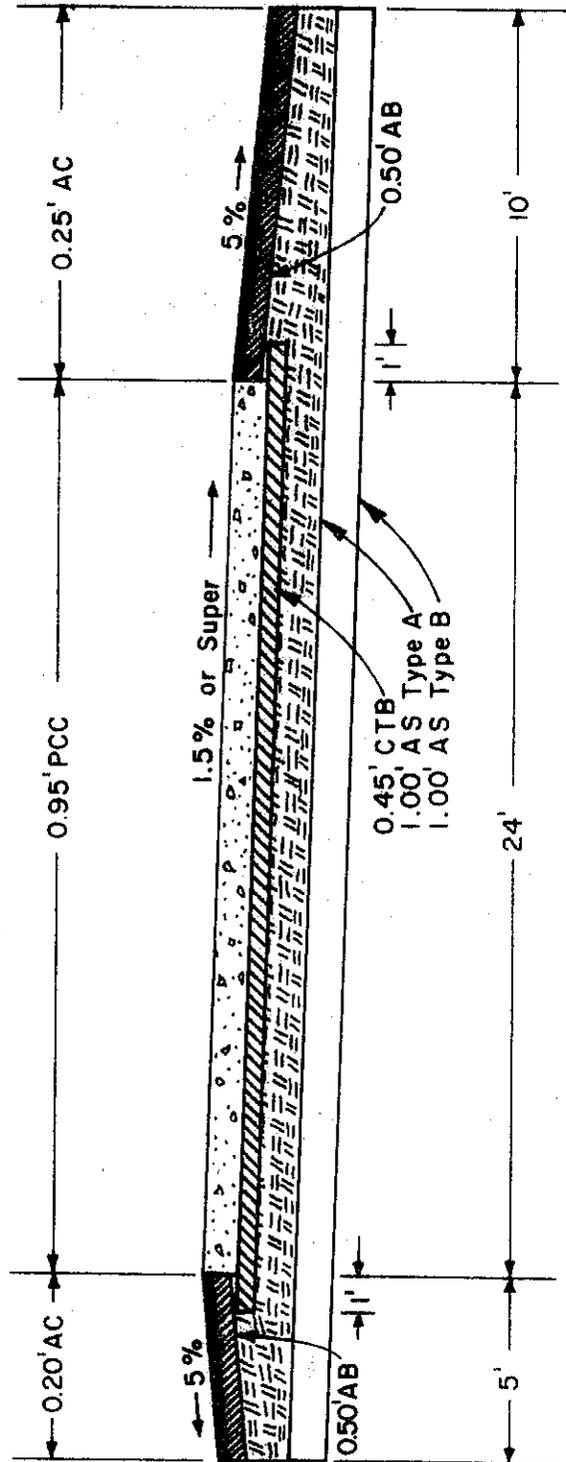
Figure 7

TYPICAL HALF SECTION
EXTRA THICKNESS PAVEMENT

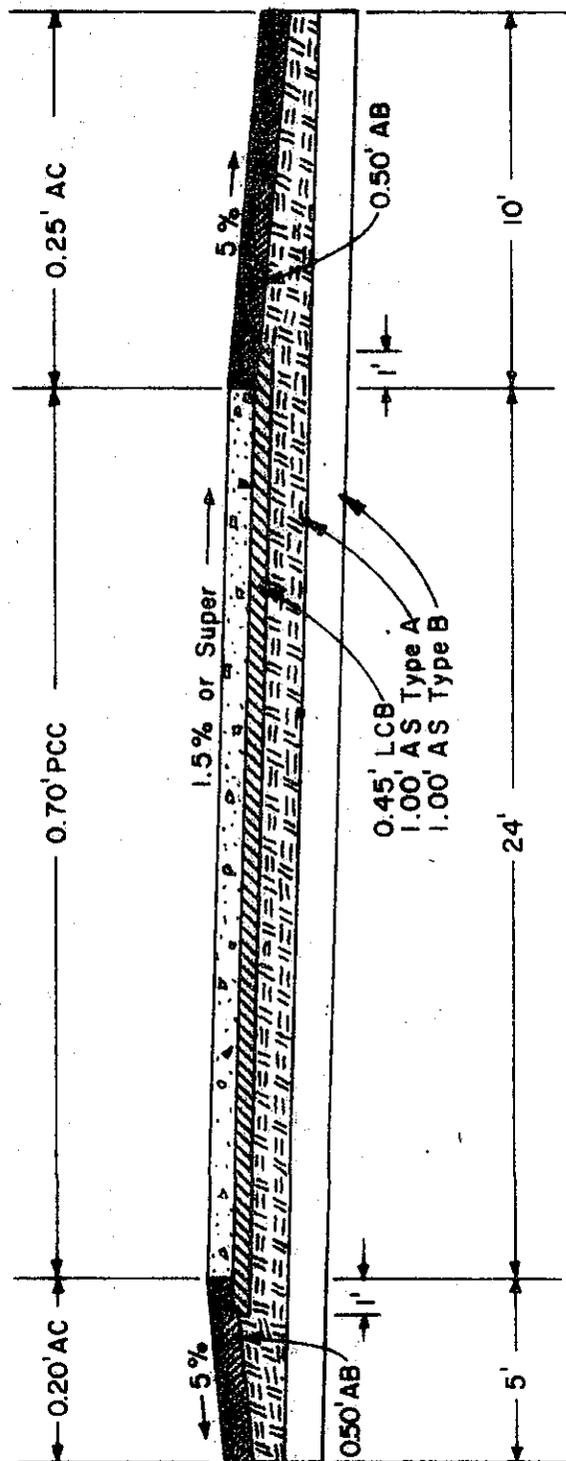
Figure 8

TYPICAL HALF SECTION
LEAN CONCRETE BASE

Lean concrete base (LCB) was placed 0.45-ft. thick, using a 4-sack concrete mix. Transverse weakened plane joints were cut at intervals of 30-ft. to relieve tensile stresses and prevent random cracking. A resin base type concrete curing compound was applied in the same manner as used for curing concrete pavement.

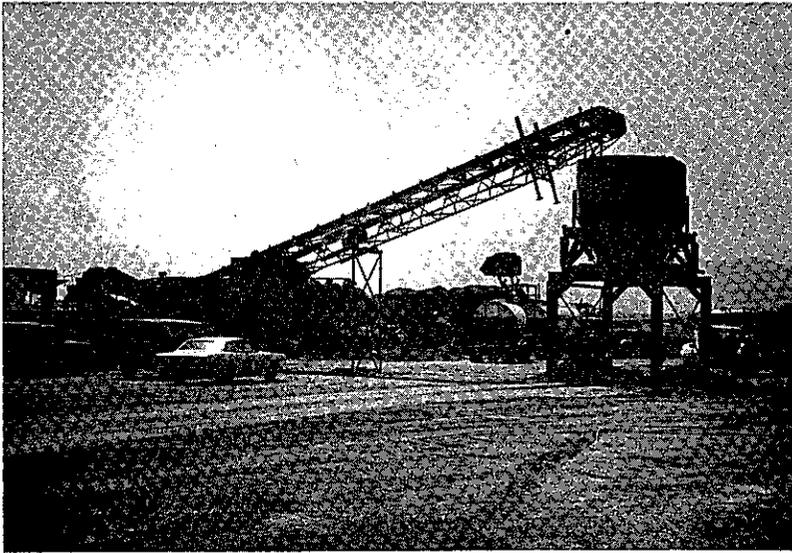
Figure 9
Plant

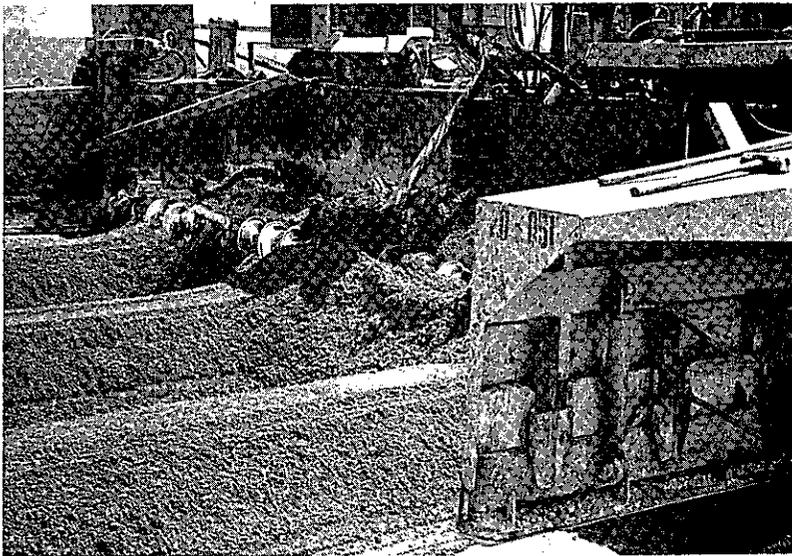
Figure 10
In windrows
at paver

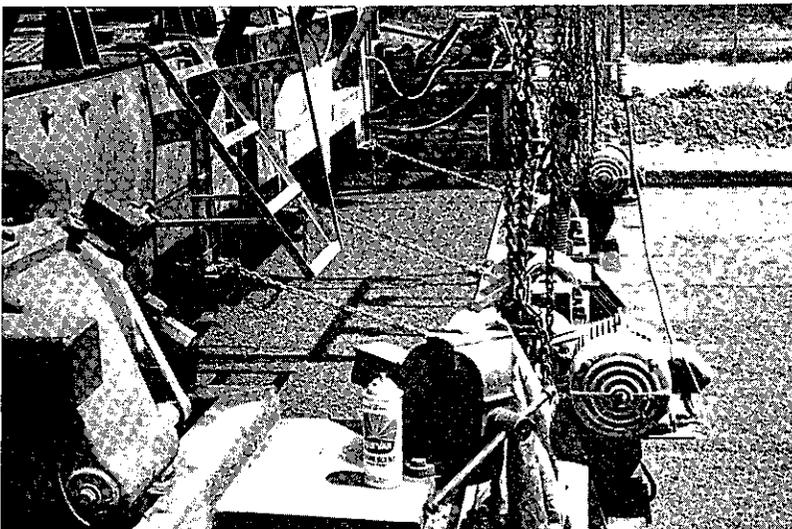
Figure 11
Behind paver

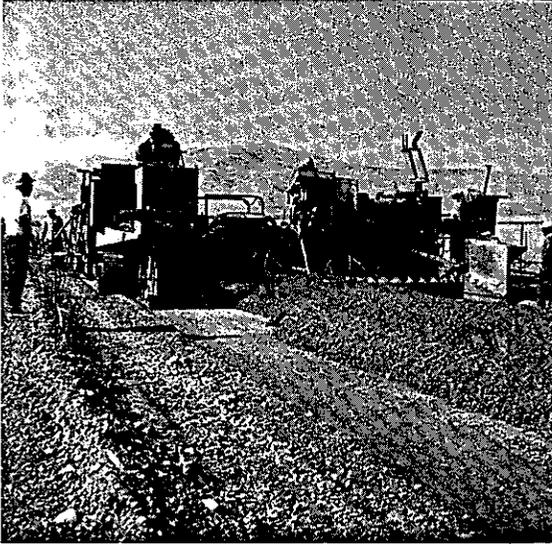
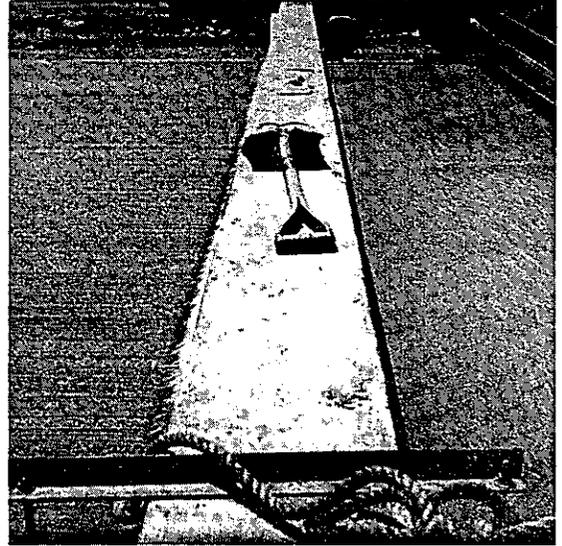
Figure 12 In front of paver.

Figure 13 After paver.

Figure 14 Texture.

The lean concrete base in Experimental Section 5 was produced in a concrete batch plant and placed with a slipform paver. (See Figures 12, 13, and 14.) A nylon broom towed behind the paver added some texture. Few problems developed with this base operation. In a few locations, hand finishing had to be employed to remove irregularities, and occasionally shrinkage cracks occurred (see Figure 15). These were probably due to a combination of factors, such as excessive working of the surface, rapid drying conditions, and loss of water to the untreated subbase. The cracks are not considered to be harmful to the LCB surface durability.

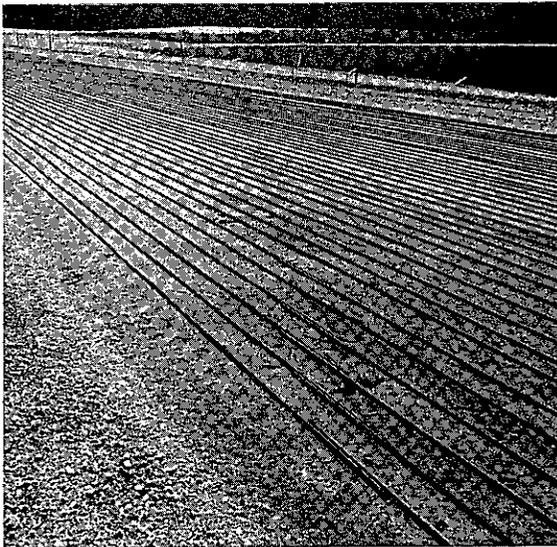
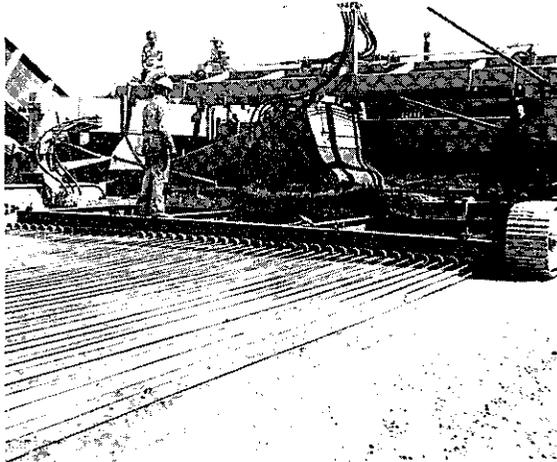
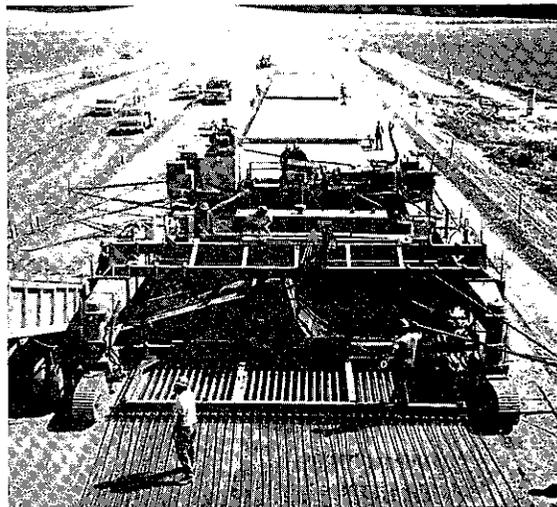
Figure 16
On CTB

Figure 17
Going through tubes
at Placer-Spreader

Figure 18
Paving train

Paving started in the section with longitudinal steel only (no transverse steel). (See Figures 16, 17, and 18). The bars were placed on the base in approximate final location and the 20-inch laps were tied at staggered intervals across the roadbed. Pushed along on skids in the front of the placer-spreader was a frame holding forty-four 2-1/4-inch diameter metal tubes with flared ends. Bars were fed through the tubes for proper positioning in the fresh concrete. Occasionally a lap splice would catch on a metal tube resulting in a brief paving delay while a bent rebar was replaced. A few minor problems arose in the use of side delivery equipment for the concrete, but these were gradually overcome. Considerable difficulty was experienced in adjusting the metal tubes to obtain proper placement of the rebars in the concrete. Much of this section has steel well below the planned depth.

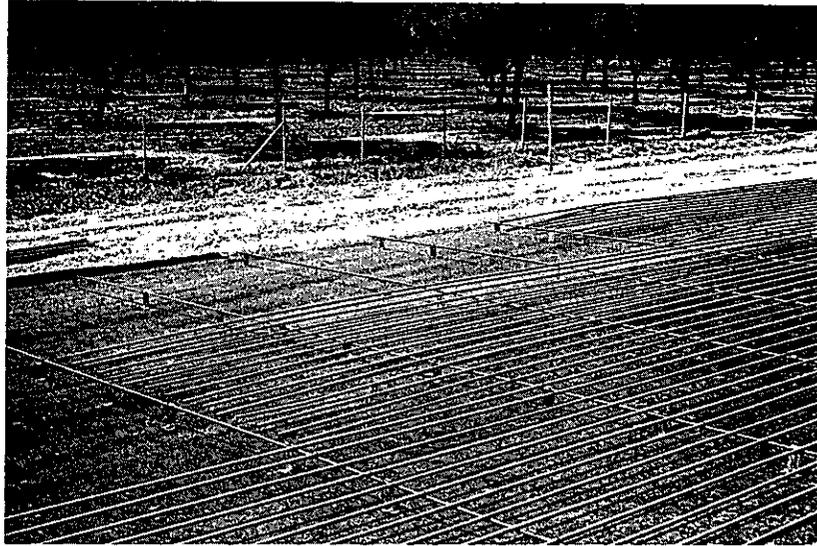
Figure 19 Placing on chairs

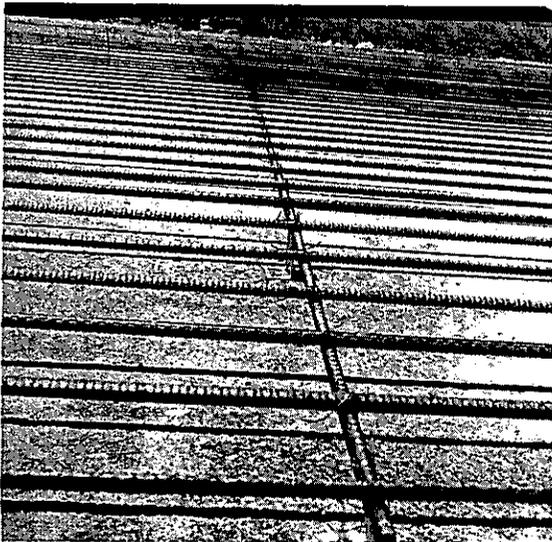
Figure 20
Longitudinal reinforcing bars
tied to transverse bars

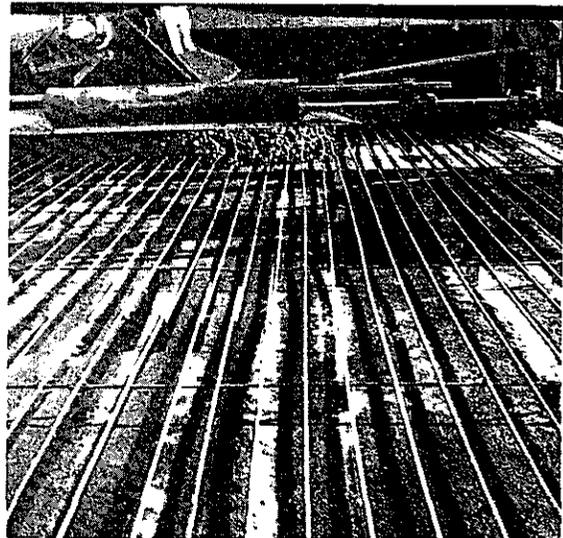
Figure 21 Placer-Spreader

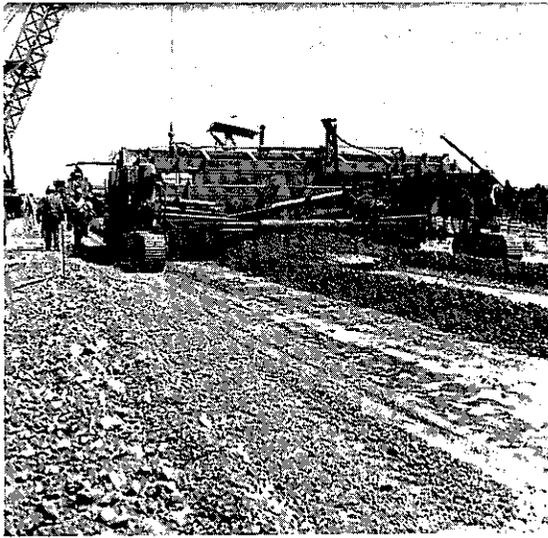
Figure 22
Concrete on CTB before
Placer-Spreader

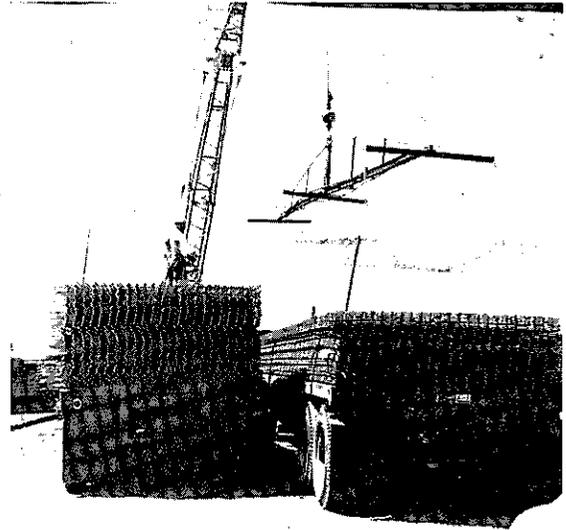
Figure 23
Fabric mats on trailers

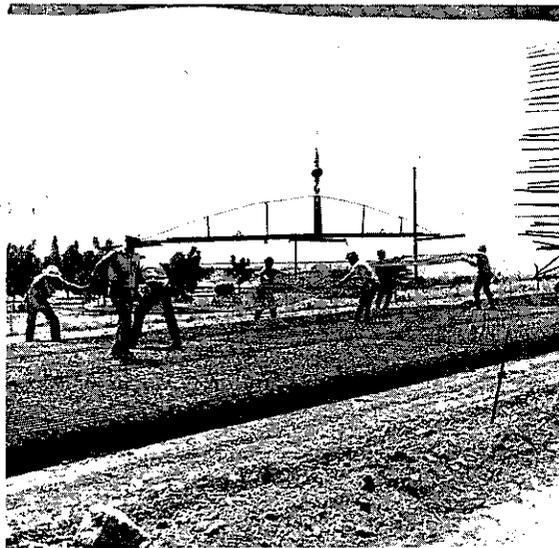
Figure 24
Mats placed onto concrete

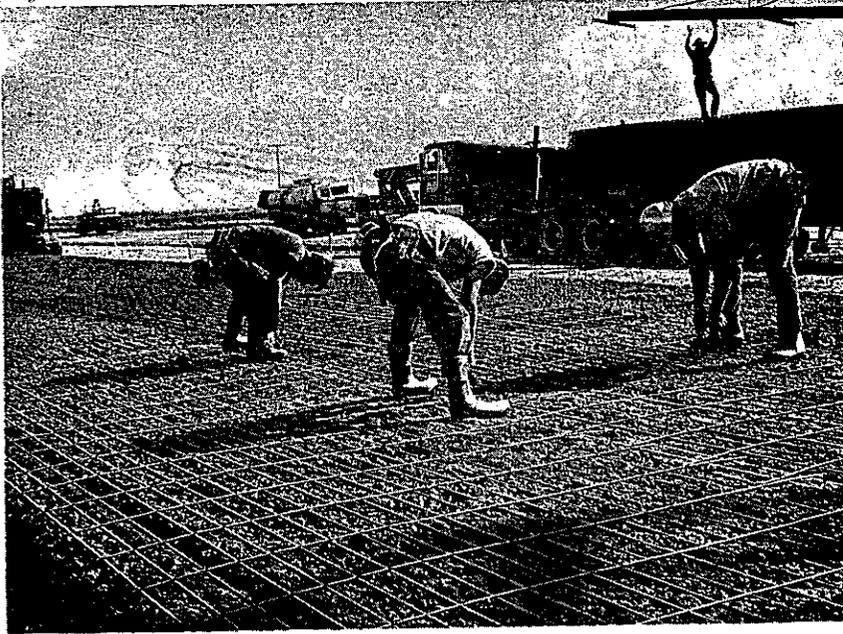
Figure 25
Laps being
tied

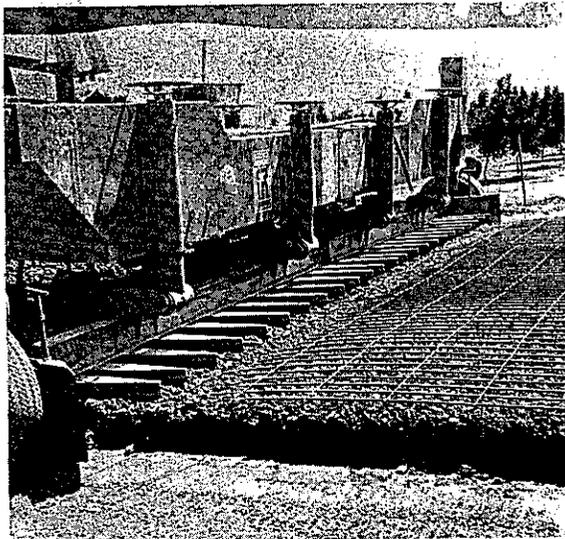
Figure 26
Mats being depressed
into concrete

3. Sled type mesh depressors can catch and move the mats longitudinally, adversely affecting the planned lap distance. This occurred at times even though the number of ties at splices were considered adequate to prevent translation.

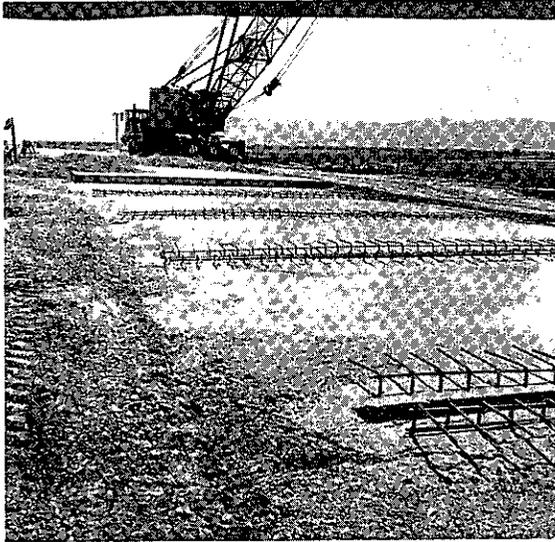
Figure 27
Lug type terminal anchor

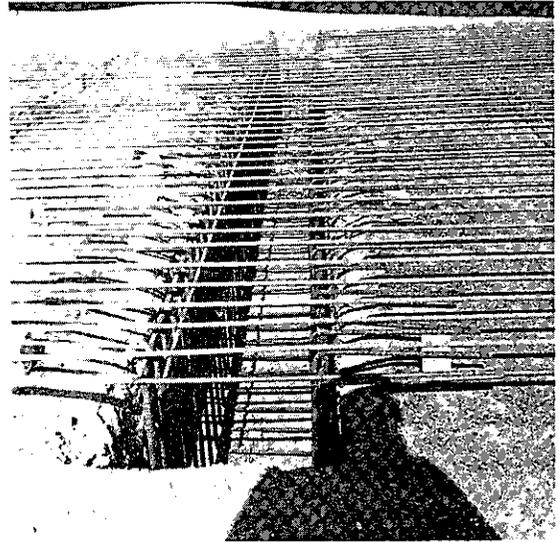
Figure 28
Reinforcement for terminal
anchor lug

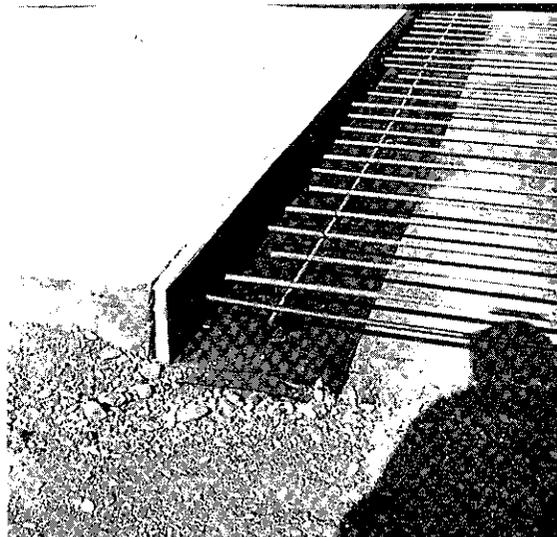
Figure 29
End of CRCP reinforcement at
bridge approach slab

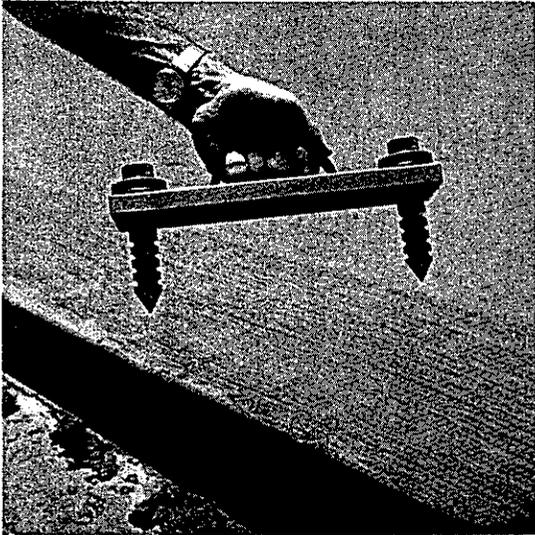
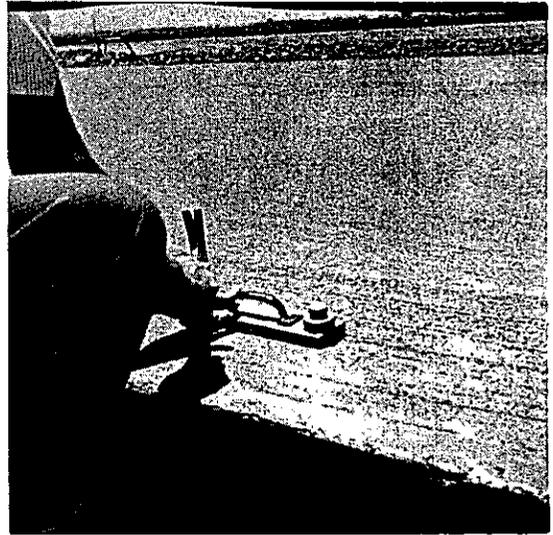
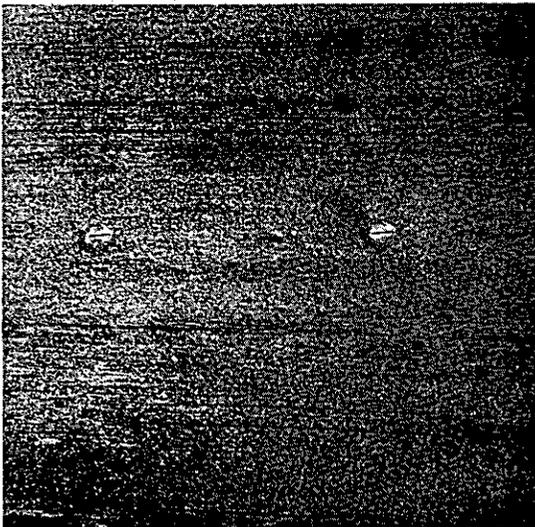
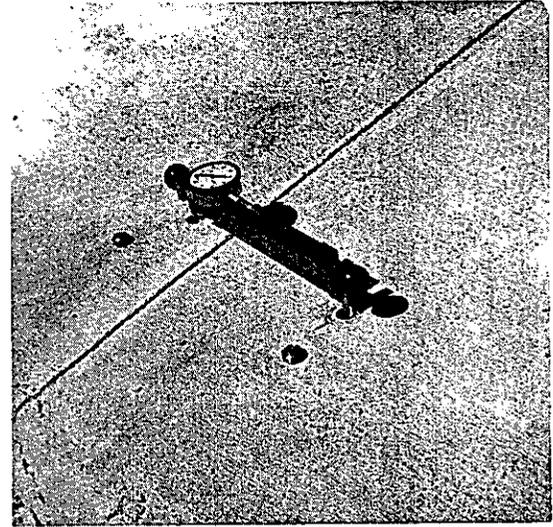
Gauge plugs attached to holder

Inserting plugs into fresh concrete

Gauge plugs in place

Strain gauge in plugs across weakened plane joint

To study movement at cracks induced by transverse weakened plane joints, sets of two gauge plugs were placed in the fresh concrete about 10 inches apart. (See Figures 30, 31, 32, and 33.) Later in the day, a saw cut 0.17-ft. deep was made between them. Twenty pairs of plugs were placed -- 10 in the control section and 10 in the short joint section. The plugs have threaded tops and screw-on caps to keep out foreign material. Measurements are made with a shop fabricated strain gauge to the nearest .001-inch. Results of measurements are shown in Tables 7 and 8. Although the amount of movement from one joint to another is not uniform, average joint width in the short spacing is about half that in the standard spacing. The total change in equivalent lengths of pavement is about the same, however.

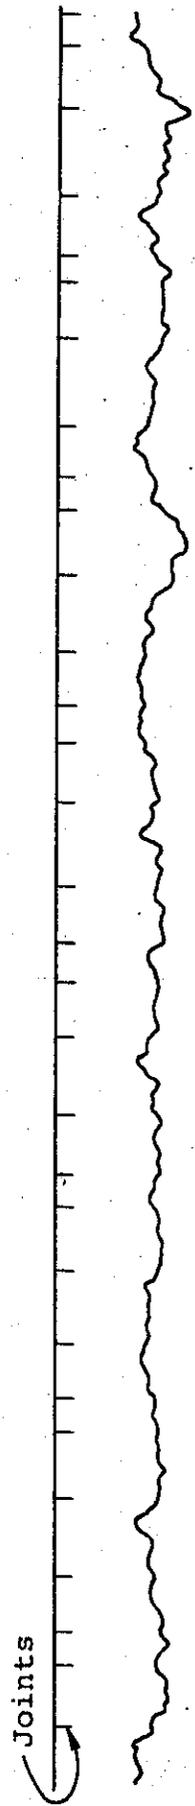
Figure 34
TYPICAL PROFILOGRAMS (16 MONTHS)

High Cement Content (Curling Evident)

Short Joint Spacing

Control Section (Curling Evident)

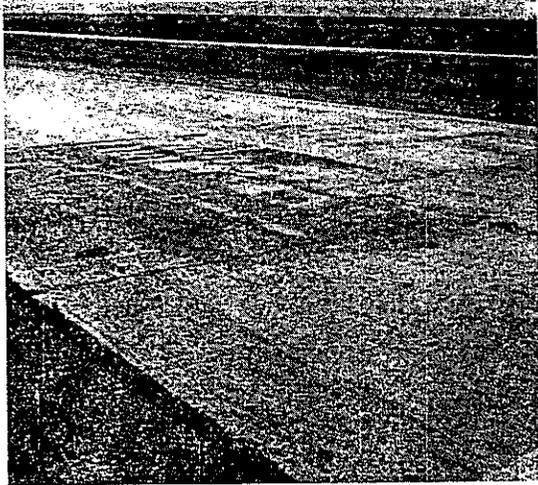
Figure 35

Large cracks in
CRCP

Shortly before the pavement was to be opened to traffic, wide transverse cracks started appearing in the two sections reinforced with welded wire fabric. Cracks were wide enough to be seen when driving by at high speed and the length was noted to be that of mat widths. Preliminary investigation revealed insufficient lap splice. A survey of both sections was made and 57 wide crack locations were found and marked for repair. At 10 locations, three cracks were present over the 24-ft. wide pavement at 4-ft. staggered mat intervals, nine locations had two cracks, and 38 locations had a crack across only one of the three mats of reinforcement (see Figure 35). Excavation at crack locations revealed laps measuring from 10-1/2 inches to a maximum gap of 16 inches. (A minimum lap of 16 inches was specified.)

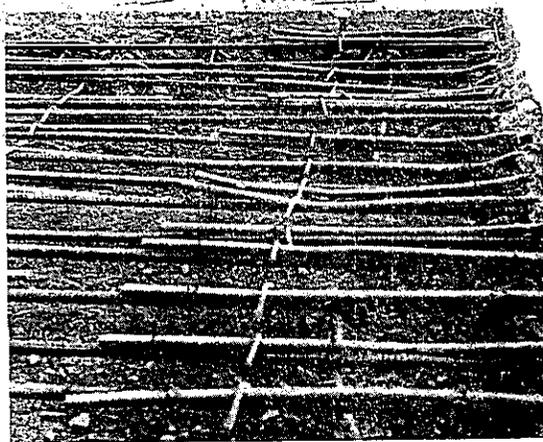
Figure 36

Pavement excavated
at cracks and
reinforcement added

Repair work consisted of saw cutting around each crack in an approximate 8-ft. by 6-ft. pattern, the 6-ft. length providing space for placement and lapping of additional reinforcement. Concrete was removed for the full depth of the slab, No. 5 bars were tied to the existing mesh (see Figure 36), and fresh concrete was placed.

Removing concrete in the repair areas also provided an opportunity to check depth of steel placement. Most of the mat was within design tolerances, but at some transverse laps, the edges had curled upward, even to the extent of being exposed at the surface in one instance. The reason for this is not known since supposedly equal pressure was applied by the depressor at all points.
