Evaluation Of Erosion From Chemically Treated Slopes In The Lake Tahoe Basin Near Luther Pass

HIGHWAY RESEARCH REPORT

INTERIM REPORT

June, 1973

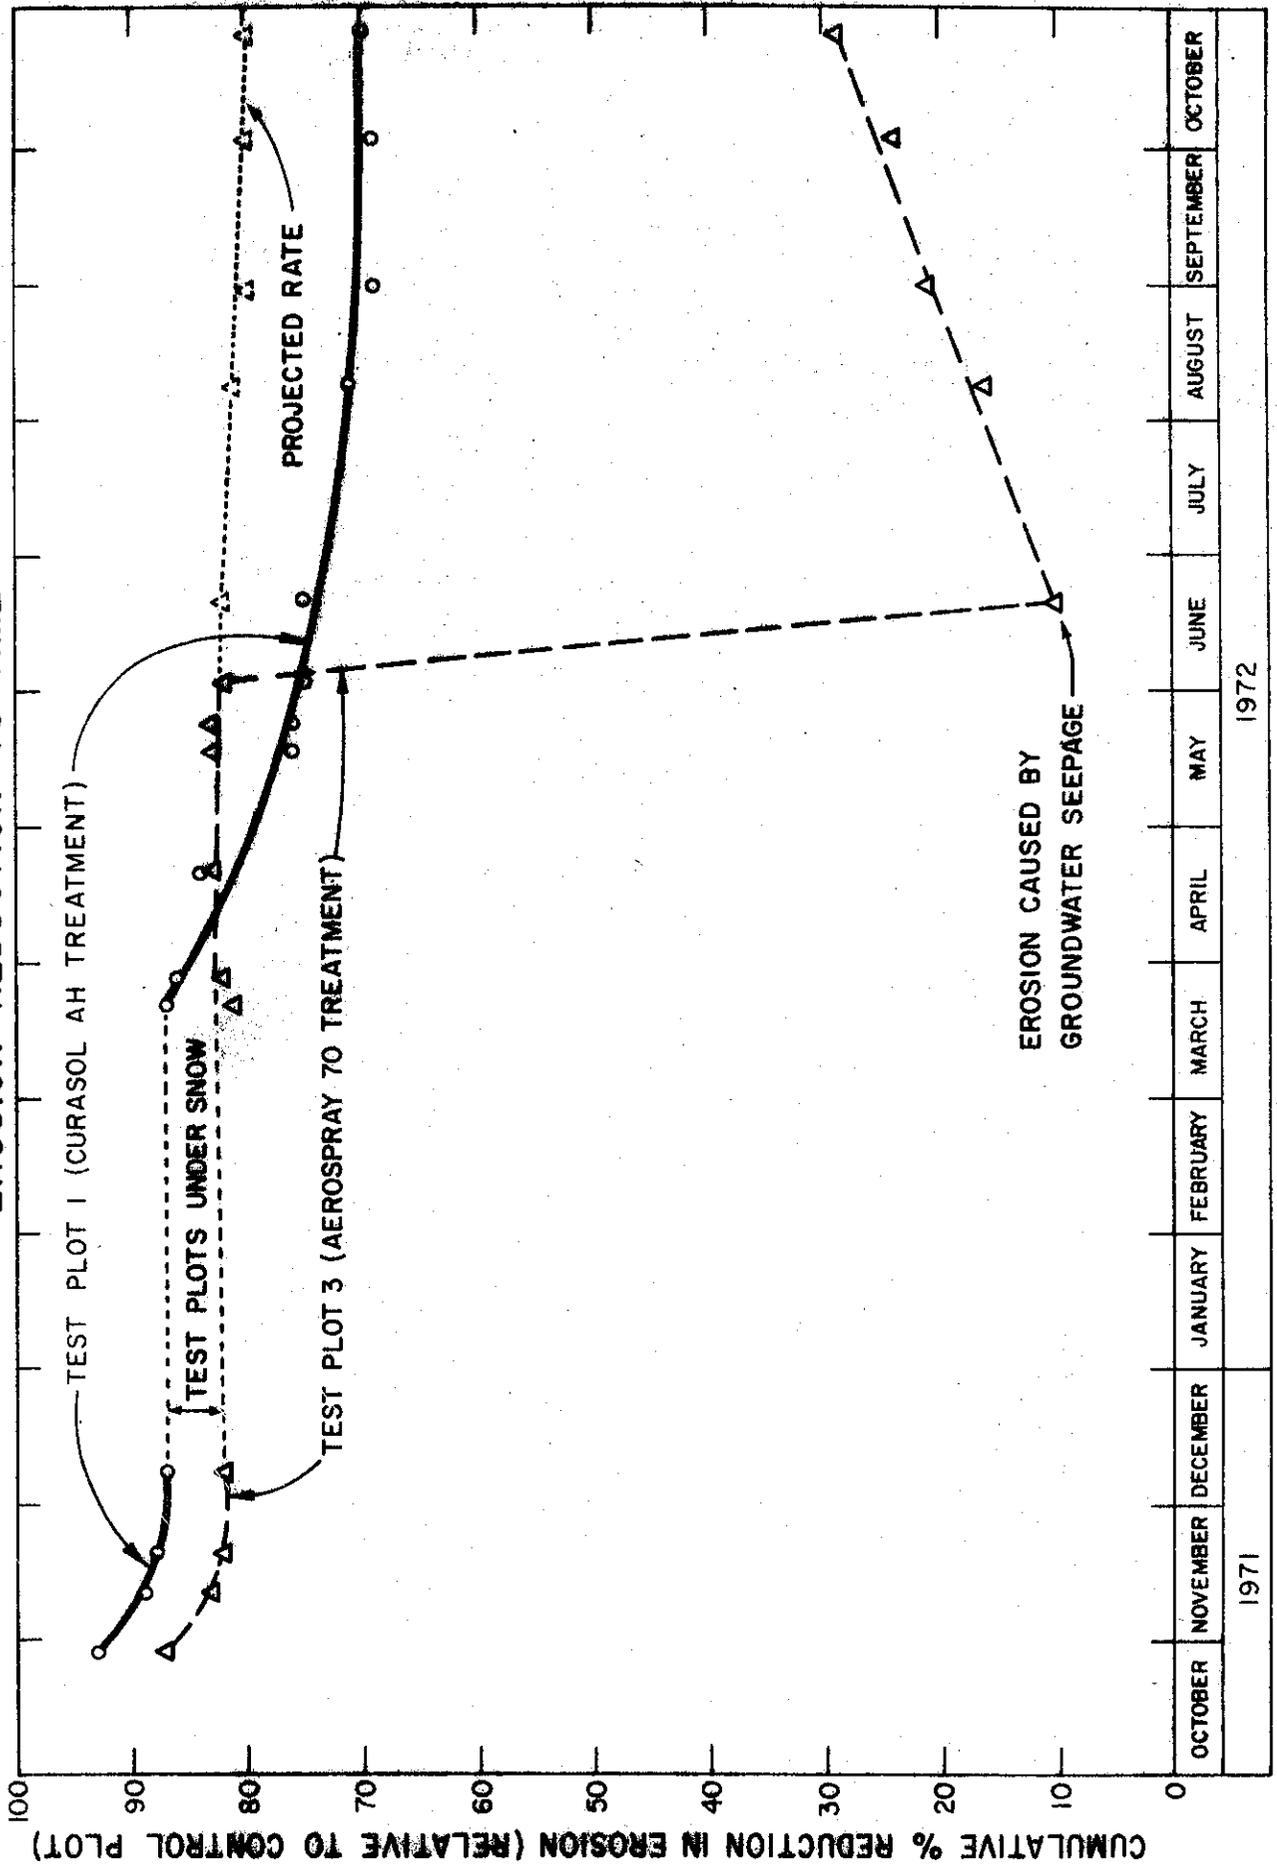
Figure 1

The reduction in erosion from the two chemically treated test plots relative to the untreated plot is shown in Figure 1.

At the beginning of the experiment, the Curasol A.H. treatment reduced erosion by about 90% while at the end of 12 months the reduction was down to about 70%. The gradual decrease in erosion reducing effectiveness was probably caused by the degradation of the chemical treatment.

The Aerospray 70 treatment was about 85% effective in reducing erosion at the beginning of the experiment and within a short period decreased to about 30%. However, the rapid decline was attributable to significant groundwater seepage which did not appear on the other plots. If this effect was neglected, the projected erosion reducing affect of Aerospray 70 at the end of 12 months is 80%.

EROSION REDUCTION VS TIME

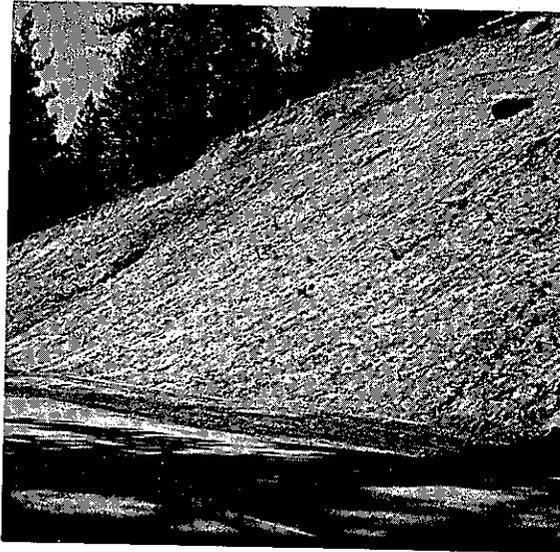
Test Slope (9-21-71)

The test slope is approximately 400 feet long and 100 feet high at the highest point, and covers approximately 3/4 of an acre.

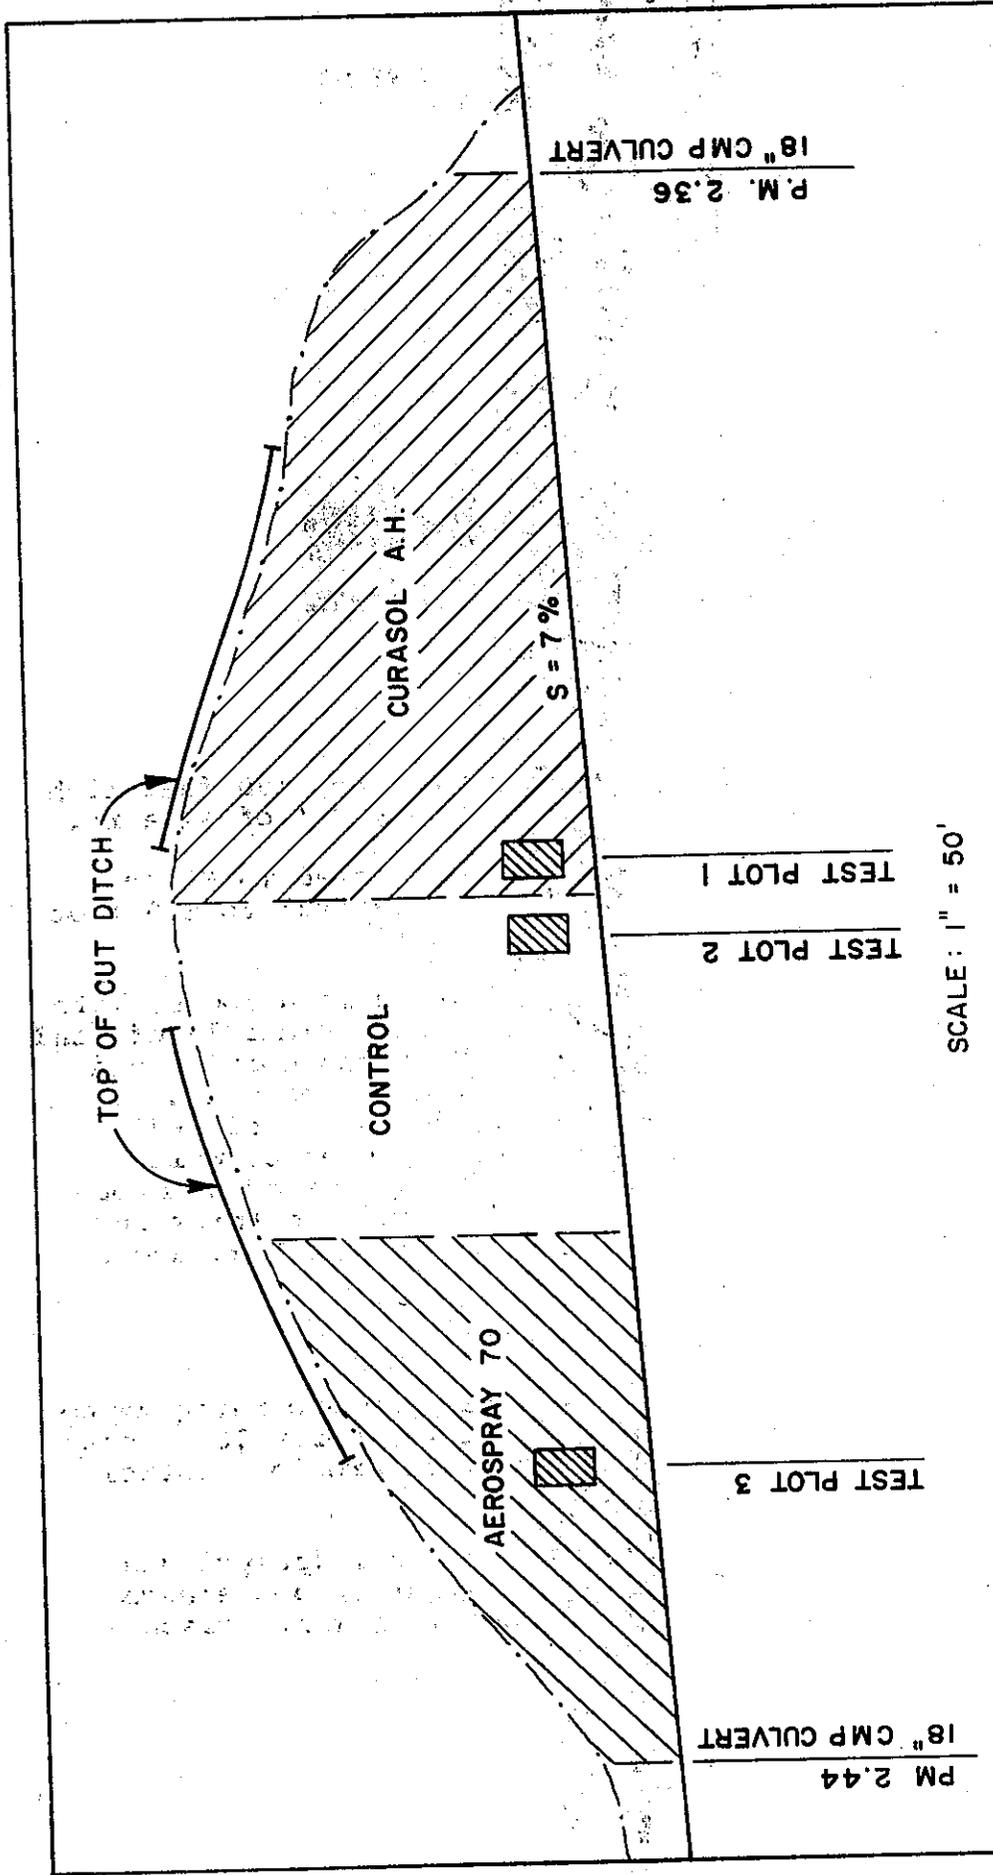
Figure 2

The configuration of the slope face is illustrated in Figure 2. The cut face slope is about 1.5 feet horizontal to 1.0 foot vertical. The slope is facing South 40° East.

SLOPE FACE AREA (PM 2.36 TO 2.44) = 31,350 S.F. = 0.72 ACRE
 EACH TEST PLOT = 10' x 15' = 150 S.F.
 ELEVATION = 7,000 FT. ABOVE M.S.L.

STATE OF CALIFORNIA
 DIVISION OF HIGHWAYS
 MATERIALS & RESEARCH DEPARTMENT
 ENVIRONMENTAL IMPROVEMENT SECTION
**SLOPE FACE CONFIGURATIONS
 AND TEST PLOT LOCATIONS**
 LUTHER PASS SLOPE TREATMENT
 LAKE TAHOE BASIN
 ROAD 03-ED-89, PM 2.4

The locations of the plots on the test slope face are illustrated in Figure 2. A photographic history of the test plots is shown in the Appendix.

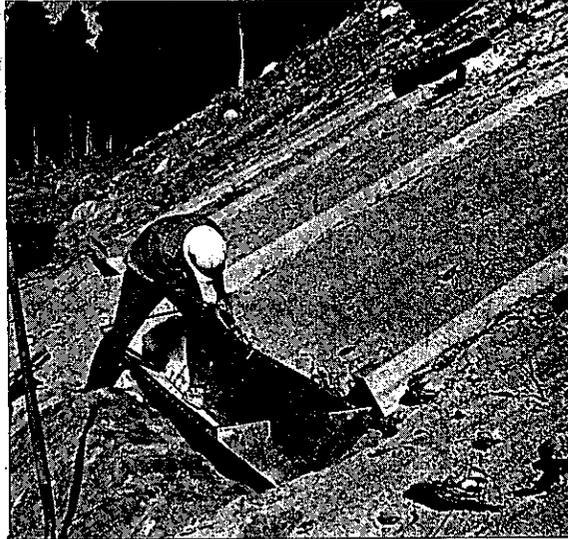
Three 10-foot by 15-foot test plots were installed on the test slope. Sediment troughs were attached at the bottoms of the test plots to collect the erosion from each plot. Upslope erosion was deflected around the sides of the test plots by deflector boards installed at the top of each test plot. The troughs and plots were designed in accordance with the procedure outlined in "Sediment Trough Method of Estimating Erosion from Highway Slopes" (2).

Installing sediment trough
at bottom of test plot.
(10-14-71)

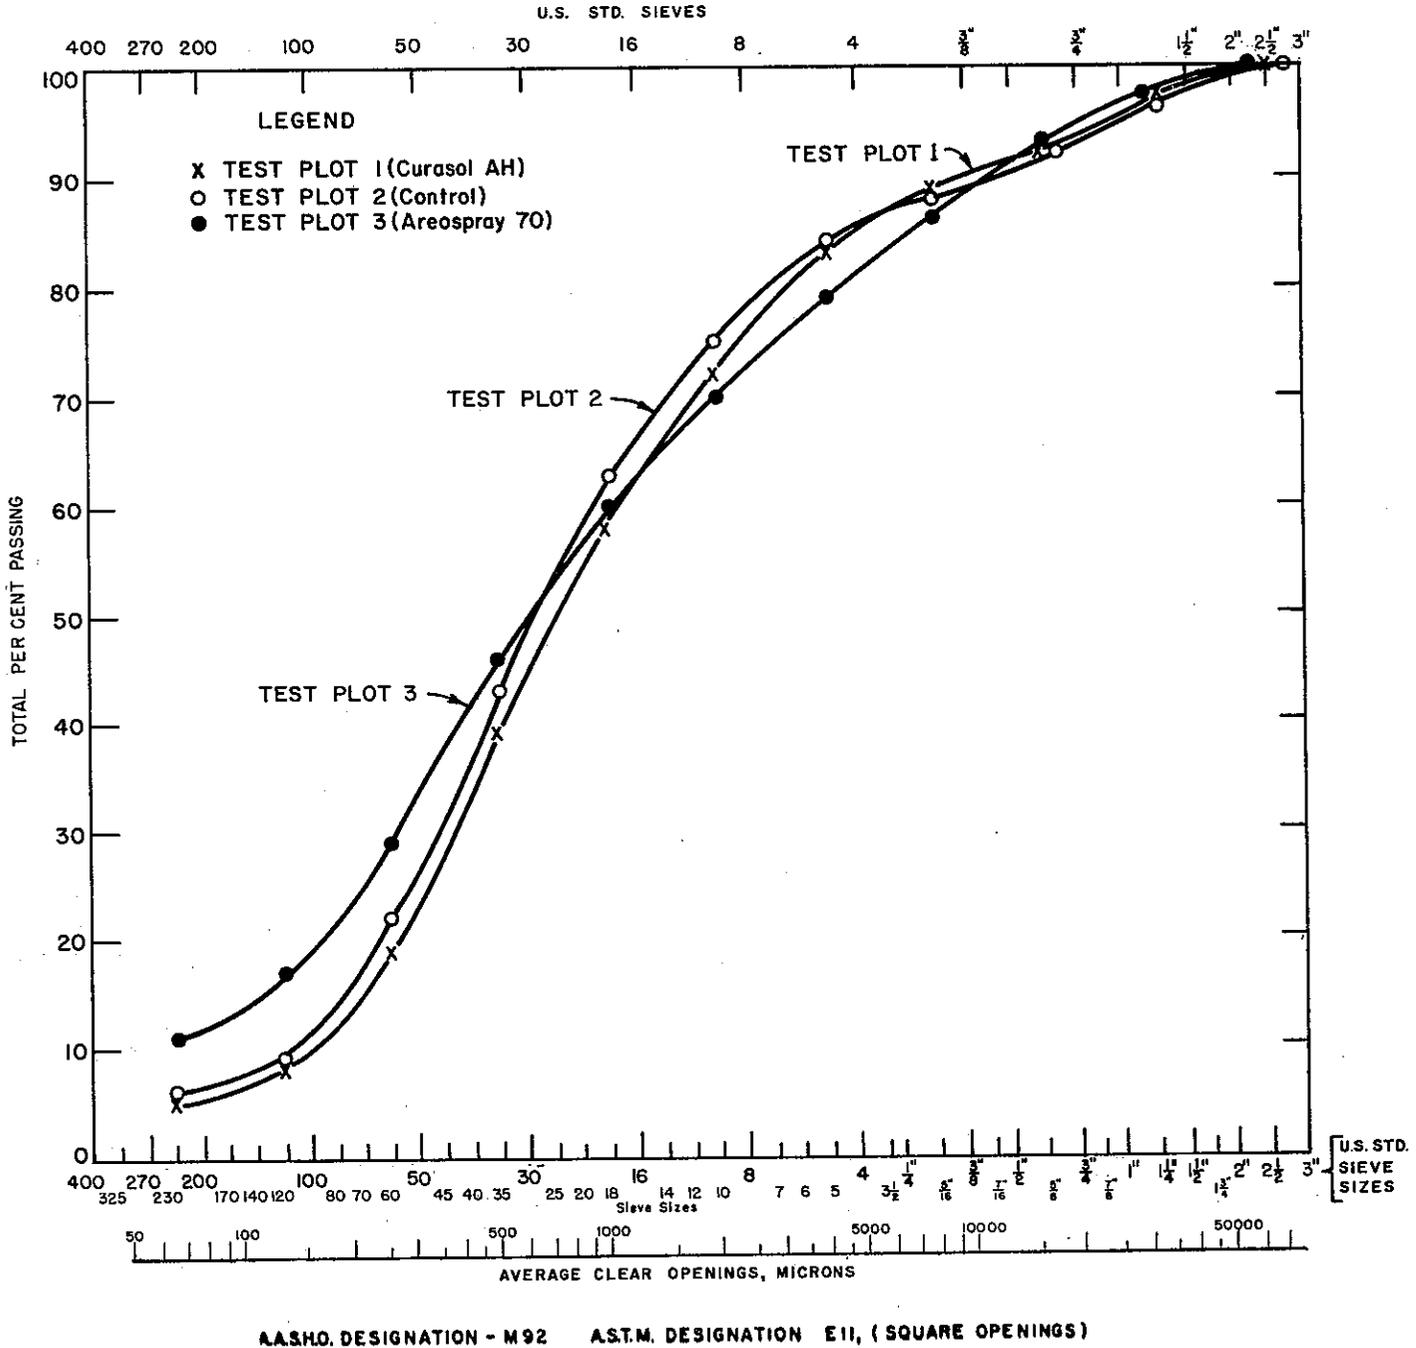
Figure 3

The combined gradation curves for each plot are illustrated in Figure 3. An analysis of these curves reveals the following information:

Sediment Particle Diameter		
	Test Plot 1	Test Plot 2	Test Plot 3
D ₉₀ (90% is finer than)	3/8"	1/2"	7/16"
D ₅₀ (50% is finer than)	700 microns	590 microns	610 microns
% Finer than 62.5 microns*	5%	6%	11%

GRADING ANALYSIS TEST PLOTS 1, 2 AND 3

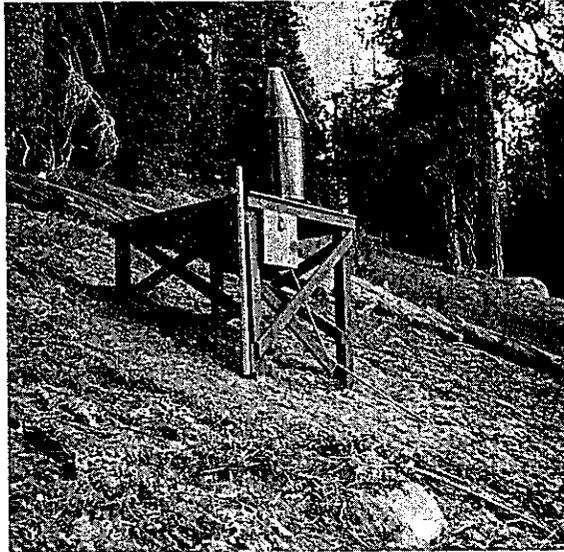
Precipitation at the test slope location was measured with a Weather Measure P511P propane heated precipitation gage and recorded on a continuous chart by a Weather Measure P522 long term event recorder. Precipitation type (rain or snow) was determined from South Lake Tahoe Airport Weather records and by discussions with Division of Highways Maintenance Department personnel located at South Lake Tahoe.

Precipitation Gage and
Snow Gage (10-14-71)

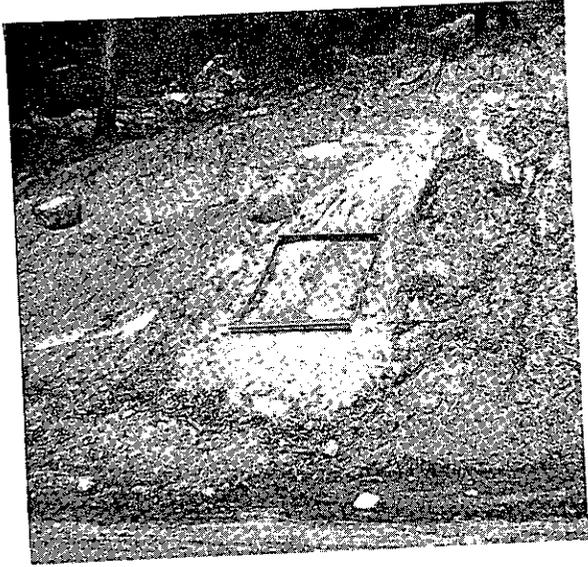
Plate 1
Slope for Test Plot 3
Prior to treatment.
(9-21-71)

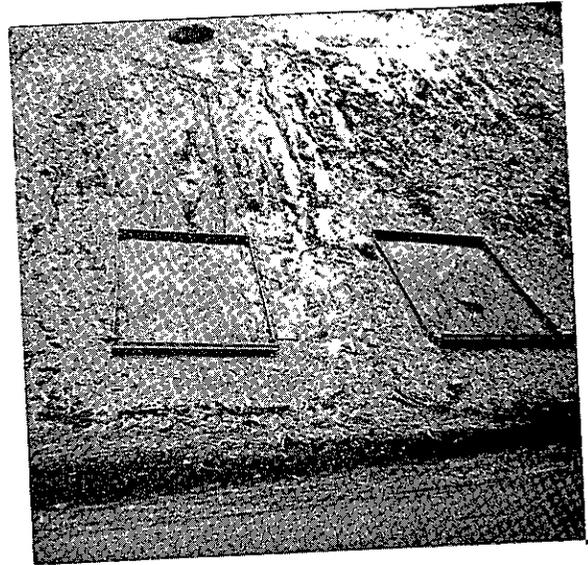
Plate 2
Slope for Test Plots 1 & 2
Prior to treatment.
(9-21-71)

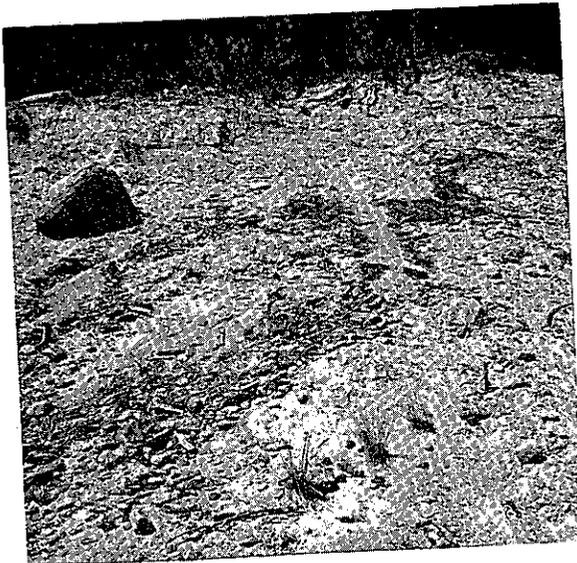
Plate 3
Test Plot 3
(10-14-71)
Start of experiment.

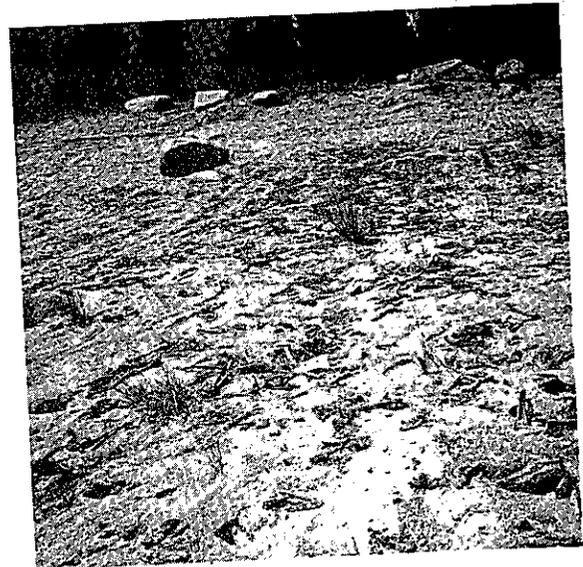
Plate 4
Test Plot 2 and Test Plot 1
(10-14-71)
Start of experiment.

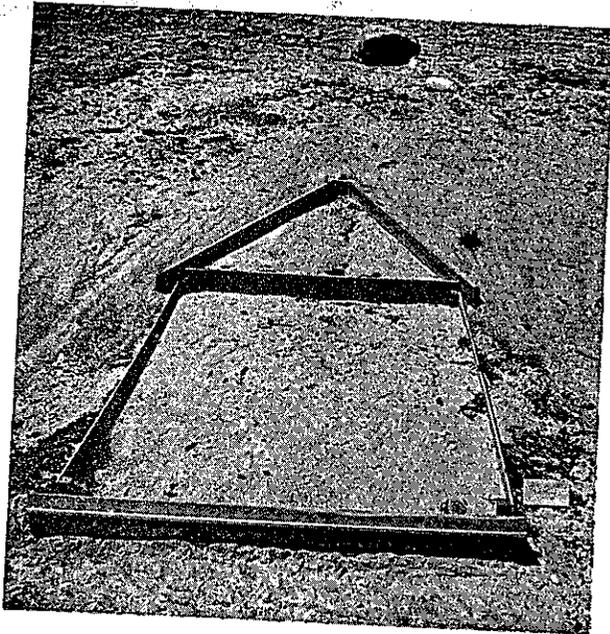
Plate 5
Test Plot 2
(11-10-71)
No visible erosion.

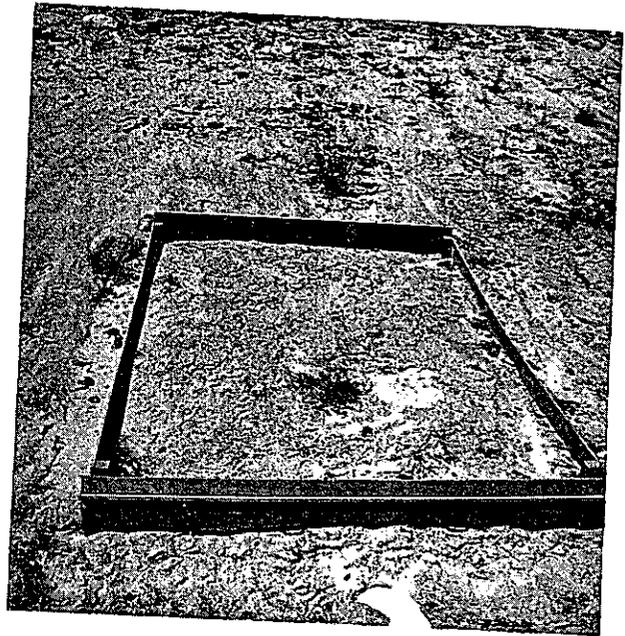
Plate 6
Test Plot 1
(11-10-71)
No visible erosion.

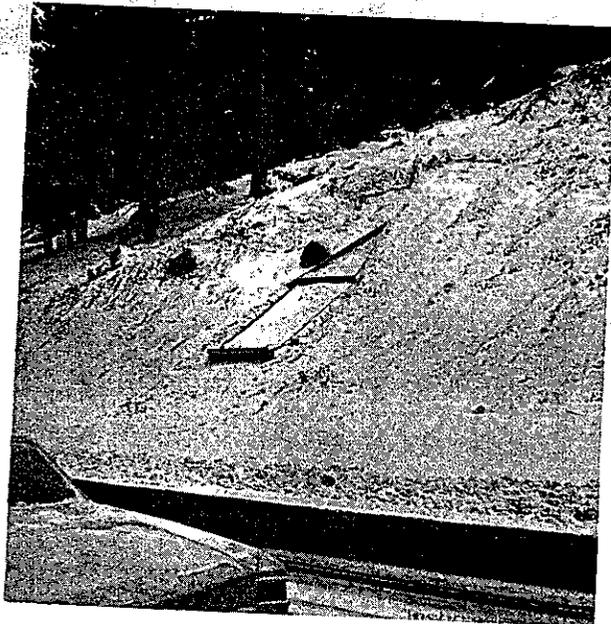
Plate 7
Test Plot 3
(11-18-71)
Under light blanket
of snow (6" \pm).

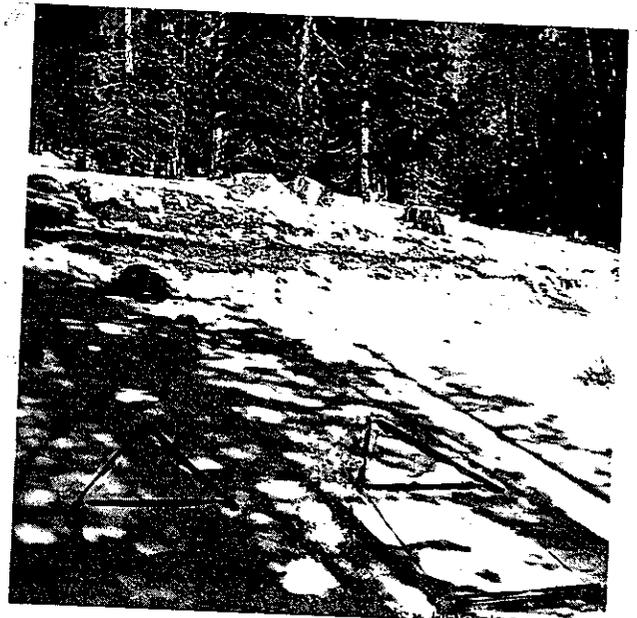
Plate 8
Test Plot 2 and Test Plot 1
(11-19-71)
Under light blanket
of snow (6" \pm).

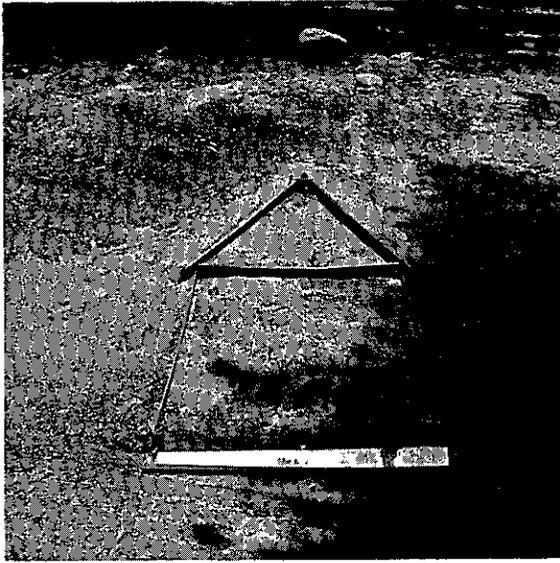
Plate 9

Test Plot 2
(3-12-72)

Light surface erosion visible.

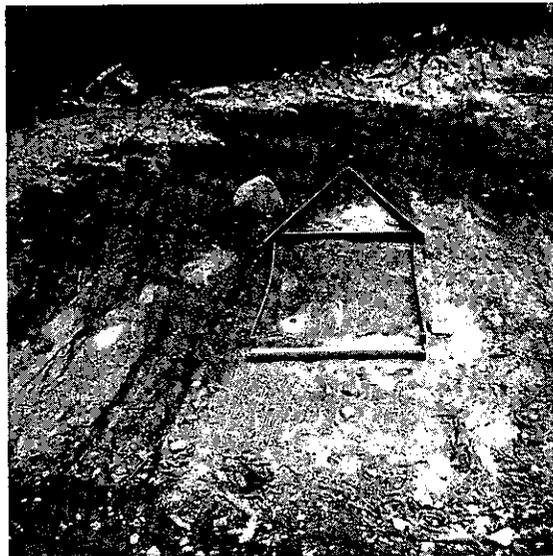
Plate 11

Test Plot 3
(3-12-72)

Note underground water seepage, and severe erosion to the left of the test plot.

Most of the erosion from the Aerospray 70 test plot attributed to rain was due to the 356 pounds of eroded sediment collected on June 21, 1972. Field observations indicated that the major portion of this erosion was caused by groundwater seepage.

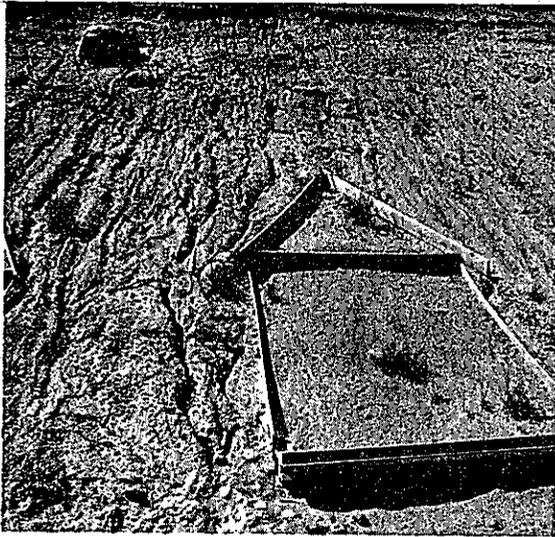
Plate 12

Test Plot 1
(6-21-72)

Light surface erosion visible.
Note severe erosion outside
left side of Plot 1.

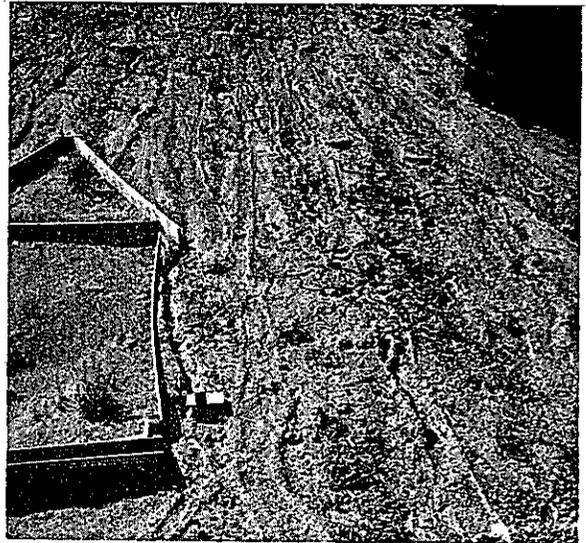
Plate 13

Test Plot 1
(6-21-72)

Note light erosion
right of Plot 1.

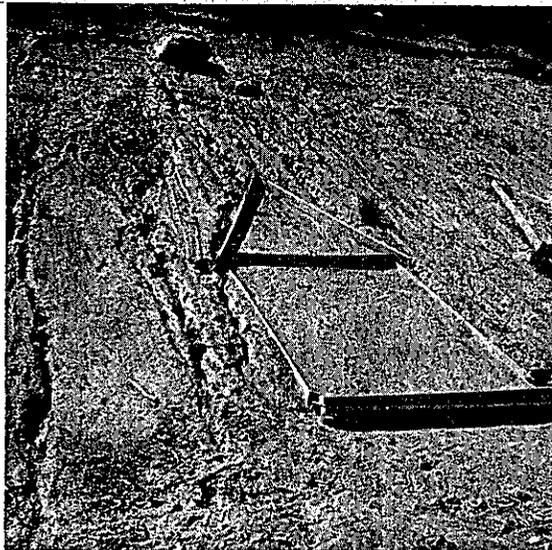
Plate 14

Test Plot 2
(6-21-72)

Light surface erosion visible.
Note severe erosion left of
Plot 2.

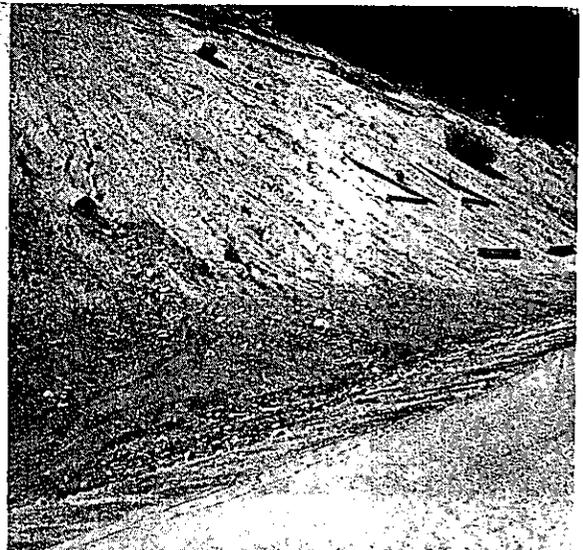
Plate 15

Severe erosion from area
between Plot 2 and 3
accumulated at the bottom
of the slope.
(6-21-72)

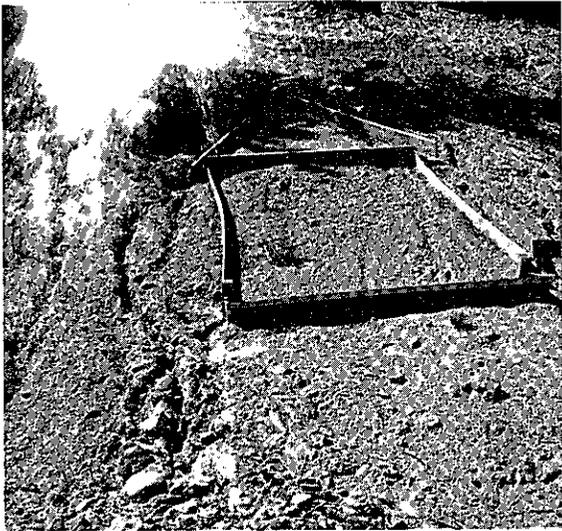
Plate 16

Test Plot 3
(6-21-72)

Note severe erosion outside
left side of Plot 3.
