Dynamic Test Of A Slipformed Concrete Barrier Type 50
Placed Over Lowered Existing Cable Barrier

Transportation Laboratory
Division of Construction and Research
Sacramento, California 95819

**Dynamic Test of a Slipformed
Concrete Barrier Type 50
Placed Over Lowered Existing
Cable Barrier**

FINAL REPORT
CA-DOT-TL-6696-1-74-36
DECEMBER 1974

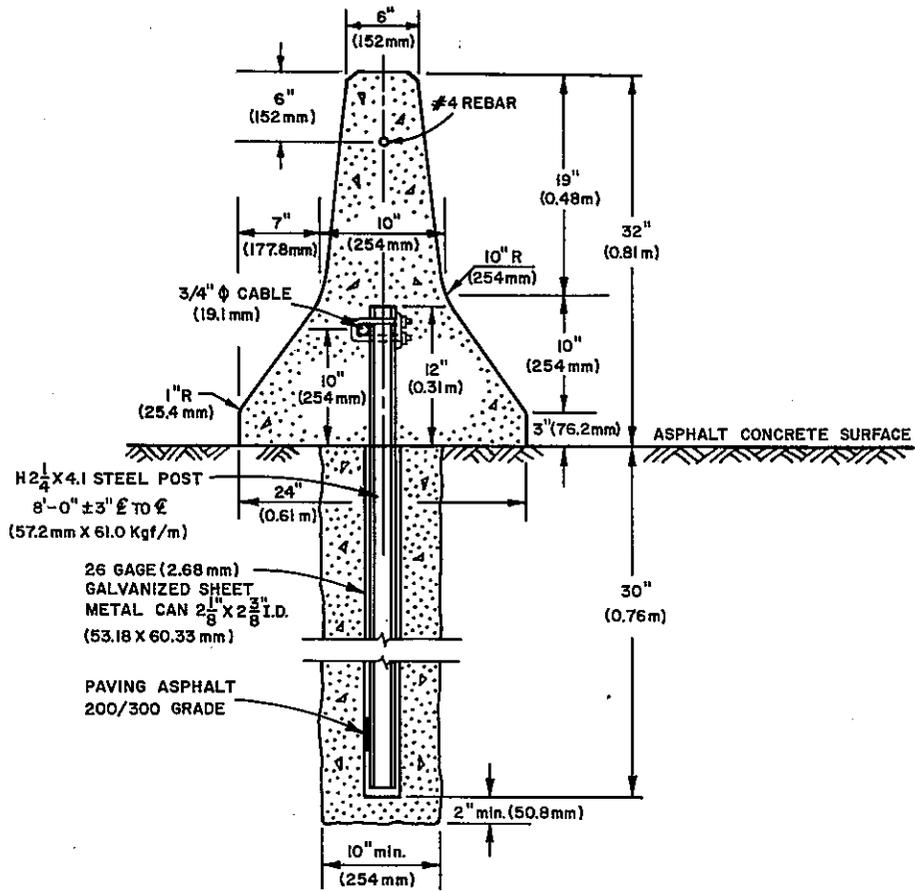
Fig. 3 TYPICAL SECTION OF SLIPFORMED
CONCRETE BARRIER TYPE 50
OVER LOWERED CABLE BARRIER

In 1972, a special construction method was approved on a trial basis for a limited number of contracts in California to replace existing cable barrier, Figures 1 and 2, in medians with a modified Concrete Barrier Type 50, Figure 3. Contractors were allowed to cut existing cable barrier posts off 1'-0" (0.305m) above grade, to remount one existing cable on the post stubs, salvaging the second cable, and to slipform the concrete barrier on top of the median surface over the cable and post stubs. The anchorage provided by the embedded lowered cable and steel post stubs eliminated the need for the continuous 10 inch (254mm) deep concrete footing normally required for Concrete Barrier Type 50, Figure 4.

The 97'-0" (29.6m) concrete test barrier was built on an asphalt concrete surface, Figure 5. Figure 3 shows the typical section of the barrier. A complete barrier plan and a summary of essential specifications are presented in the Appendix.

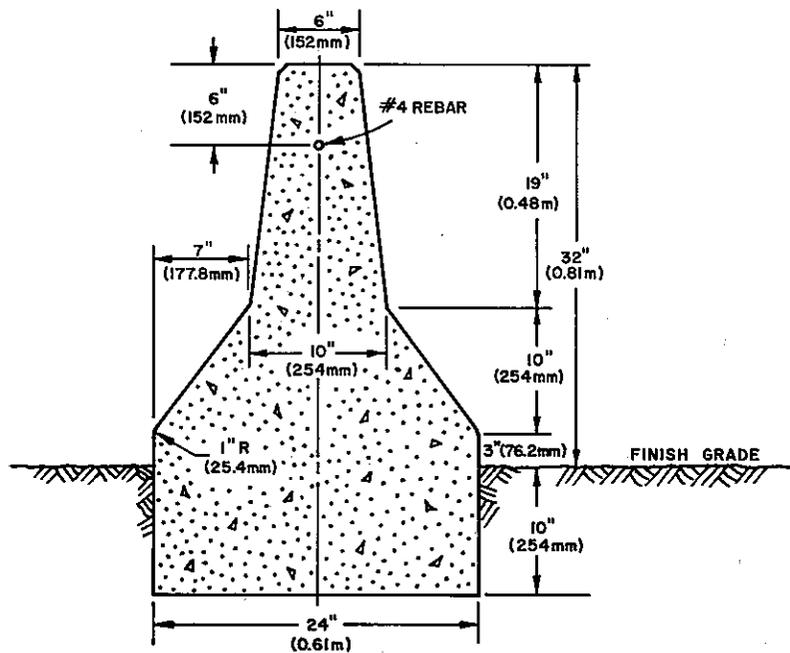
Fig. 4 TYPICAL SECTION OF CONCRETE
BARRIER TYPE 50

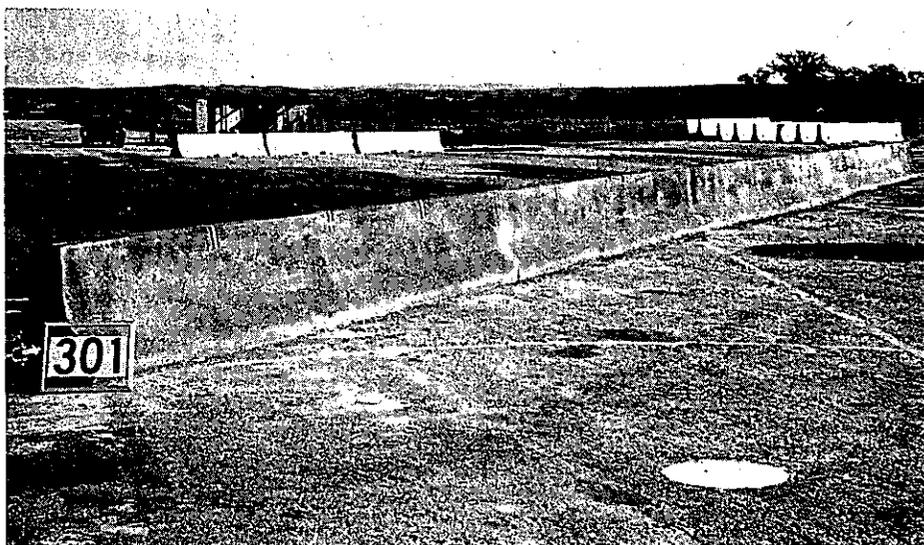
FIGURE 5, TEST INSTALLATION

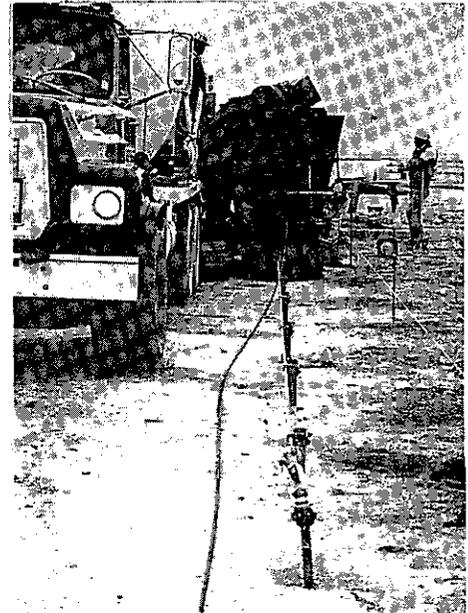
FIGURES 6 AND 7, MILLER FORMLESS MACHINE DURING SLIPFORMING OPERATION

The modified Concrete Barrier Type 50 was slipformed over the steel post stubs and attached cable by slipforming equipment manufactured by Miller Formless Co., Inc. of McHenry, Illinois. This particular machine was equipped with a wall mule, an on-board concrete supply, and a transfer auger. Modern Alloys, Inc. of Stanton, California (a subsidiary of Transportation Safety Systems, Inc.) was contracted to build the test installation. Figures 6 and 7 show the machine during the slipforming operation. The asphalt concrete surface was swept before the slipforming operation began.

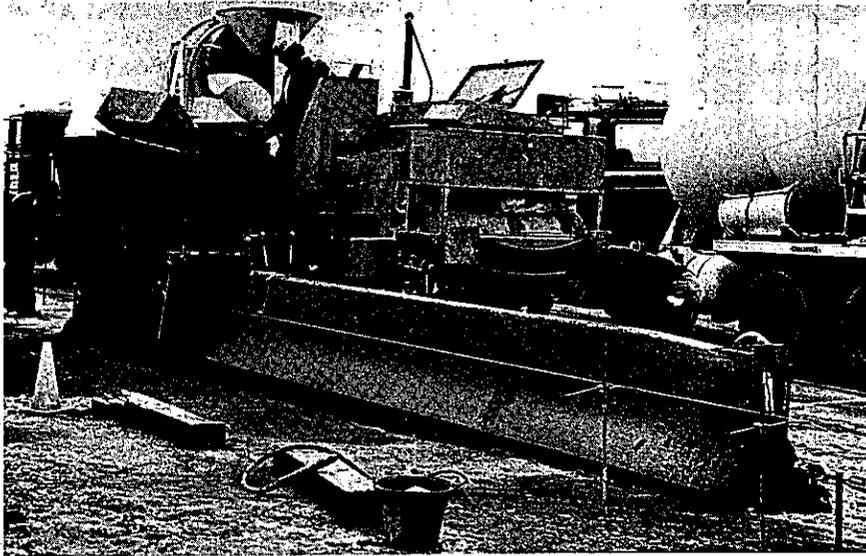
FIGURE 8, SLIPFORMED BARRIER BEFORE START OF FINISHING OPERATION

Contraction joints were placed in the concrete barrier every 20'-0" (6.1 m) along the length of the test installation. Figures 8 and 9 show the barrier before and during the finishing operation.

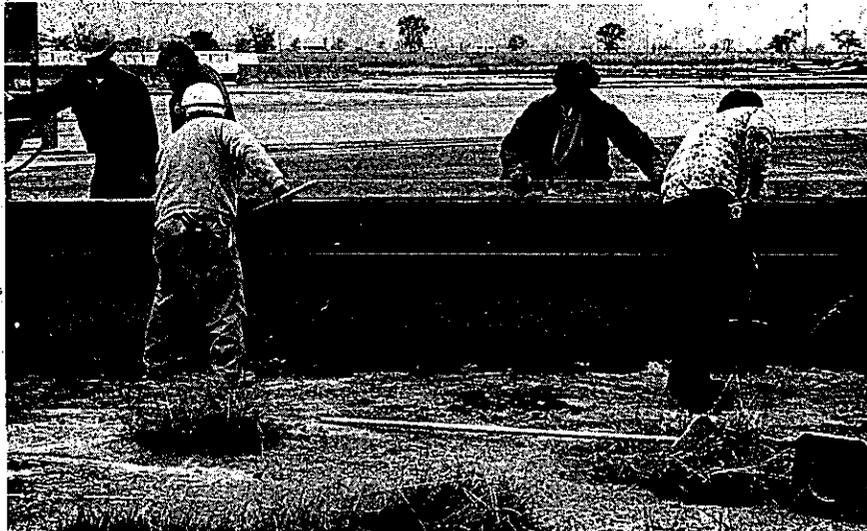
FIGURE 9, SLIPFORMED BARRIER DURING THE FINISHING OPERATION

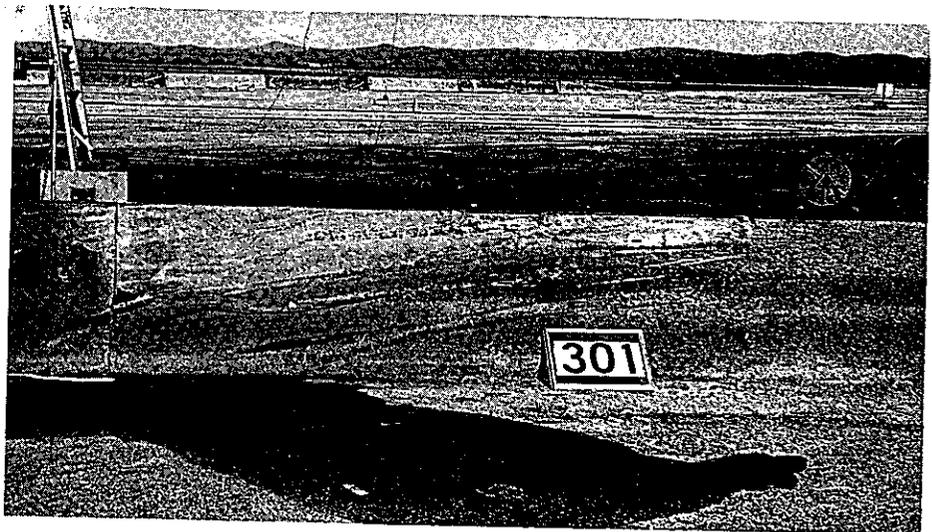
FIGURE 10,
BARRIER DAMAGE

FIGURE 11, BARRIER
DAMAGE AT CONTRACTION
JOINT SHOWN IN FIGURE 10

There was no evidence of any structural failure of the barrier. No visible cracks were detected. The only damage imparted to the barrier was a small spalled area 5" x 4" x 1/2" (127 x 102 x 13 mm) at a contraction joint near impact and a few scrapes and tire marks. Figures 10 and 11 show the barrier damage.

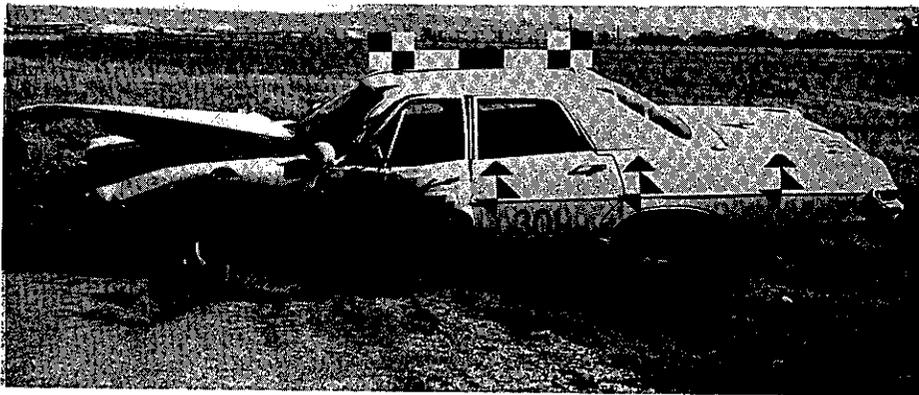
FIGURE 12, VEHICLE DAMAGE

1. The left front quarter was severely crushed.
2. The front bumper was pushed up into the engine compartment in the vicinity of the left front wheel well.
3. The left front door was jammed and buckled outward approximately 4 1/2" (114 mm) from its original plane.
4. The left front wheel A-frame and stabilizer bars were bent under the vehicle.
5. The left front tire was flat.
6. The left side of the radiator was pushed back to the fan.
7. The hood was sprung open.
8. The front windshield was shattered due to frame distortion and glass fragments were found inside the passenger compartment.
9. The dashboard fractured near the steering wheel column.
10. There was minor sheet metal buckling at the roof above the left door post.

The test vehicle could not be driven away. The Traffic Accident Scale (TAD) [2] symbols are: FL-6, LFQ-6, and LBQ-1. The Vehicle Damage Index (VDI) [3] classification is 11FYEW7. Figures 12 and 13 show the vehicle damage.

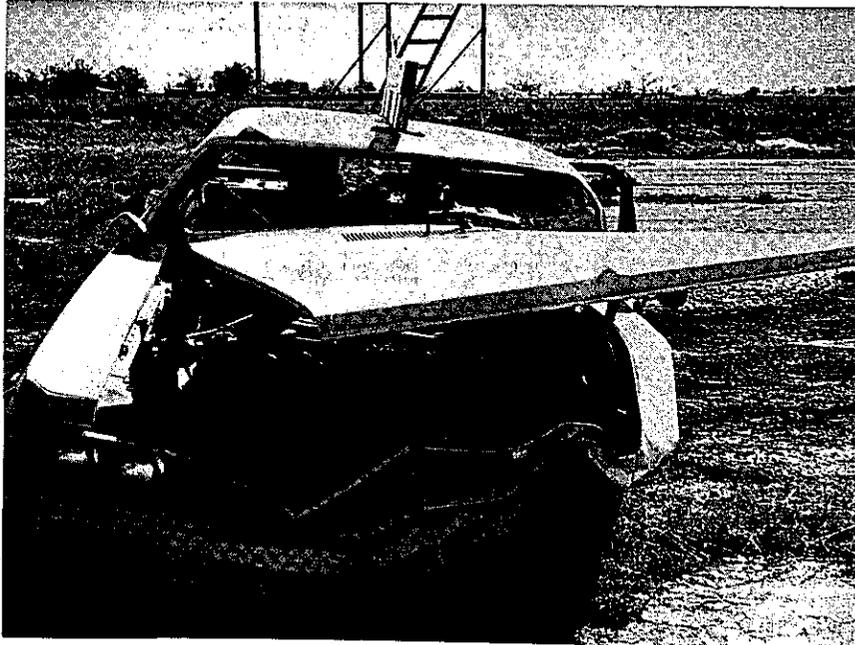
FIGURE 13, VEHICLE DAMAGE

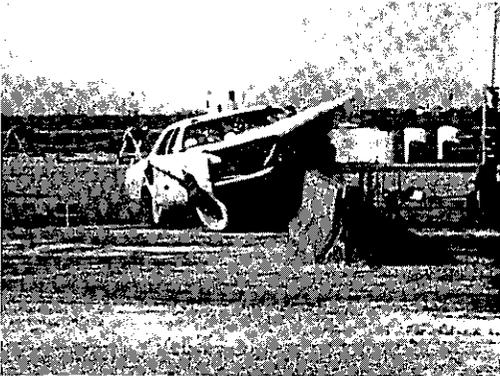
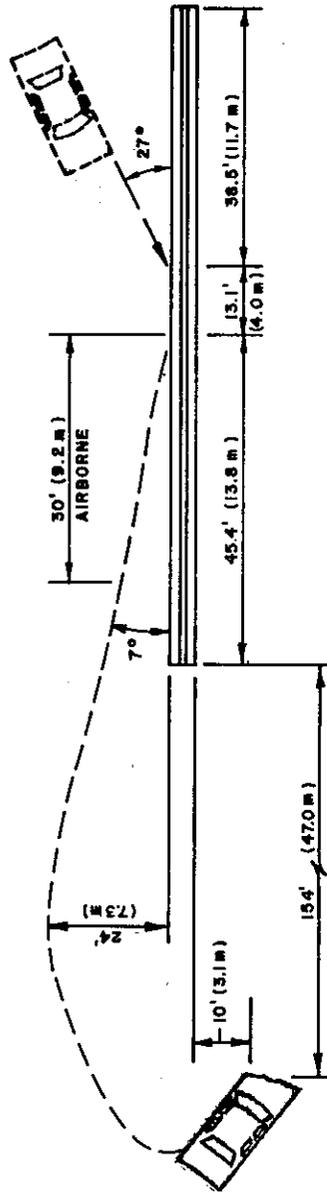
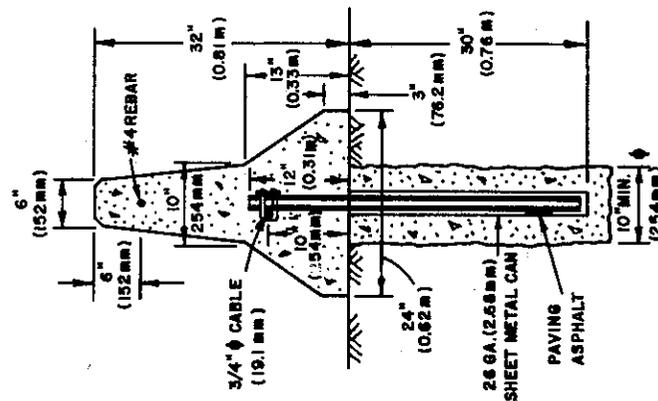
Figure 14 TEST 301

BARRIER.....	Slipformed Type 50 Over	TEST NO.....	301
POST.....	Lowered Cable Barrier	DATE.....	1/22/74
POST SPACING.....	H 2 1/4 x 4.1 Steel (57.2 mm x 6.10 Kg/m)	VEHICLE.....	1969 Dodge Polara
LENGTH OF INSTALLATION.....	8'-0" (2.44 m)	VEHICLE WEIGHT.....	4860 lbs. (2204 kgf)
MAX. PERM. BARRIER DEFL. (lateral).....	.97'-0" (29.6 m)	(w/dummy & instrumentation)	
MAX. 50msec. AVG. VEHICULAR DECELERATION -	.0075" (1.91 mm)	IMPACT SPEED.....	68 mph (109 km/hr)
lateral.....	13.8 G's (136 m/s ²)	IMPACT ANGLE.....	27°
longitudinal.....	11.7 G's (115 m/s ²)	EXIT ANGLE.....	7°
DUMMY RESTRAINT.....	Lap Belt	EXIT SPEED.....	50 mph (80 km/hr)
		MAX. VEHICLE RISE.....	3.2' (0.98 m)

Figure 14 summarizes the results of the test. The exit angle represents the direction the center of gravity of the vehicle was moving immediately following final contact with the barrier. This angle is estimated using high speed movies from cameras mounted over the impact area. It is not necessarily the heading of the longitudinal axis of the vehicle.

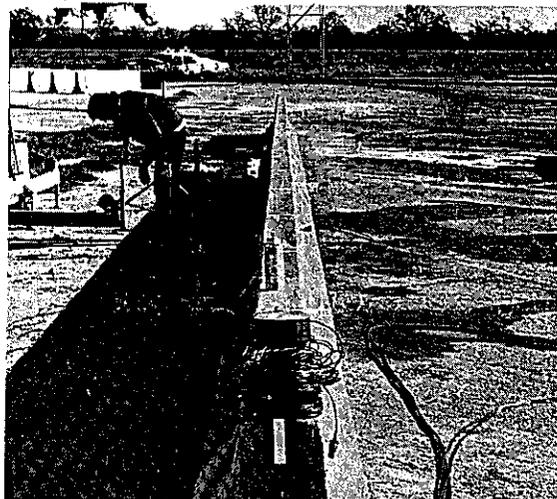
FIGURE 15, FINAL VEHICLE POSITION

It is difficult to determine whether the post trajectory behavior of the test vehicle would pose a hazard to traffic traveling along the highway near the impact location. Other variables such as median width, median surface material and texture, weather conditions, sight distance, reaction time, etc. would also have to be considered along with post trajectory rebound in order to assess the possibility of multiple vehicle collisions. Figure 15 shows the final position of the test vehicle in relation to the test barrier.

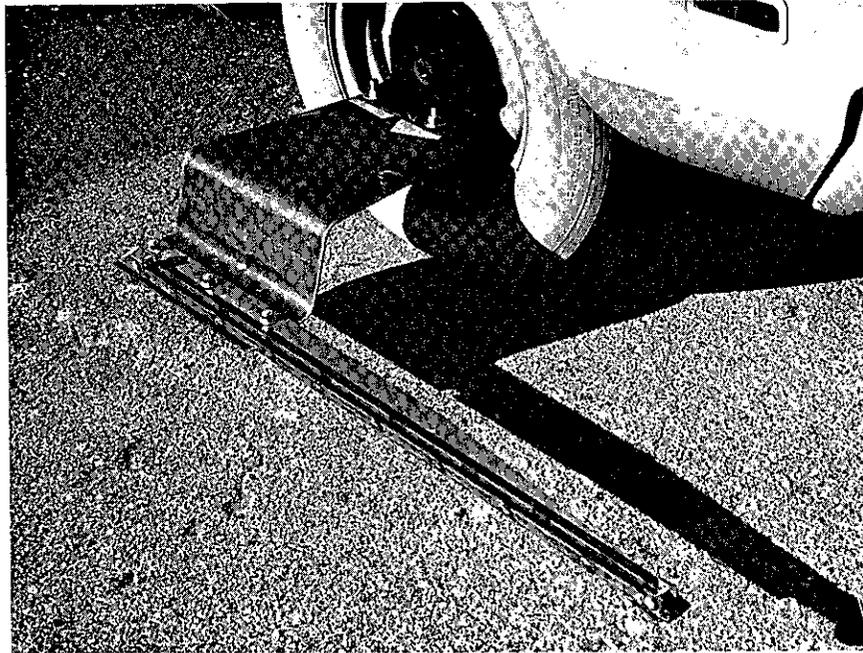
FIGURE 1A, CABLE GUIDANCE BRACKET

A cable guidance system was used to direct the vehicle into the barrier. The guidance cable, anchored at each end of the vehicle path, passed through a slipbase guide bracket attached to the left front wheel spindle of the vehicle. A steel angle post driven into the ground near the barrier projected high enough to knock the bracket off the vehicle just prior to impact so that the vehicle was free of the cable. Figure 1A shows the guidance bracket attached to the vehicle.

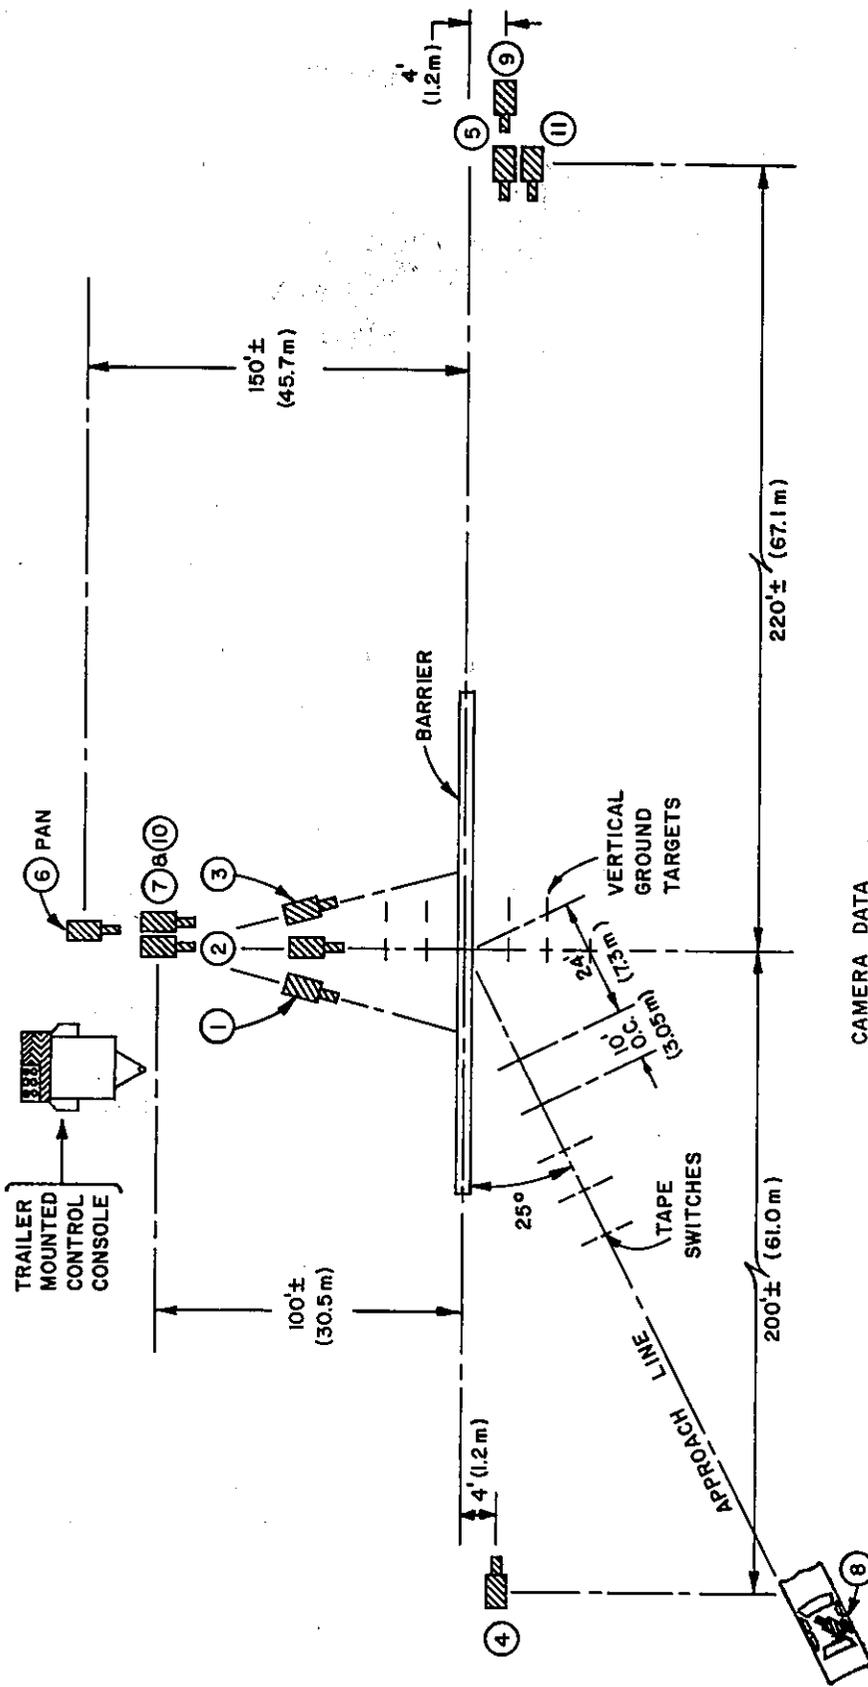
CAMERA DATA

- ①②③ PHOTO-SONICS, 13.0mm LENS, 275 FPS* MOUNTED ON 35' (10.7m) TOWER, AND ORIENTED TO COVER THE AREAS INDICATED ABOVE.
- ④⑤ PHOTO-SONICS, 4" (101.6mm) LENS, 220 FPS.
- ⑥ PHOTO-SONICS, 4" (101.6mm) 150 FPS
- ⑦ PHOTO-SONICS, 2" (50.8mm) 220 FPS
- ⑧ PHOTO-SONICS, 5.3mm WIDE ANGLE LENS, 200 FPS, INSIDE TEST CAR.
- ⑨ HULCHER, 70mm SEQUENCE CAMERA, 12" (0.30m) LENS, MOUNTED ABOUT 12' (3.7m) HIGH ON SCAFFOLD.
- ⑩ BOLEX, 1" (25.4mm) LENS, 24 FPS
- ⑪ HULCHER, 35mm SEQUENCE CAMERA 20 FPS

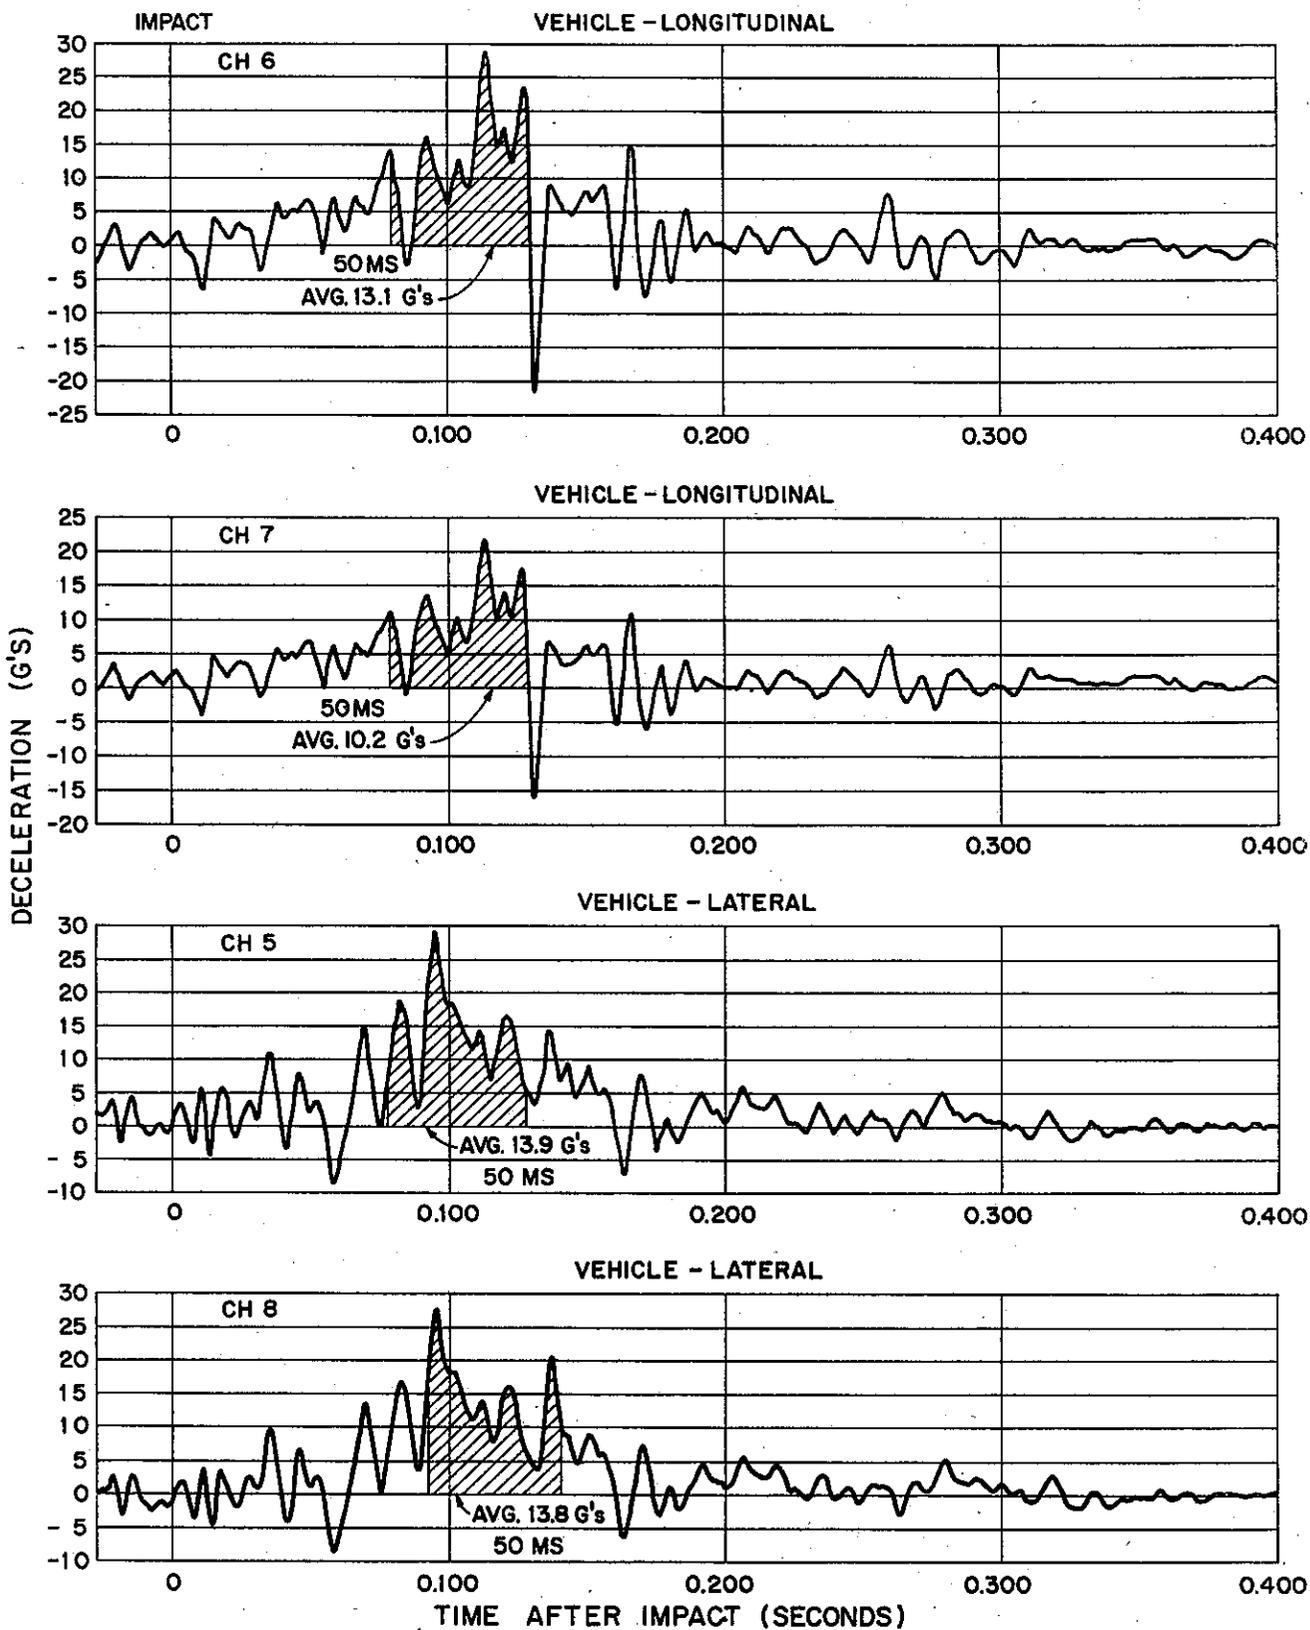
Figure 4A VEHICLE DECELERATION VS TIME
 TEST 301, 68 MPH, 27 DEGREES
 DATA FILTERED AT 100 HERTZ
 SLIPFORMED TYPE 50 OVER LOWERED CABLE BARRIER

A total of eight Statham accelerometers, of the unbonded strain gage type, were used for deceleration measurement. Of these, four were mounted, one in the chest and three in the head cavity, in the anthropometric dummy, and four were mounted on the floorboard of the test vehicle. In addition one seat belt transducer was installed on the dummy's lap belt. The nine transducers transmitted data through a 1000 ft. (305m) Belden #8776 umbilical cable that ran from a rear mounting on the test vehicle to a 14 channel Hewlett Packard 3924C magnetic tape recording system. This recording system was mounted in an instrumentation trailer located in the test control area. Figure 3A shows the location of the transducers in the test vehicle. Three pressure activated tape switches were mounted on the pavement at fixed intervals in the vehicle approach path. When activated by the test vehicle's tires, these switches produced sequential impulses which were recorded with the transducer signals on the tape recorder. Concurrently a 100 millisecond time cycle signal was impressed on the tape. All of the tape recorder data were subsequently played back through a Visicorder which produced an oscillographic trace (line) on paper. Each paper record contained a curve of data from one of the nine transducers, the signals from the three tape switches, and the 100 millisecond time cycle marking. Some of the records of accelerometer data had high frequency spikes which made analysis difficult. Therefore, the original test data was filtered at 100 Hertz with a Krohn-Hite filter. The smoother resultant curves gave a good representation of the overall vehicle deceleration without significantly altering the amplitude and time values of the deceleration pulse. Transducer records are presented in Figures 4A and 5A.

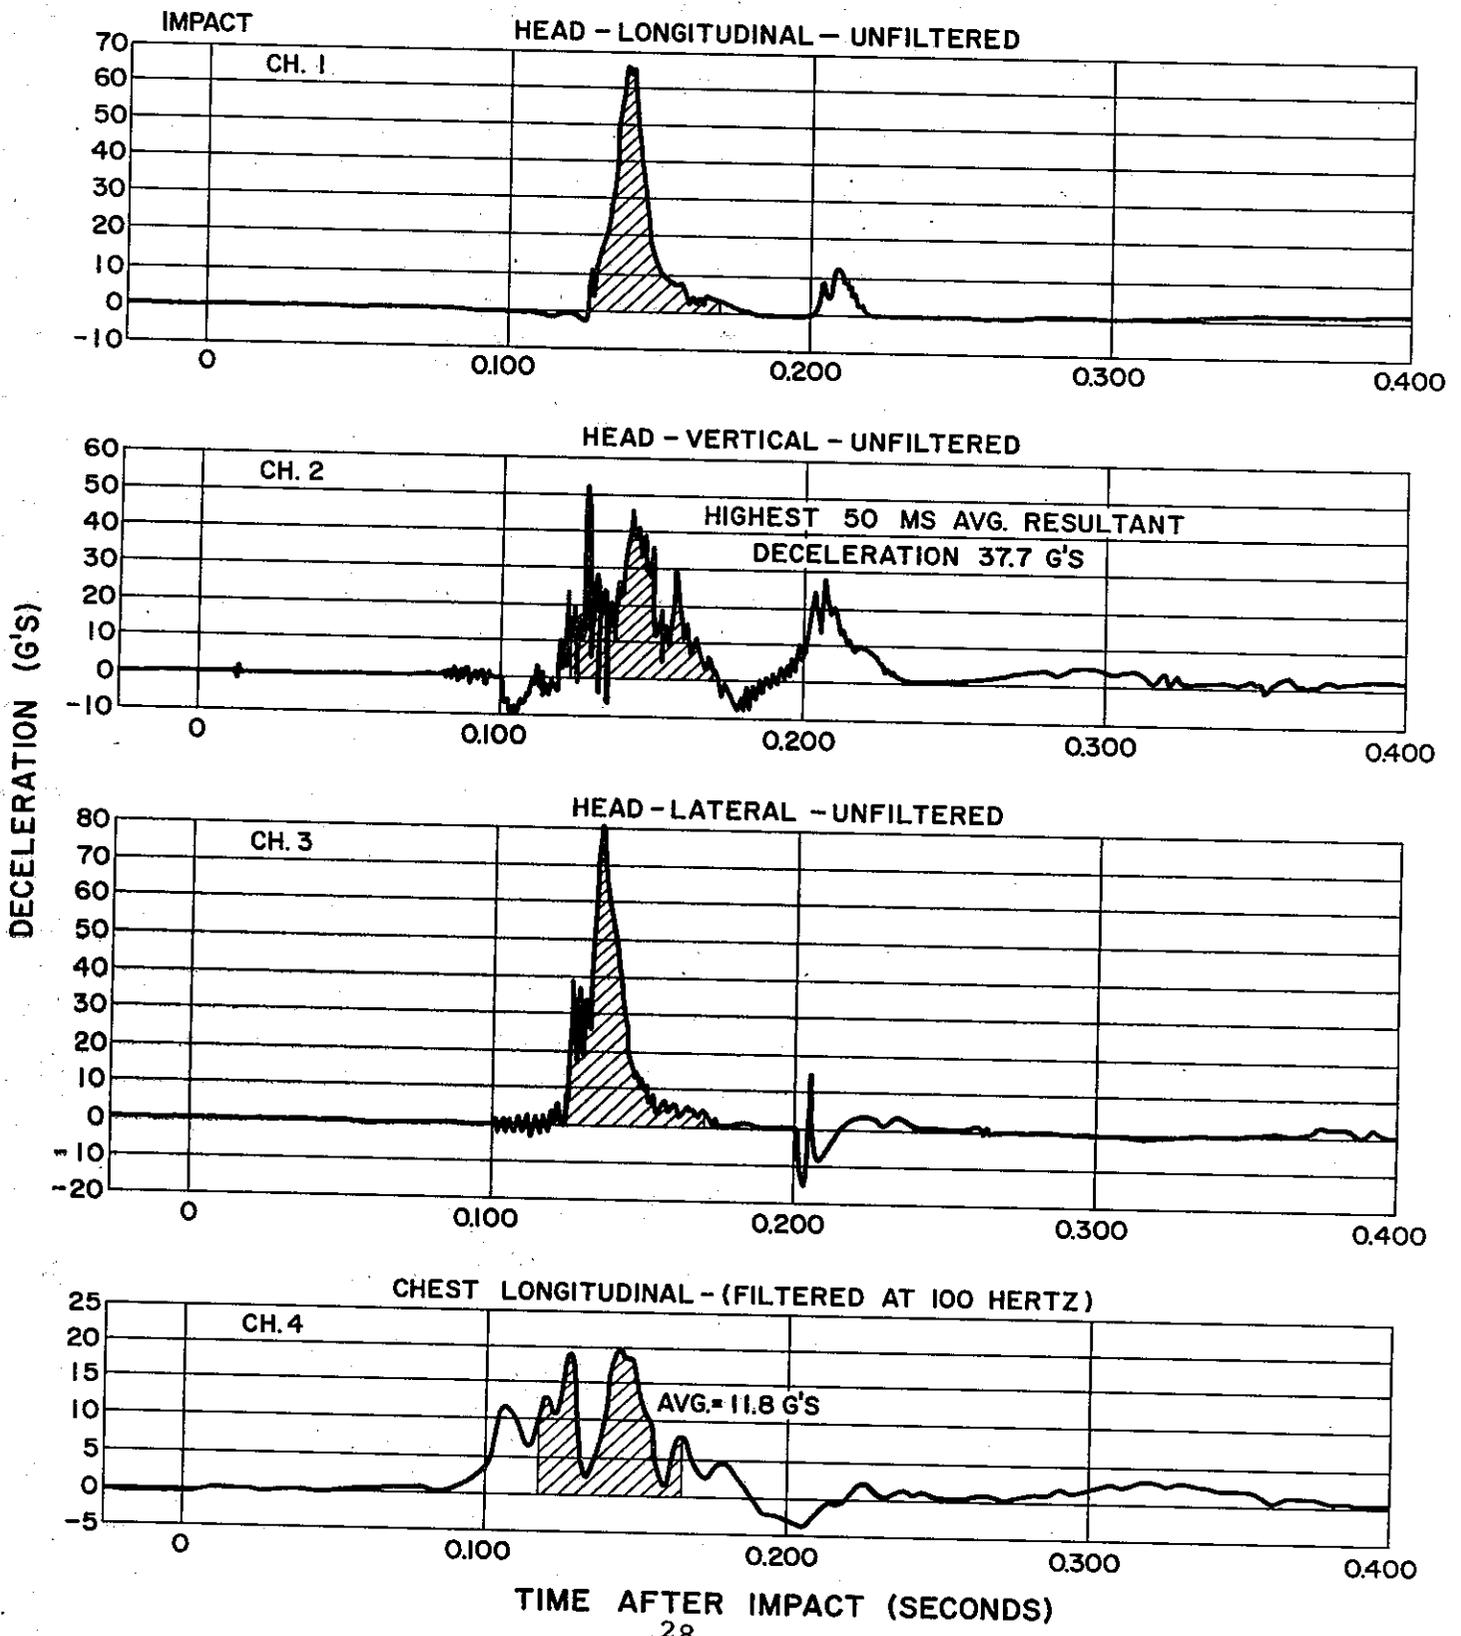
Figure 5A "DUMMY" DECELERATION VS TIME
TEST 301, 68 MPH, 27 DEGREES, LAP BELT
SLIPFORMED TYPE 50 OVER LOWERED CABLE BARRIER

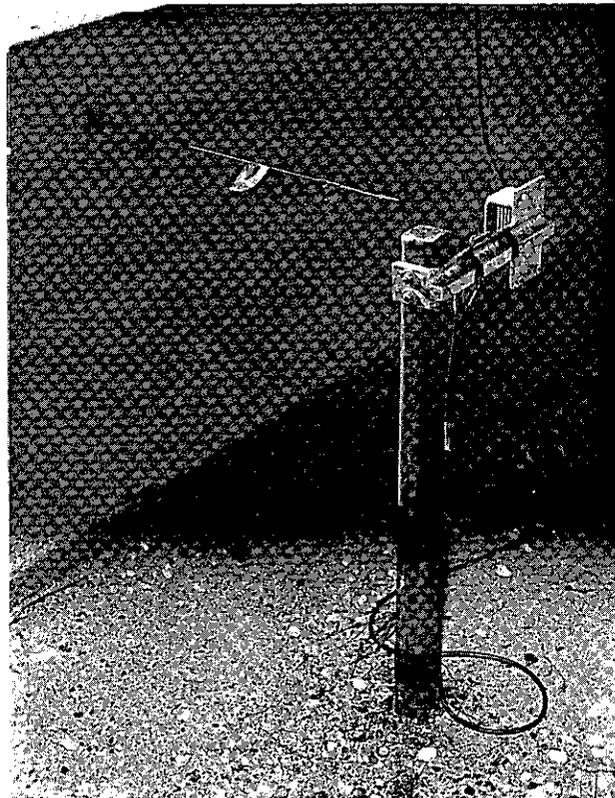
FIGURE 6A, HOUSTON DEFLECTION POTENTIOMETER

Houston Deflection Potentiometers, Figure 6A measured the dynamic deflection of the test barrier during impact. Figure 7A shows the record of this measurement.

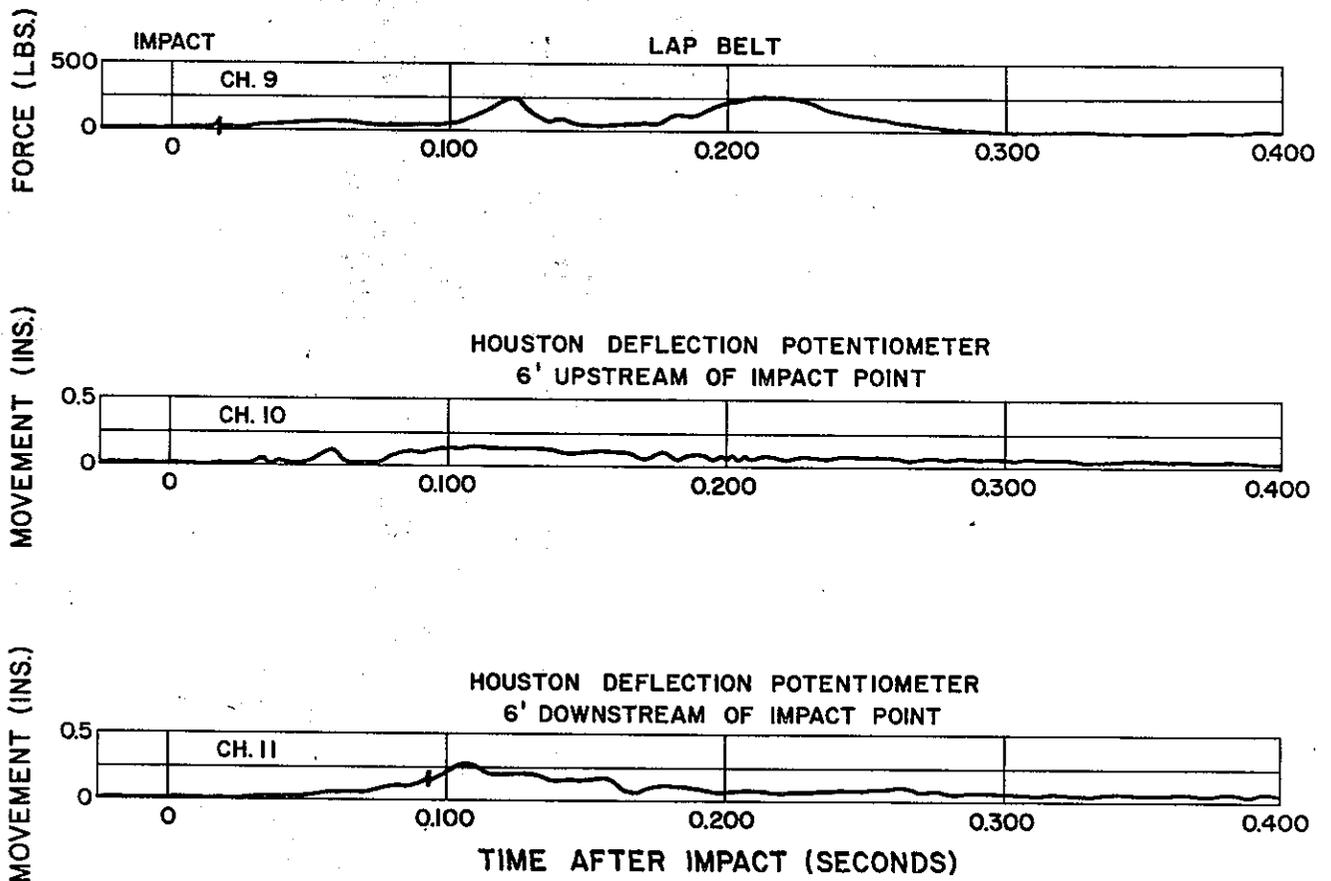
Figure 7A DUMMY LAP BELT LOAD VS TIME &
 BARRIER DEFLECTION
 TEST 301, 68 MPH, 27 DEGREES
 SLIPFORMED TYPE 50 OVER LOWERED CABLE BARRIER
 DATA UNFILTERED

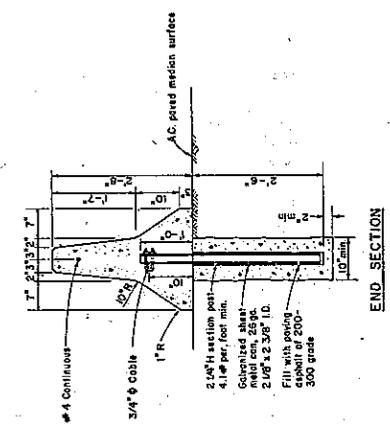
END SECTION
1/2" = 1'

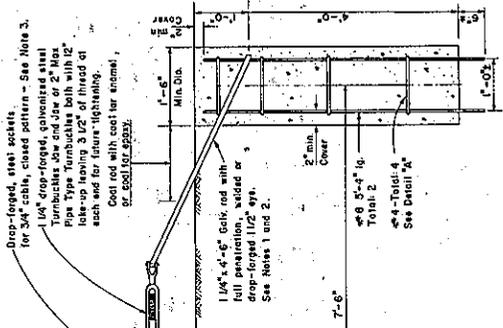
ANCHOR ASSEMBLY
1" = 1'

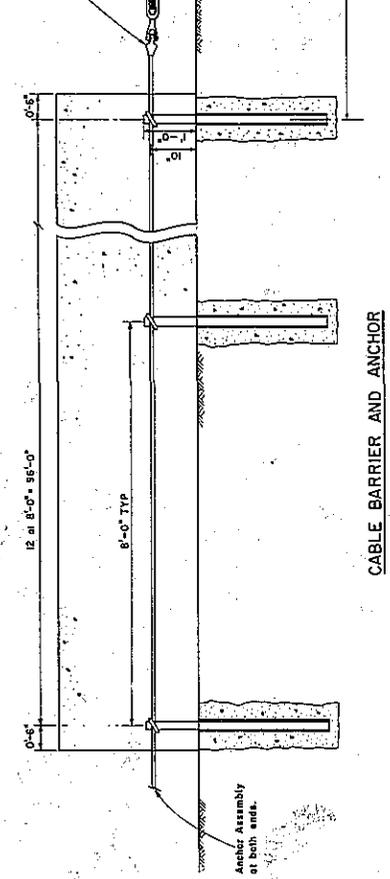
CABLE BARRIER AND ANCHOR
1" = 1'

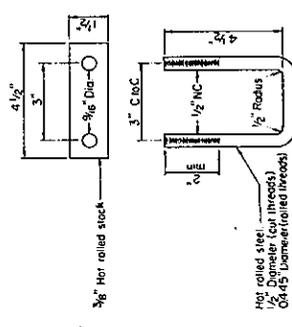
CABLE CLAMP DETAIL
1/2" = 1'

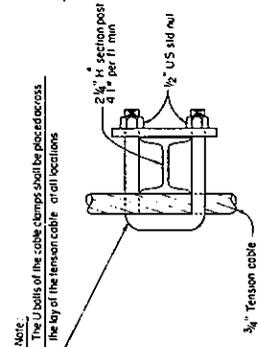
LINE POST ASSEMBLY
1/2" = 1'
