CA/TL-90/05

Field Tests and Evaluation of Rockfall Restraining Nets

June 1990

Office of Transportation Materials and Research
California Department of Transportation
Sacramento, California 95819

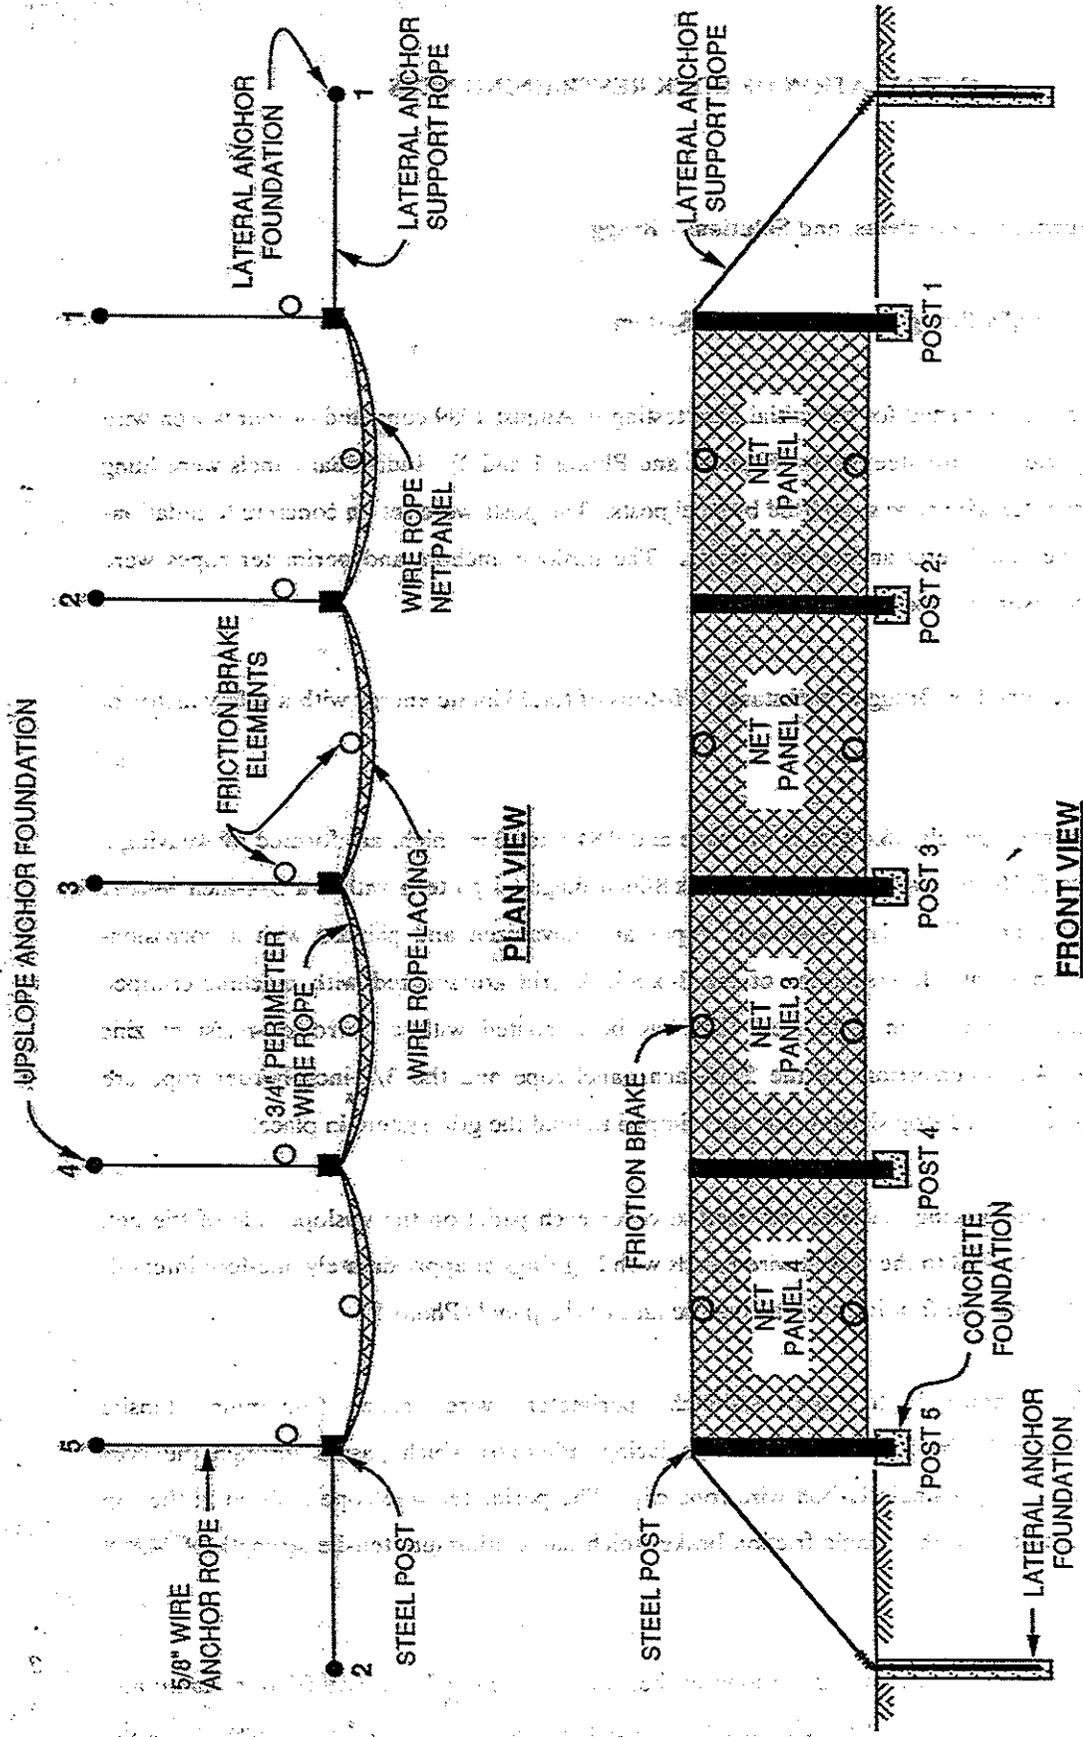
Figure 1. PLAN VIEW AND FRONT VIEW OF BRUGG ROCK NET CONSTRUCTED FOR THE INITIAL FIELD TESTING

The Brugg rock net constructed for the initial field testing in August 1989 consisted of four woven wire rope panels supported by five steel posts (Figure 1 and Photos 1 and 2). Individual panels were hung from a heavy perimeter wire rope supported by steel posts. The posts were set on concrete foundations secured by upslope and lateral anchor wire ropes. The upslope anchors and perimeter ropes were fitted with energy absorbing friction brakes.

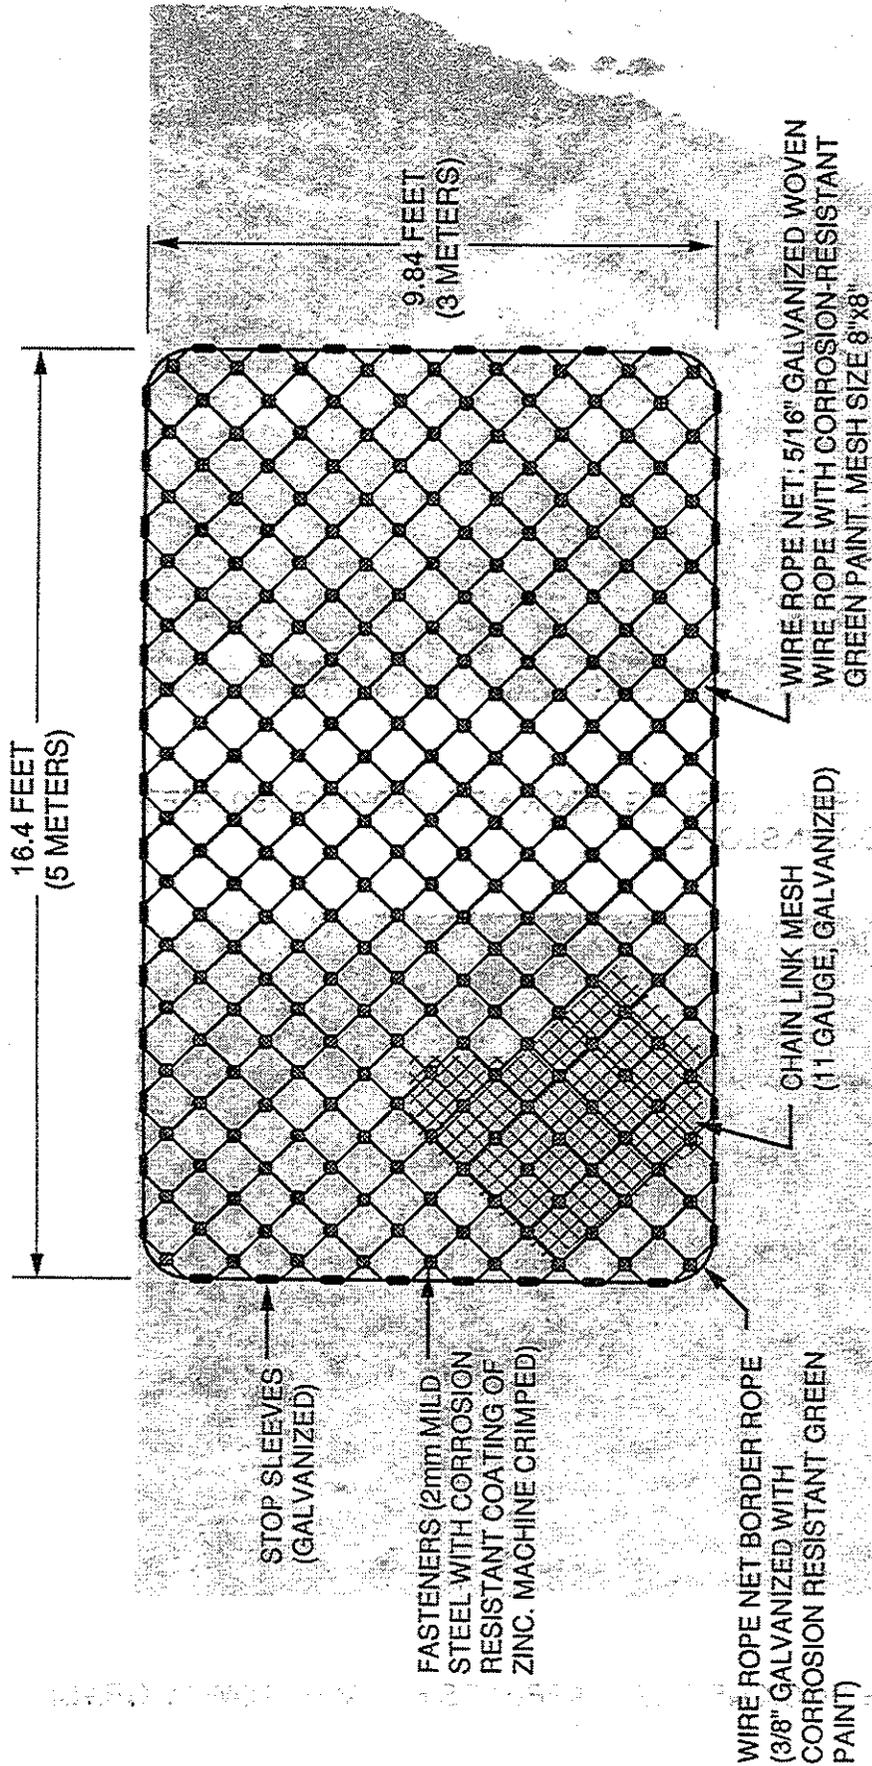
**Figure 2. DETAIL OF THE BRUGG WOVEN WIRE ROPE
PANEL USED IN THE INITIAL FIELD TESTING**

Brugg woven wire rope panels, 16.4 feet (5 m) wide and 9.84 feet (3 m) high, are formed by weaving a single, continuous 5/16-inch wire rope into an 8- x 8-inch diagonal pattern within a 3/8-inch border wire rope (Figure 2 and Photo 3). Both wire ropes are galvanized and painted with a corrosion-resistant light green paint. Intersections of the 8- x 8-inch grid are secured with machine-crimped fasteners fabricated from 2 mm mild steel that has been coated with a corrosion-resistant zinc compound (Photo 4). Intersections of the 5/16-inch panel rope and the 3/8-inch border rope are secured by heavy galvanized stop sleeves that are crimped to hold the grid system in place.

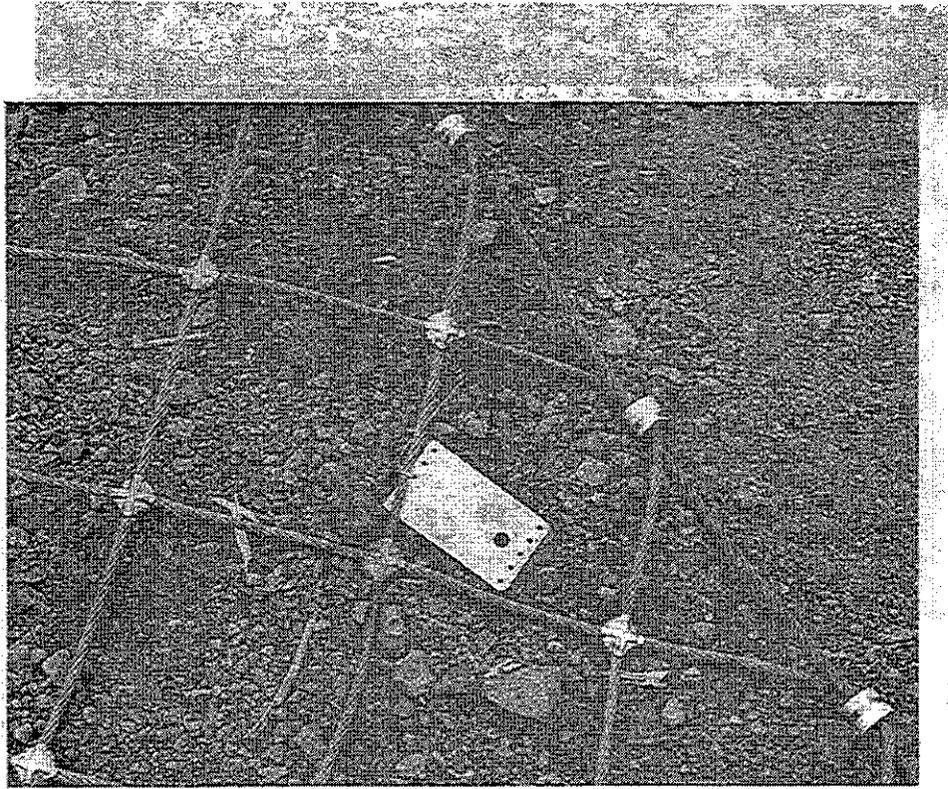
Photo 3. CLOSE-UP OF BRUGG WOVEN WIRE ROPE NET SHOWING GRID SPACING, NET FASTENERS, AND BORDER ROPE

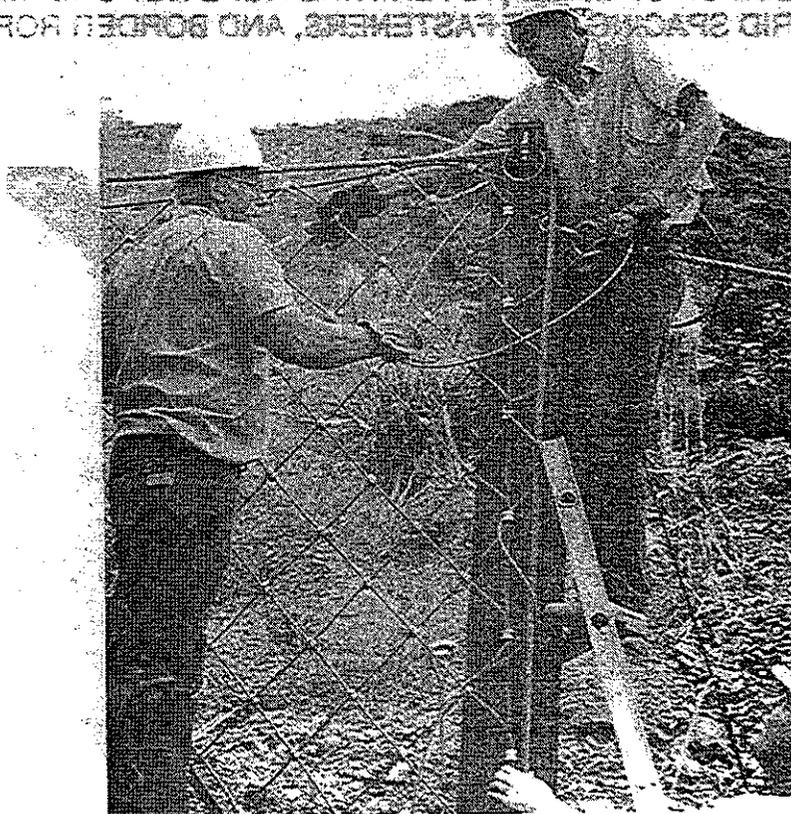
Photo 6. CONNECTING THE NET PANELS TO THE PERIMETER WIRE ROPE WITH WIRE ROPE LACING

The lacing wire ropes should be replaced each time they are disassembled because of distortion of the wire ropes near their ends where they are wrapped three times around the perimeter wire rope and the post fittings (Photo 55). After impact, the wrapped lacing wire ropes are permanently distorted with a curl or kink in the rope. Relacing with this distorted rope is difficult and time consuming (Photo 6).

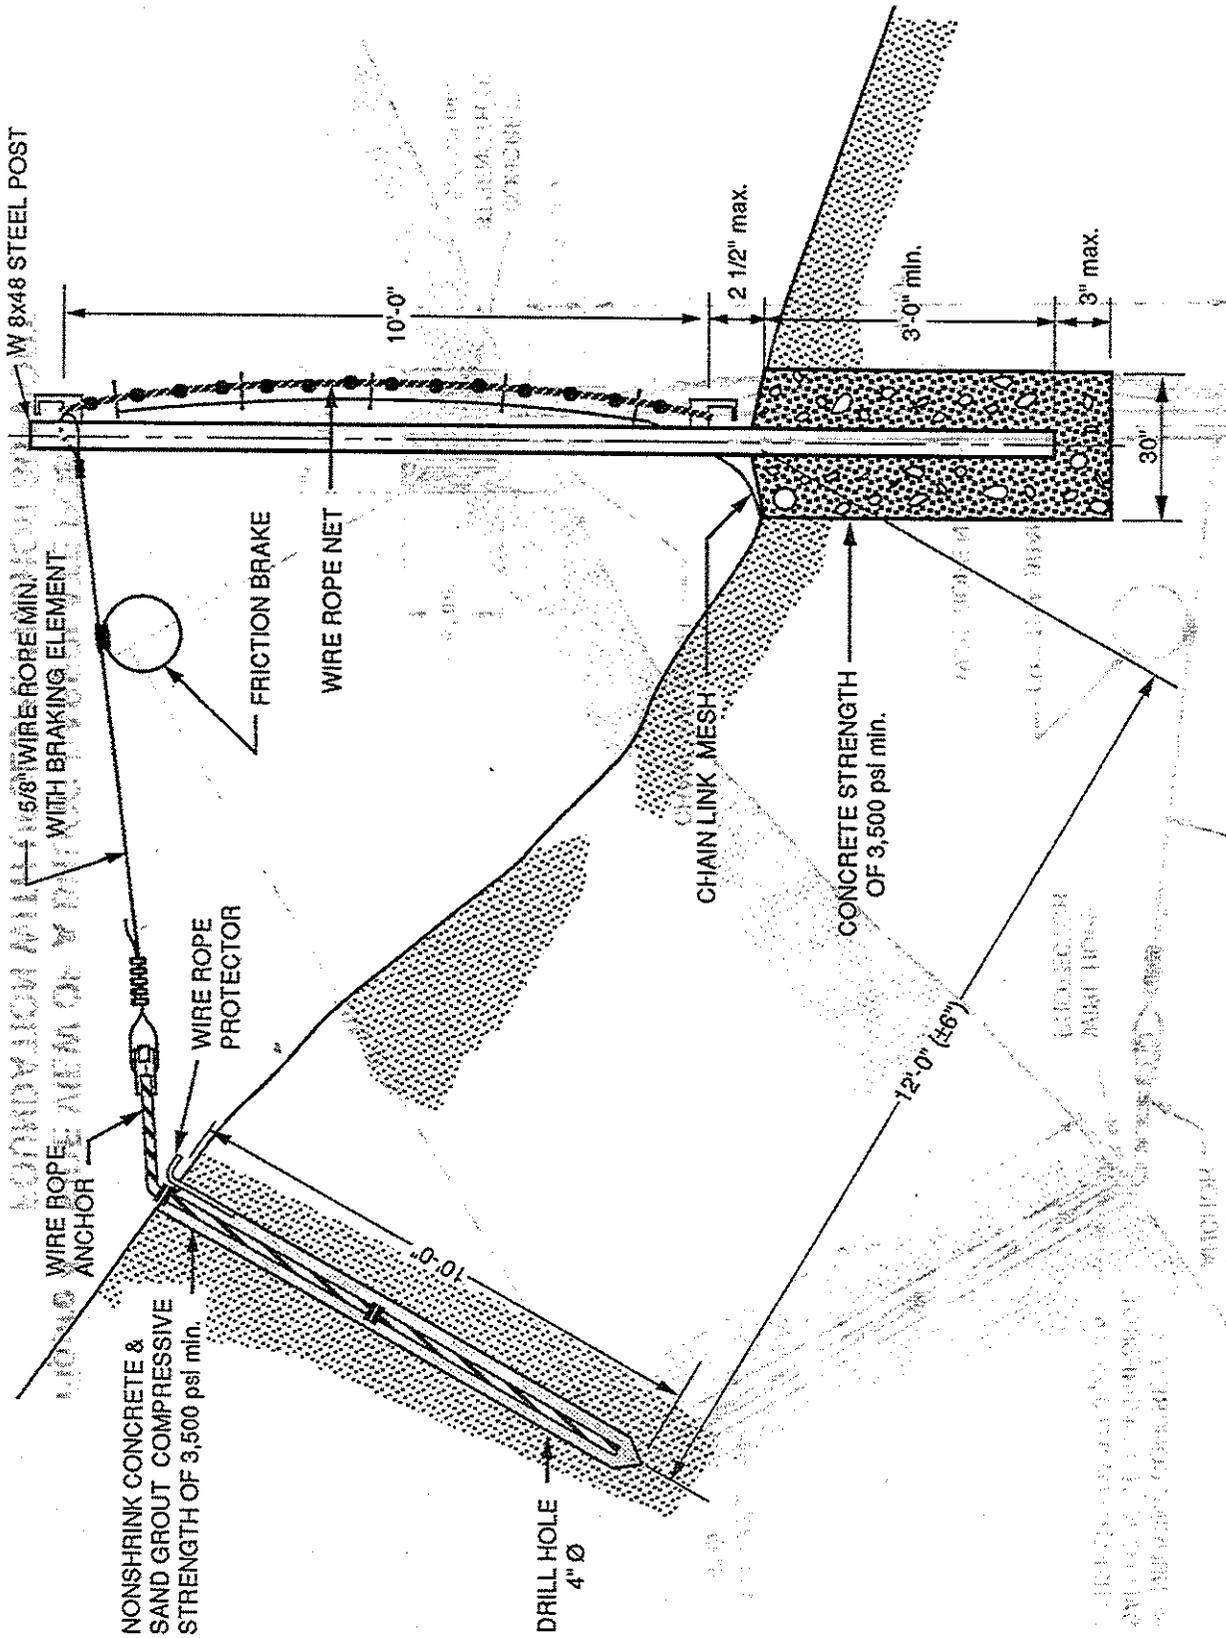
Figure 3. SIDE VIEW OF A BRUGG FULLY EMBEDDED POST FOUNDATION WITH UPSLOPE ANCHOR SUPPORT

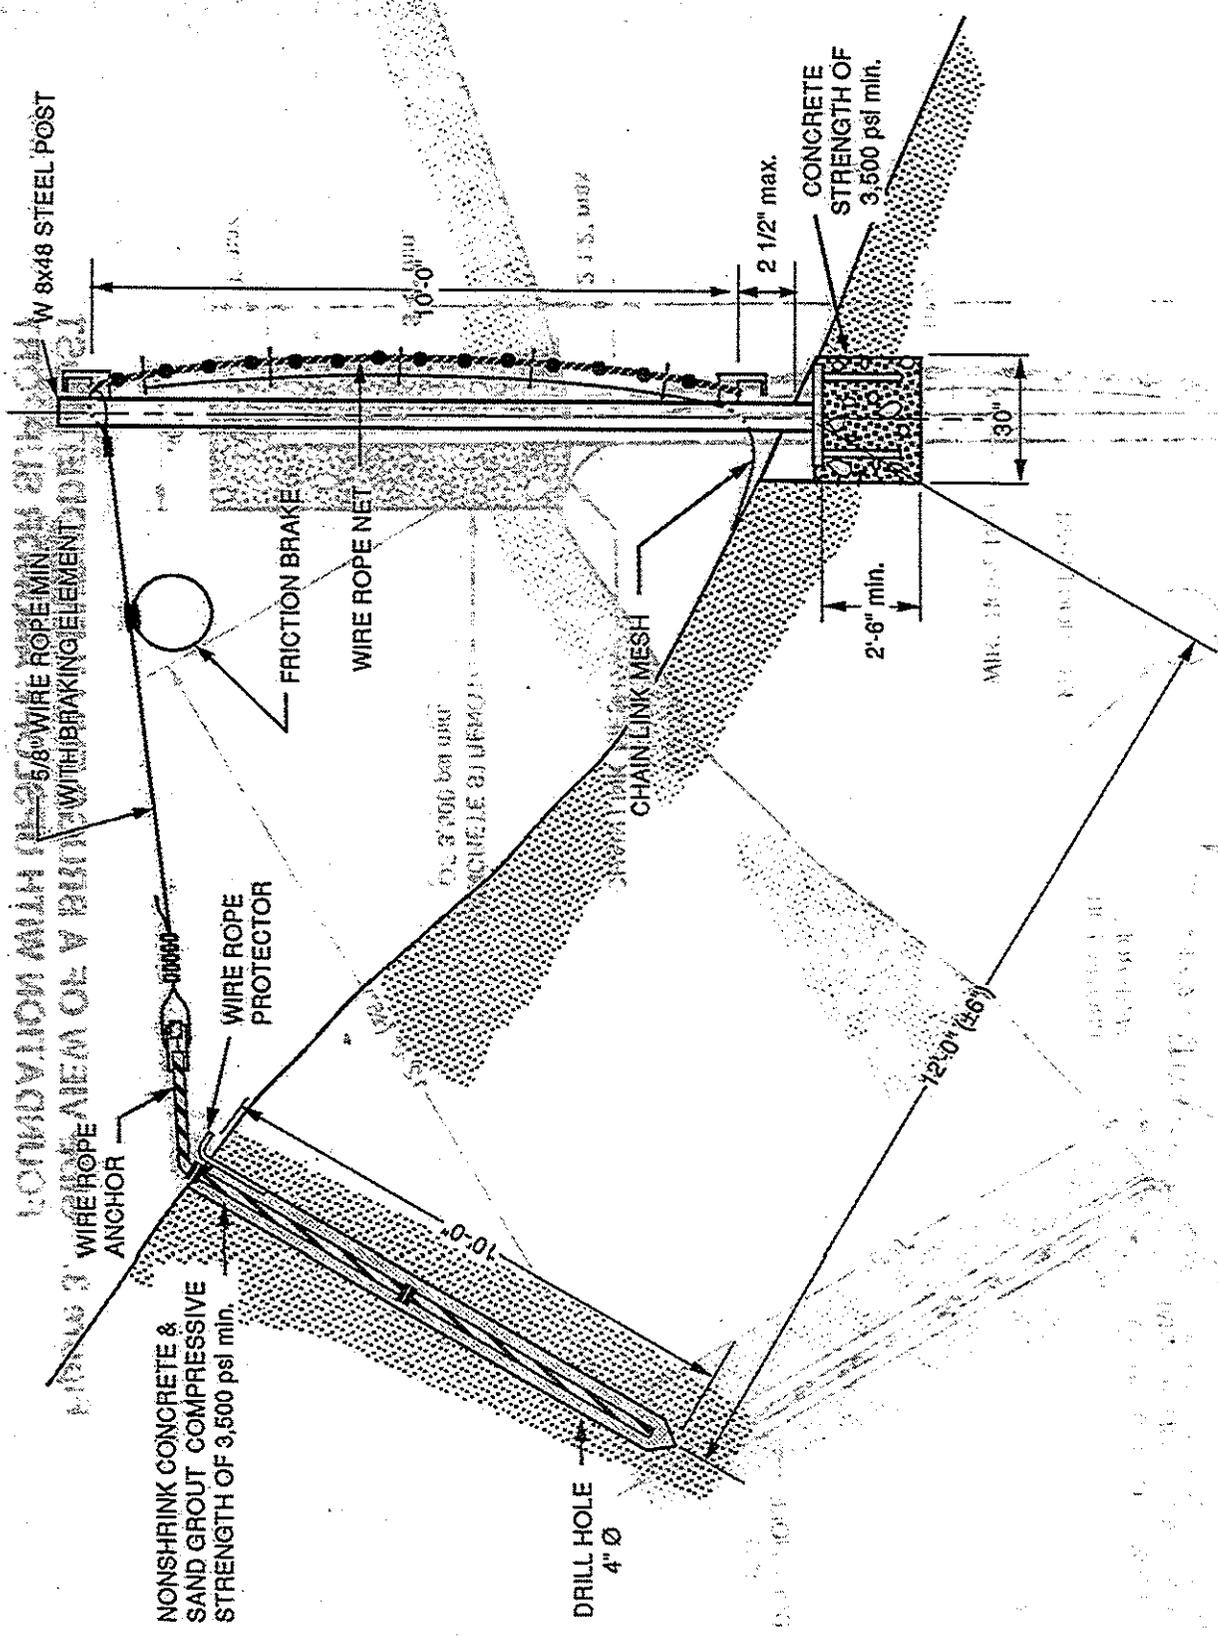
Figure 4. SIDE VIEW OF A BRUGG BASEPLATE POST FOUNDATION WITH UPSLOPE ANCHOR SUPPORT

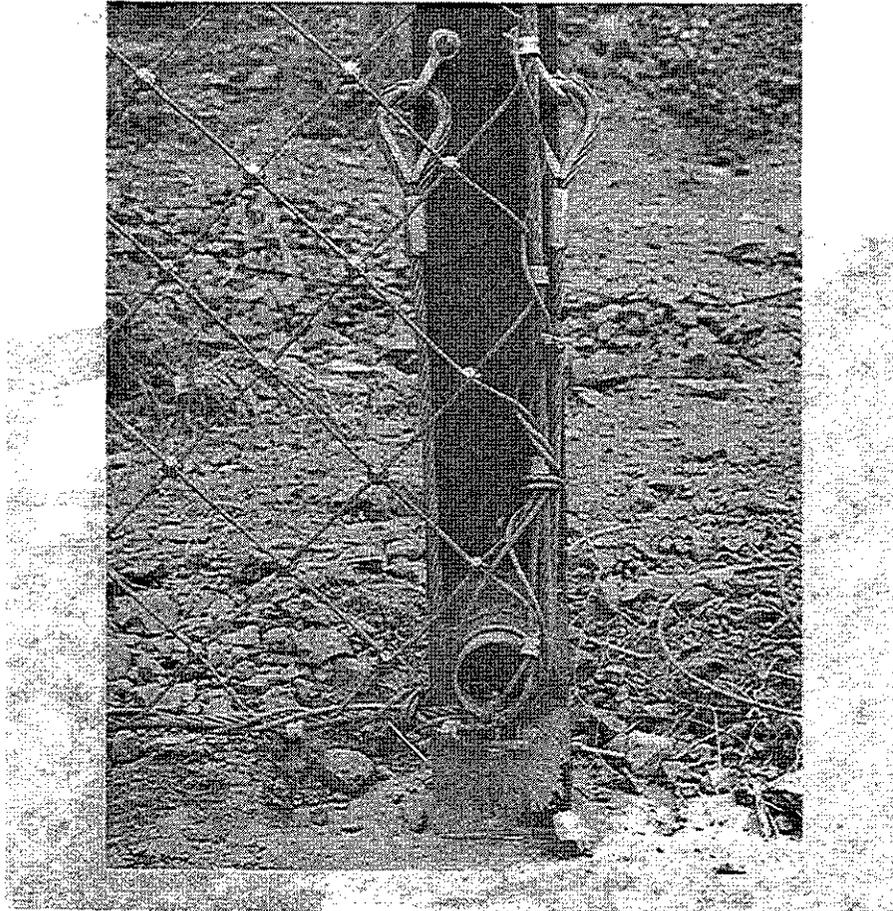
Photo 8. DETAIL OF BRUGG FULLY EMBEDDED POST. NOTE TRIPLE-TWISTED LACING CABLE ATTACHMENT AND SINGLE CABLE CLIP CONNECTION

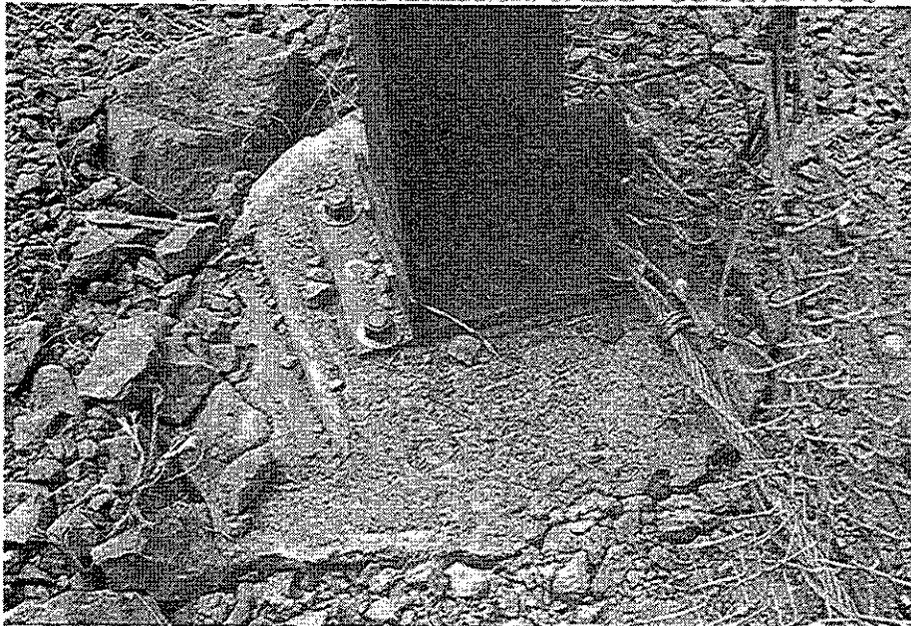
Photo 9. DETAIL OF BRUGG BASEPLATE POST ATTACHMENT

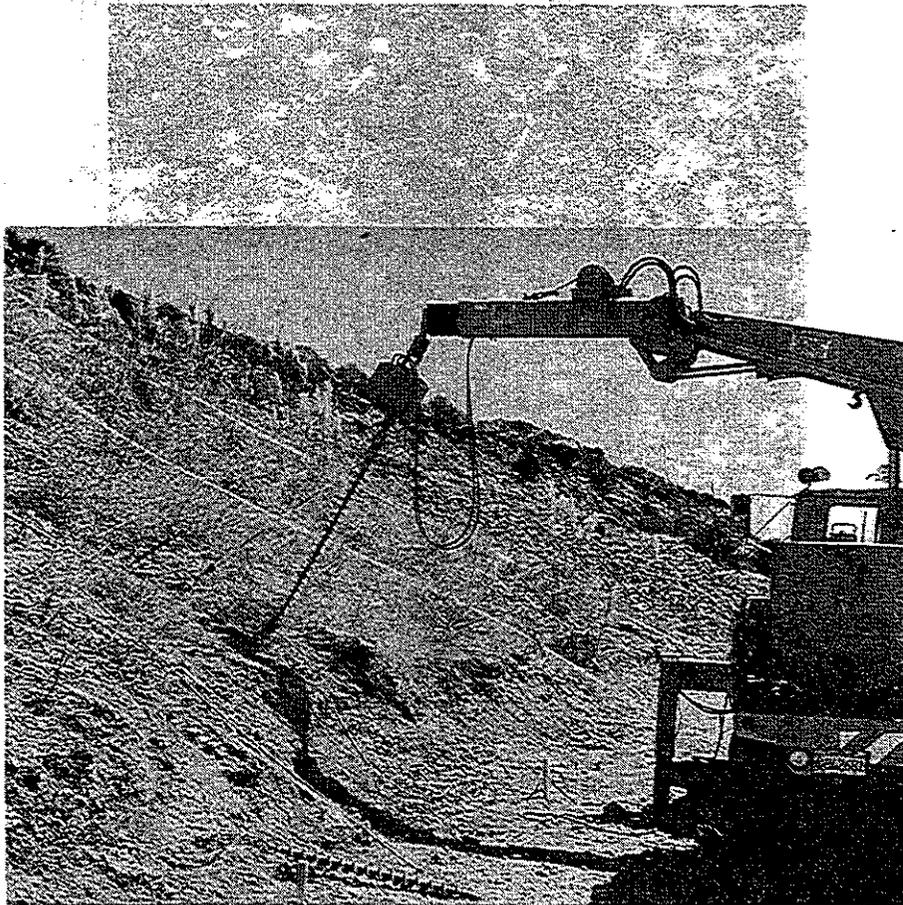
Photo 10. DRILLING ANCHOR FOUNDATION HOLES WITH 4-INCH
CONTINUOUS FLIGHT AUGERS USING A HYDRAULICALLY
POWERED TRUCK-MOUNTED ARTICULATED BOOM

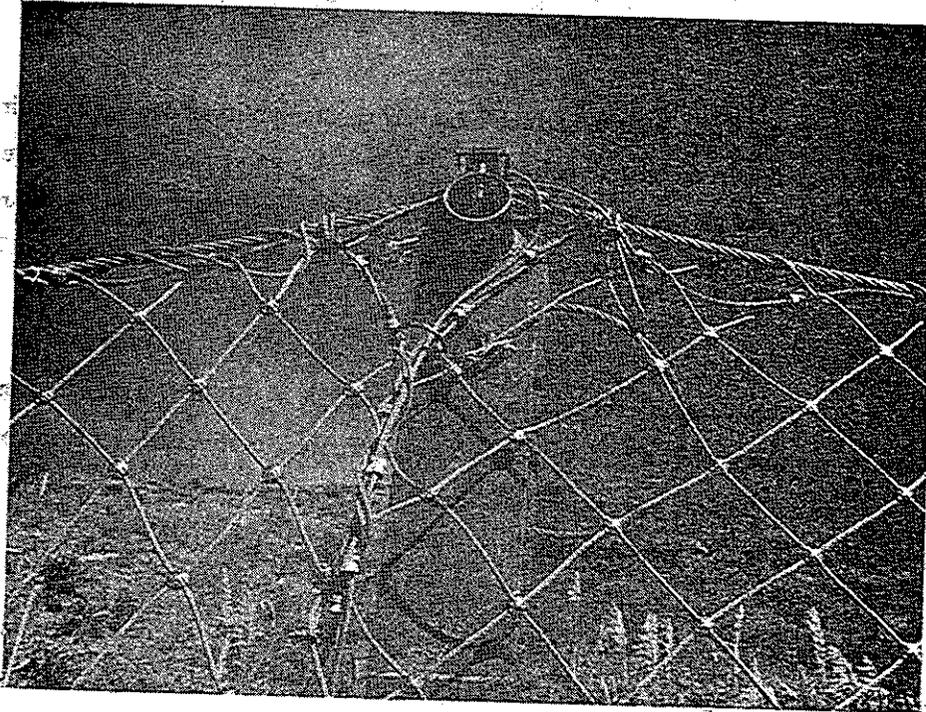
Photo 11. DETAIL OF A BRUGG POST WITH MACHINED FITTINGS SUPPORTING THE PERIMETER WIRE ROPE

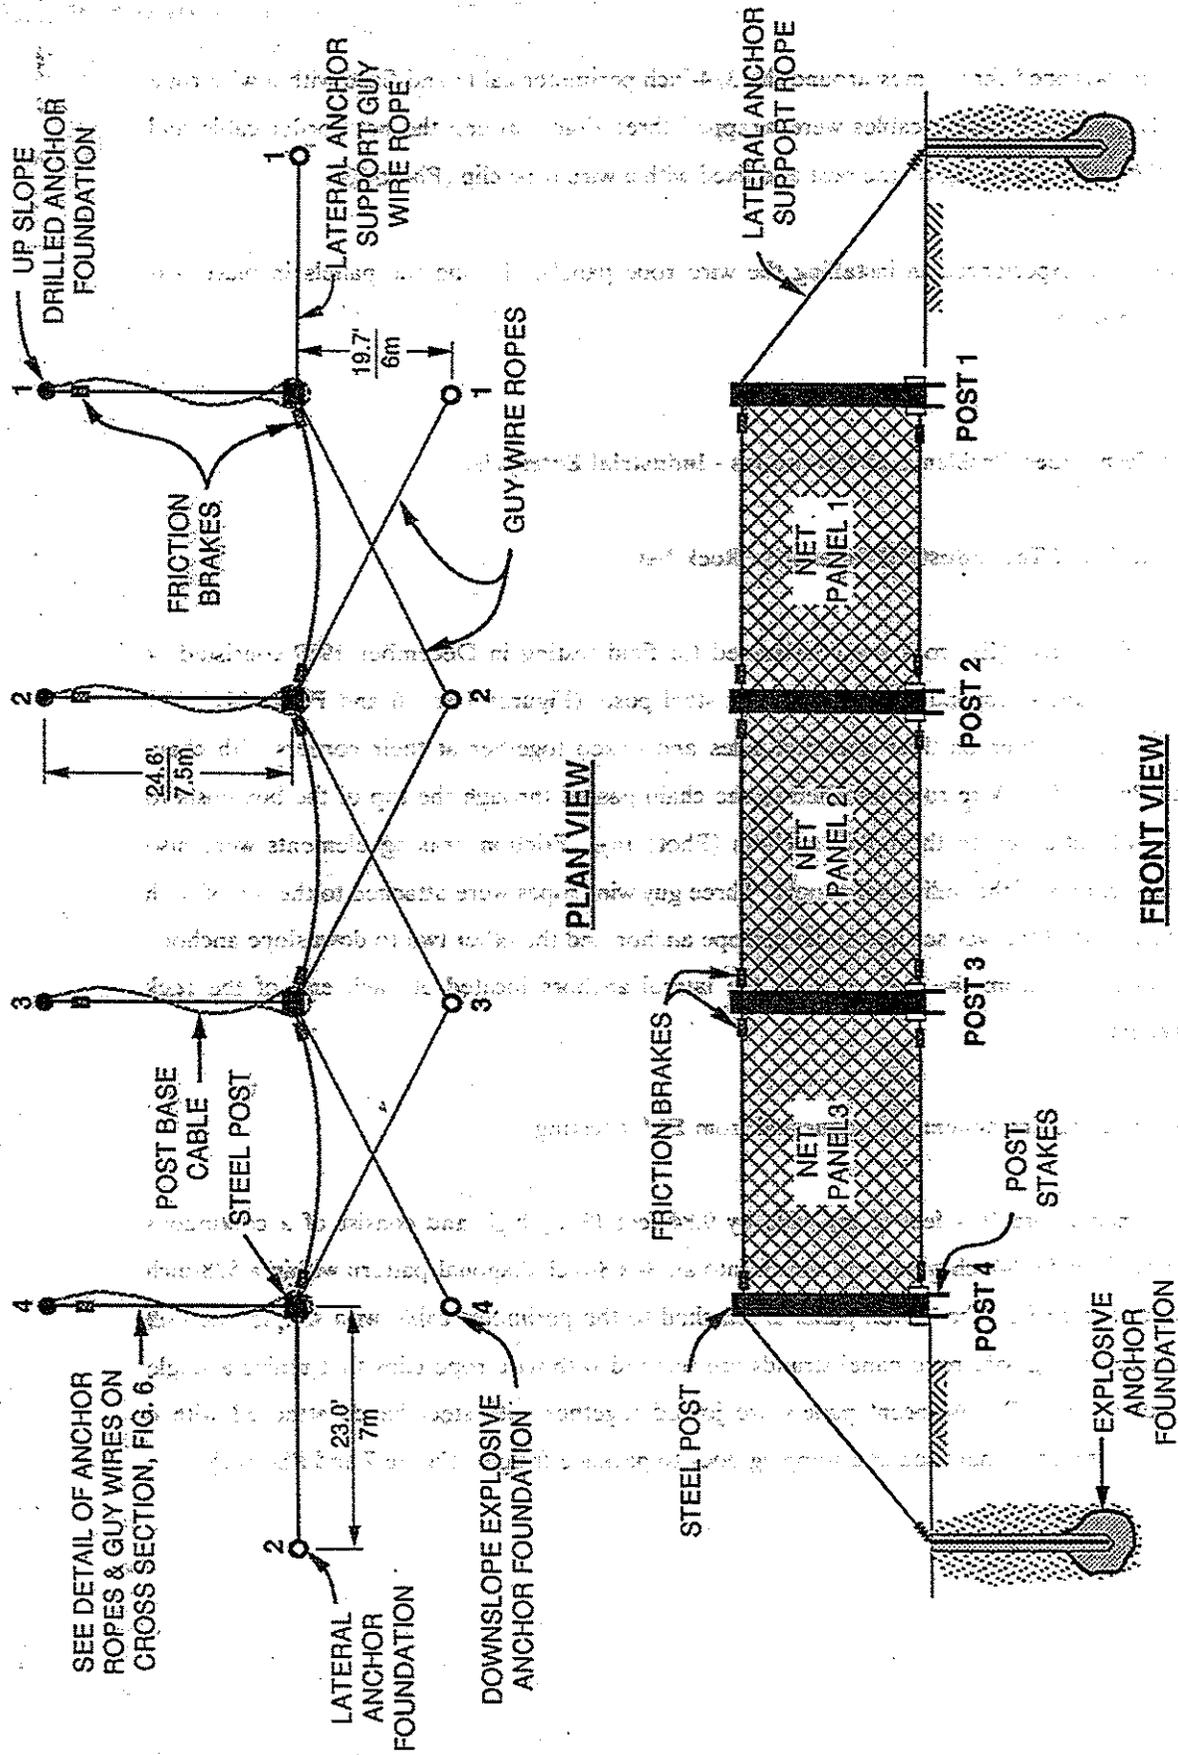
Figure 5. FRONT AND PLAN VIEW OF THE INDUSTRIAL ENTERPRISE ROCK NET CONSTRUCTED FOR FIELD TESTING

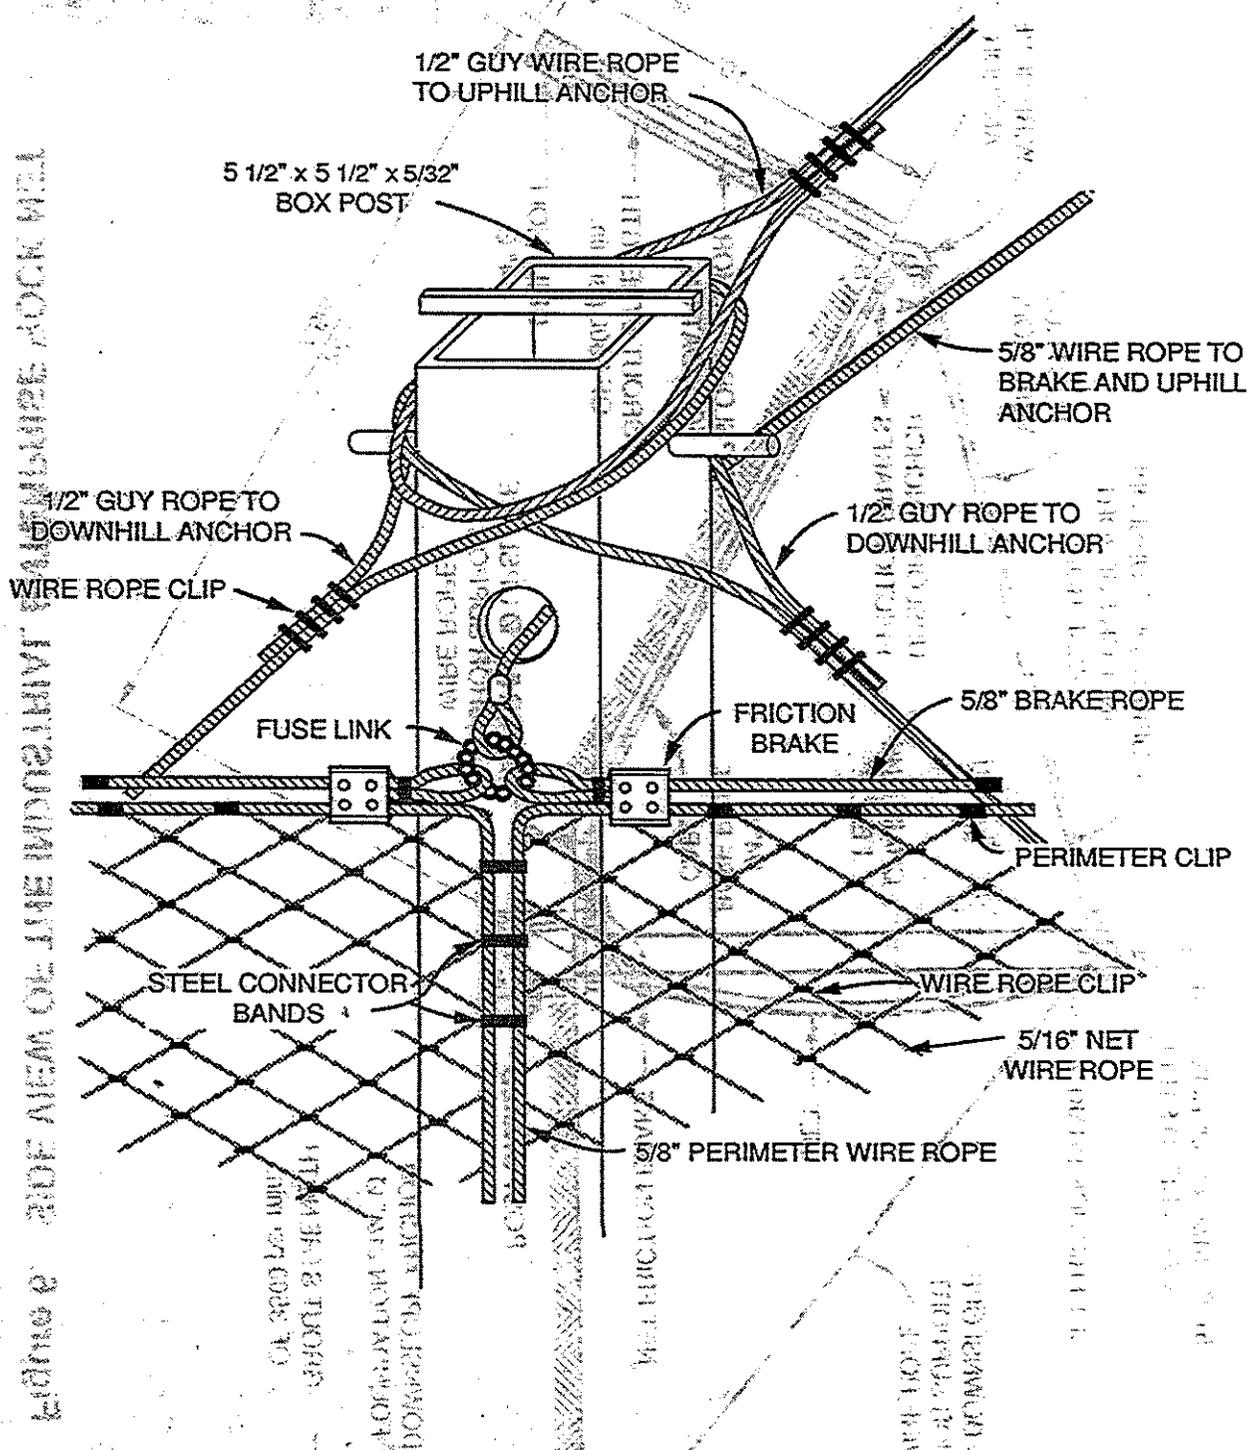
Figure 7. DETAIL OF INDUSTRIAL ENTERPRISE TOP POST ASSEMBLY

EI woven wire panels are 16.4 feet (5 m) wide by 9.84 feet (3 m) high and consist of a continuous unpainted, galvanized 5/16-inch wire rope woven into an 8- x 8-inch diagonal pattern within a 5/8-inch perimeter rope (Figure 8). The woven panel is attached to the perimeter cable with simple one-bolt clamps. The intersecting wire rope panel strands are secured with wire rope clips that utilize a single nut and washer (Photo 17). Adjacent panels are joined together with steel bands attached with a banding machine similar to that used at a shipping dock to package freight (Figure 7 and Photo 18).

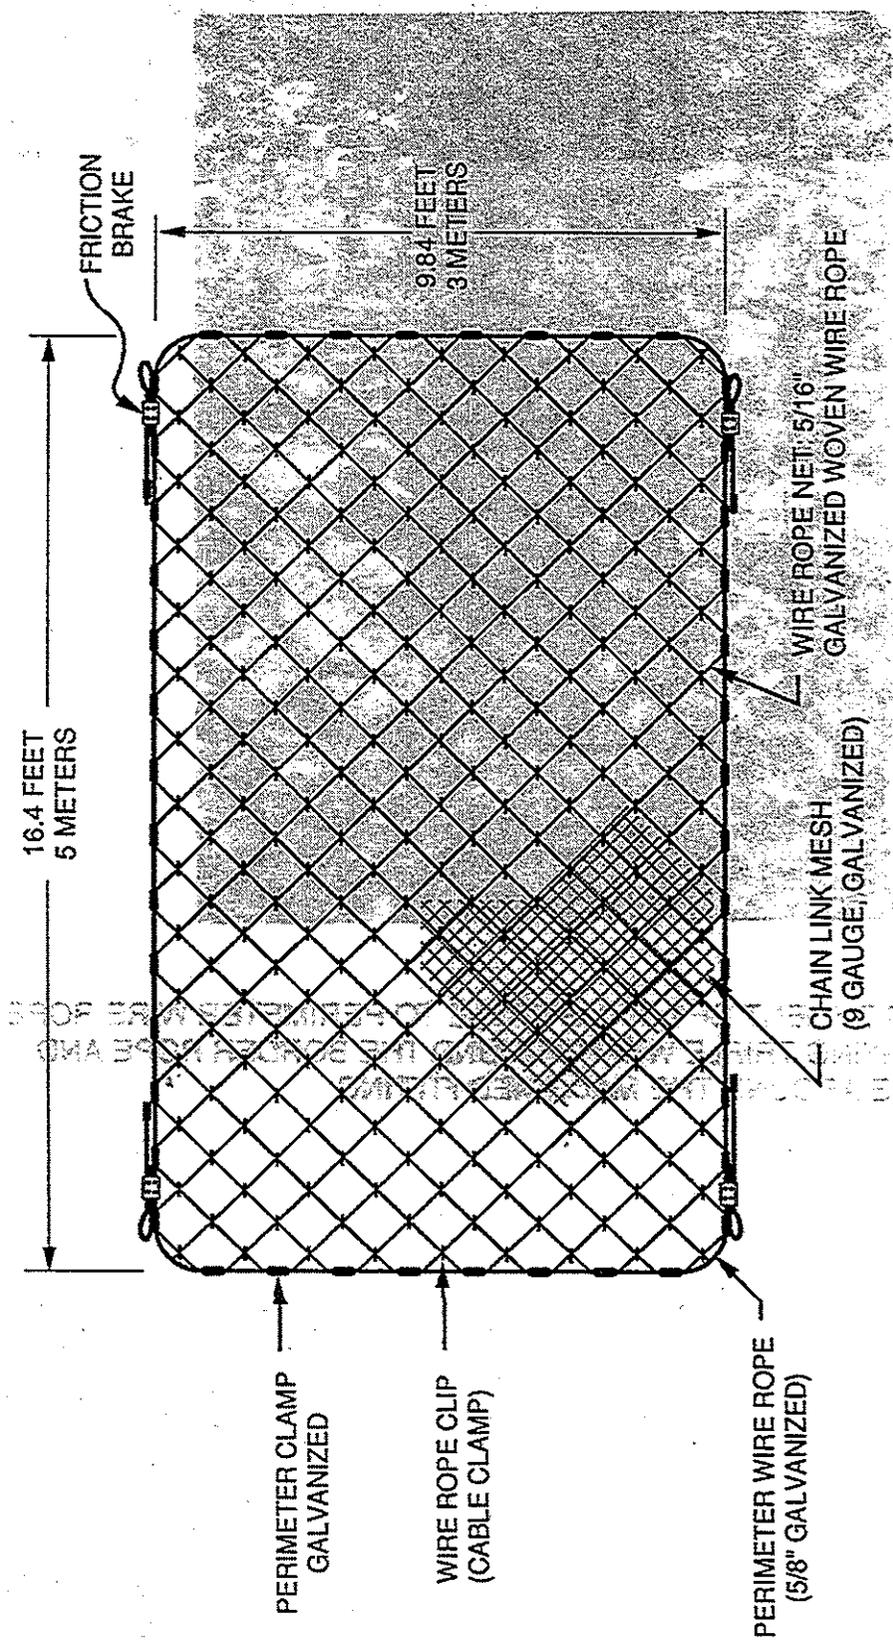
**Figure 8. DETAIL OF THE INDUSTRIAL ENTERPRISE
 WOVEN WIRE ROPE PANEL**

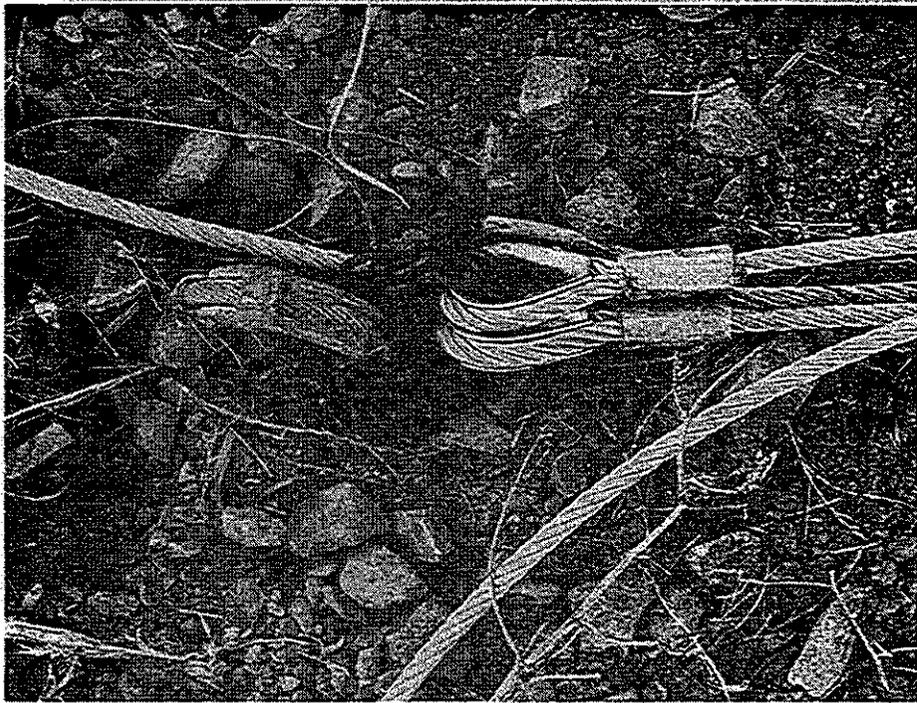
Photo 16: INDUSTRIAL ENTERPRISE UPSLOPE ANCHOR FUSE LINK ATTACHMENT

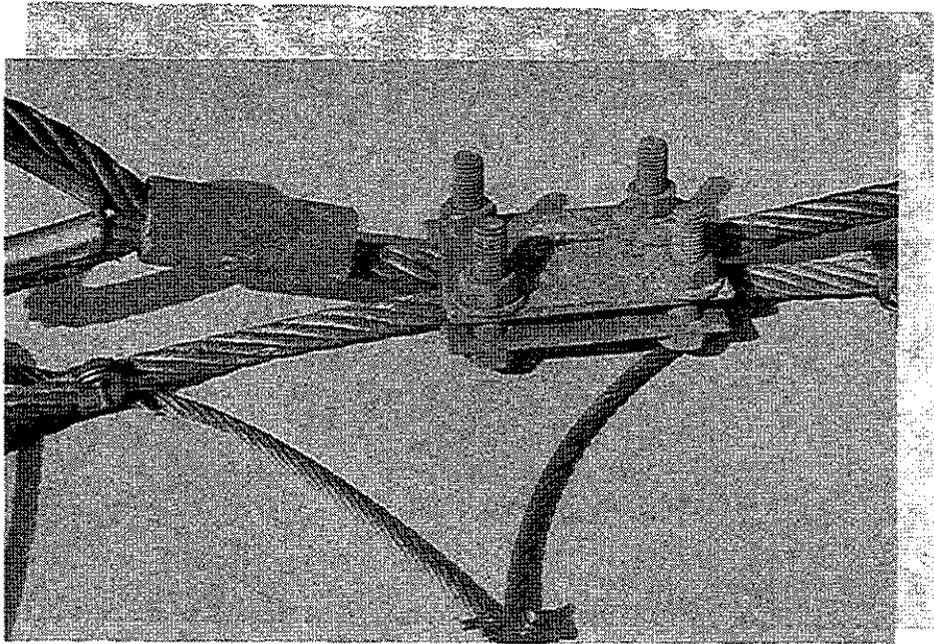
Photo 19. INDUSTRIAL ENTERPRISE NET PANEL FRICTION BRAKE

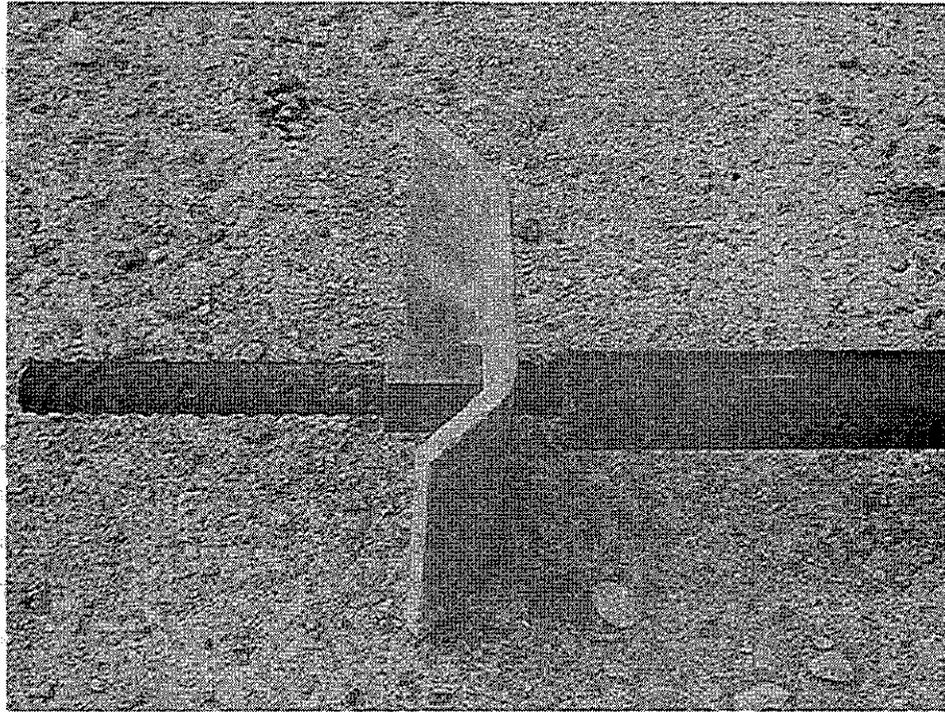
Photo 26. INDUSTRIAL ENTERPRISE FOUNDATION ANCHOR ASSEMBLY. (Photo Courtesy of Alain Lazard)

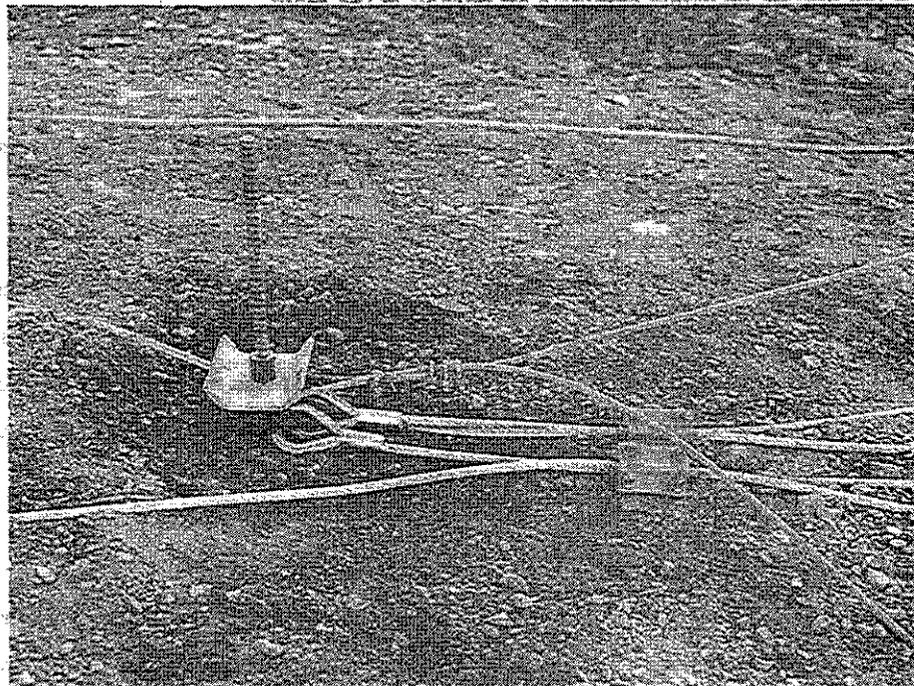
Photo 27. INDUSTRIAL ENTERPRISE FOUNDATION ANCHOR ASSEMBLY WITH GUY WIRE ROPES AND FRICTION BRAKES ATTACHED

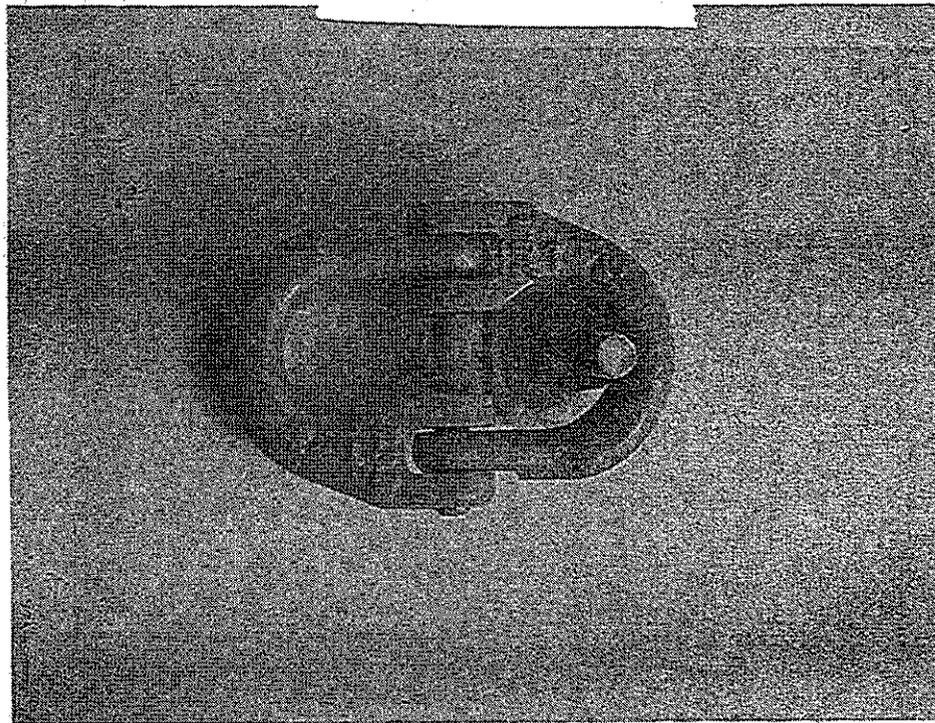
Photo 31. INDUSTRIAL ENTERPRISE "D"-SHAPED LINK FOR ATTACHMENT OF FUSE. (Photo Courtesy of Alain Lazard)

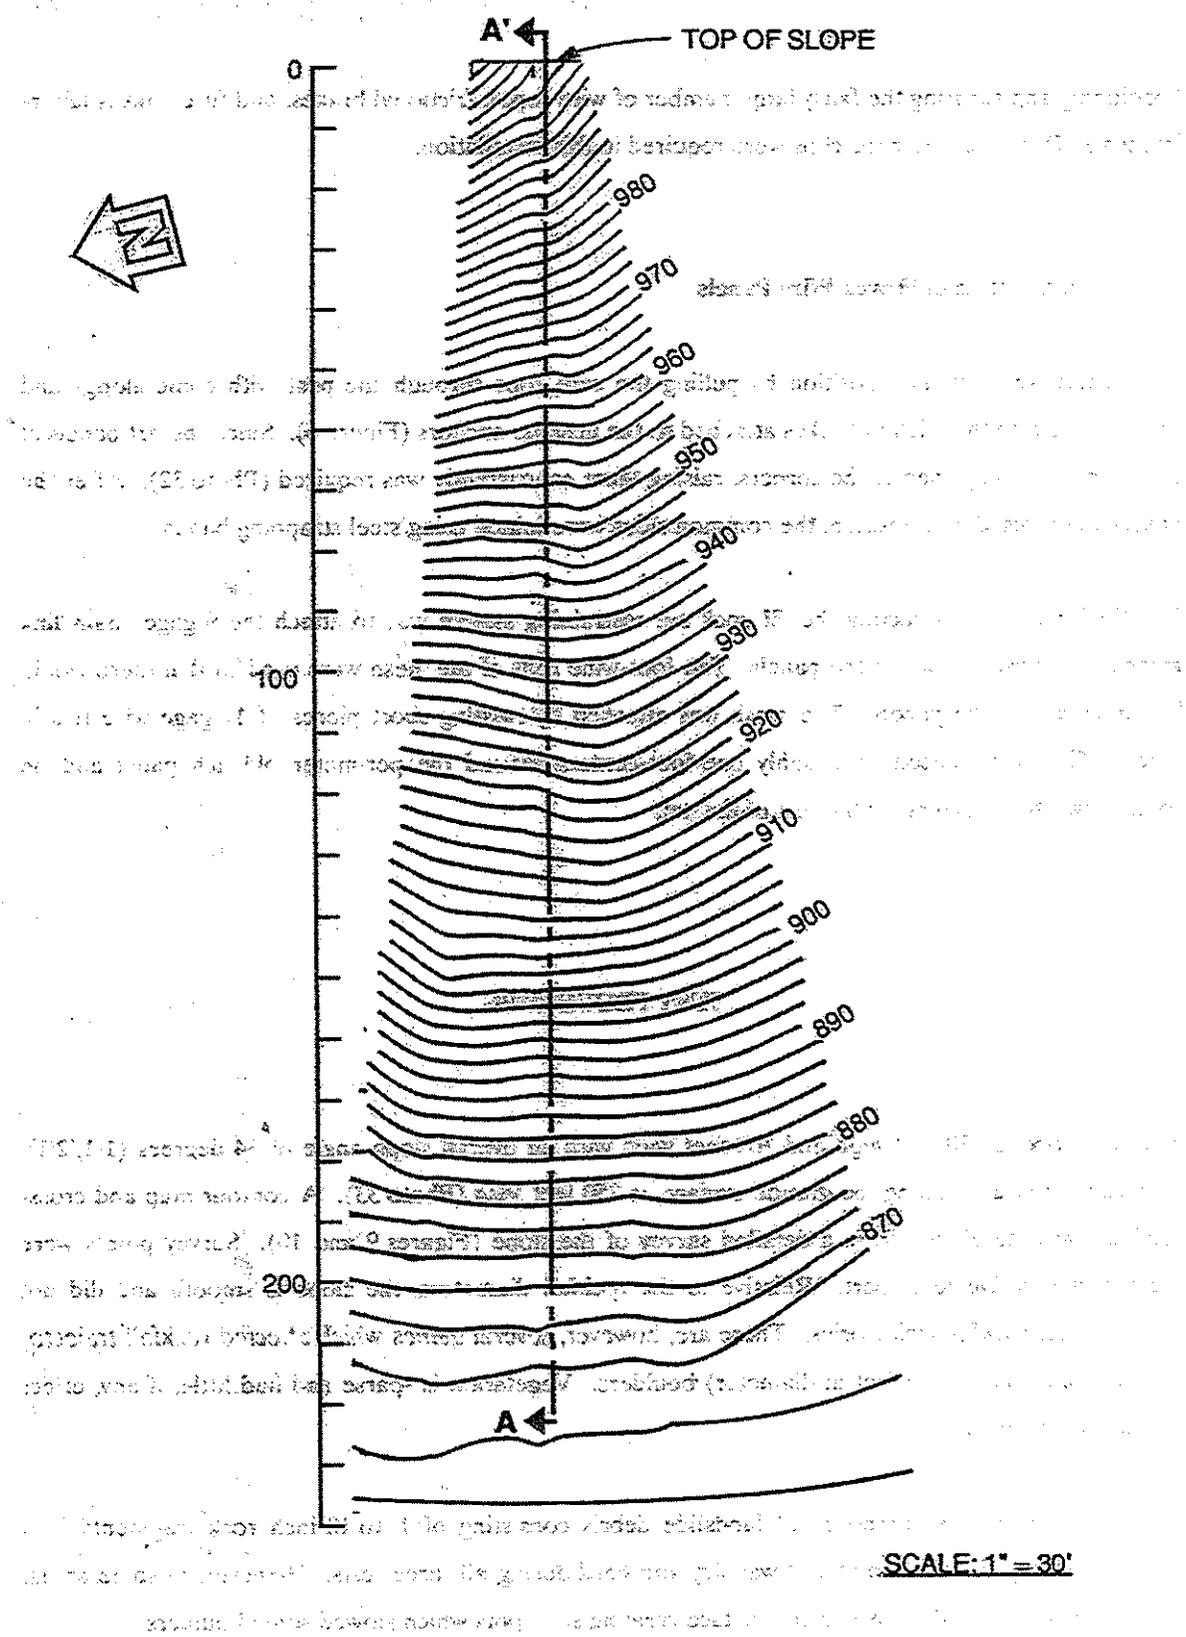
Figure 9. TEST SLOPE PLAN VIEW
