CA/TL-90/05

Field Tests and Evaluation of Rockfall Restraining Nets

June 1990

Office of Transportation Materials and Research
California Department of Transportation
Sacramento, California 95819

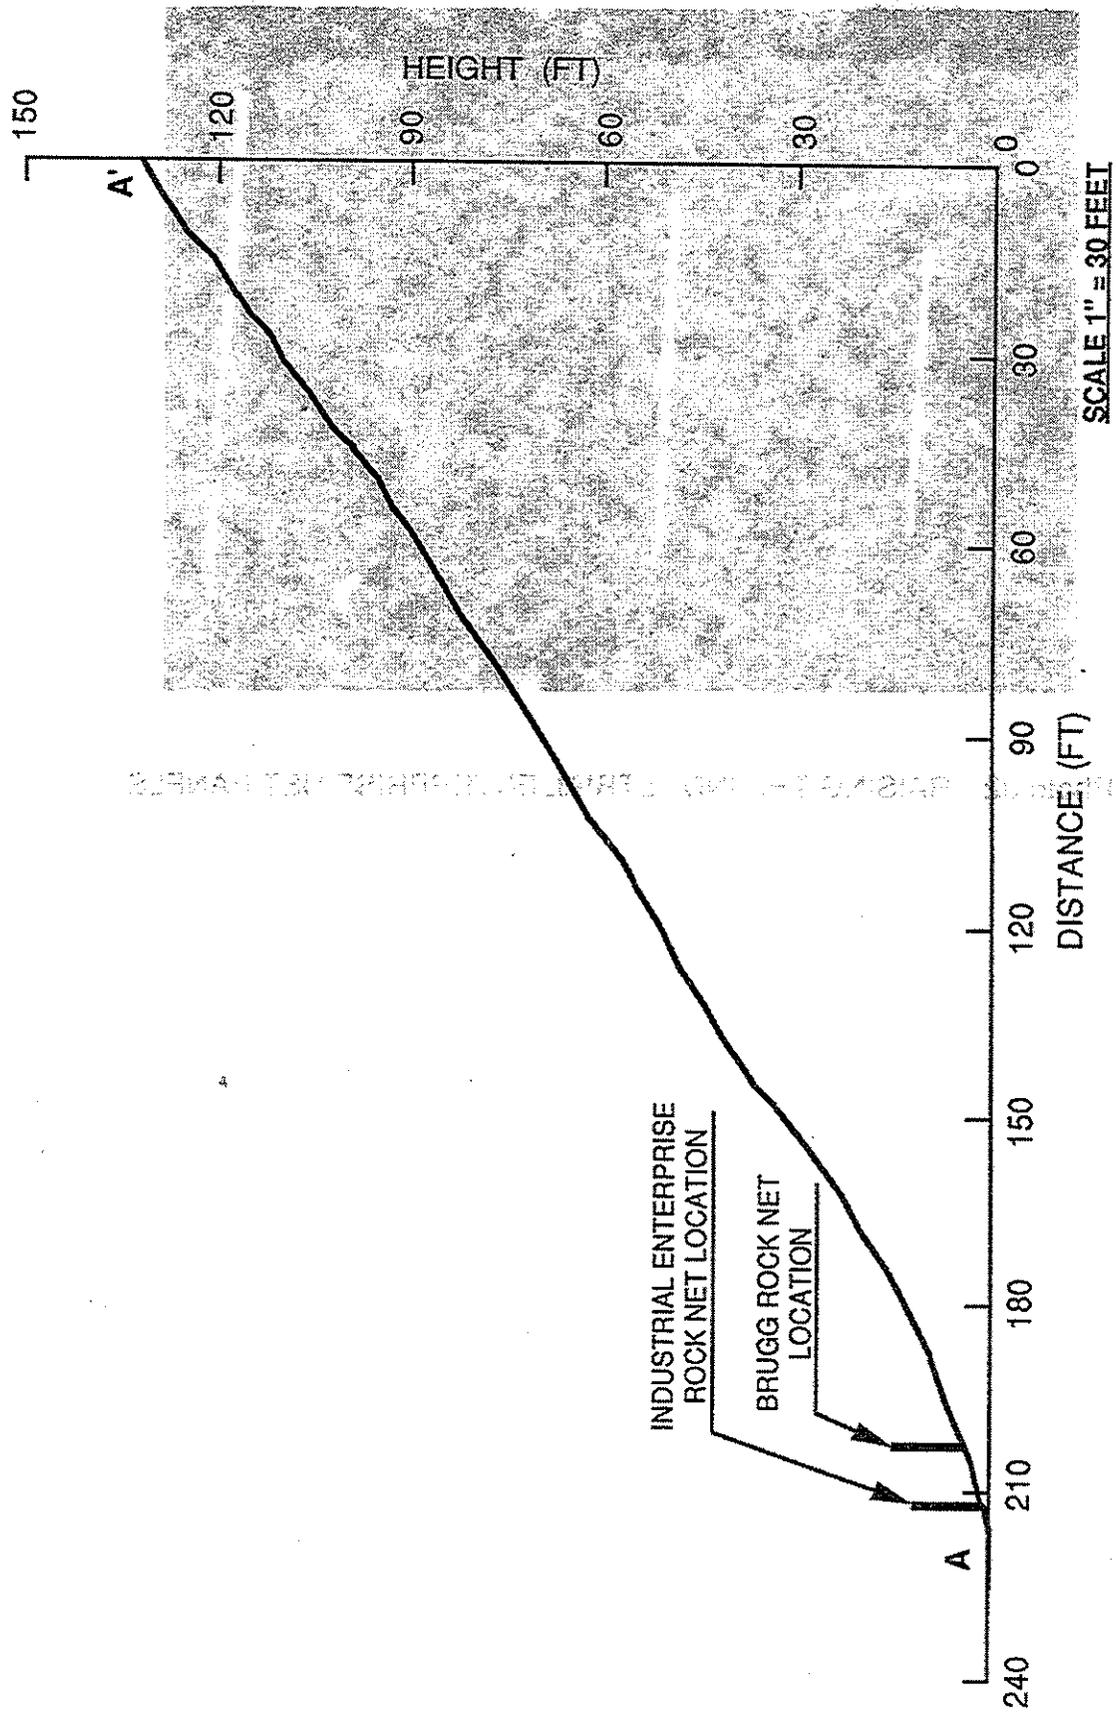
Figure 10. CROSS SECTION A-A'

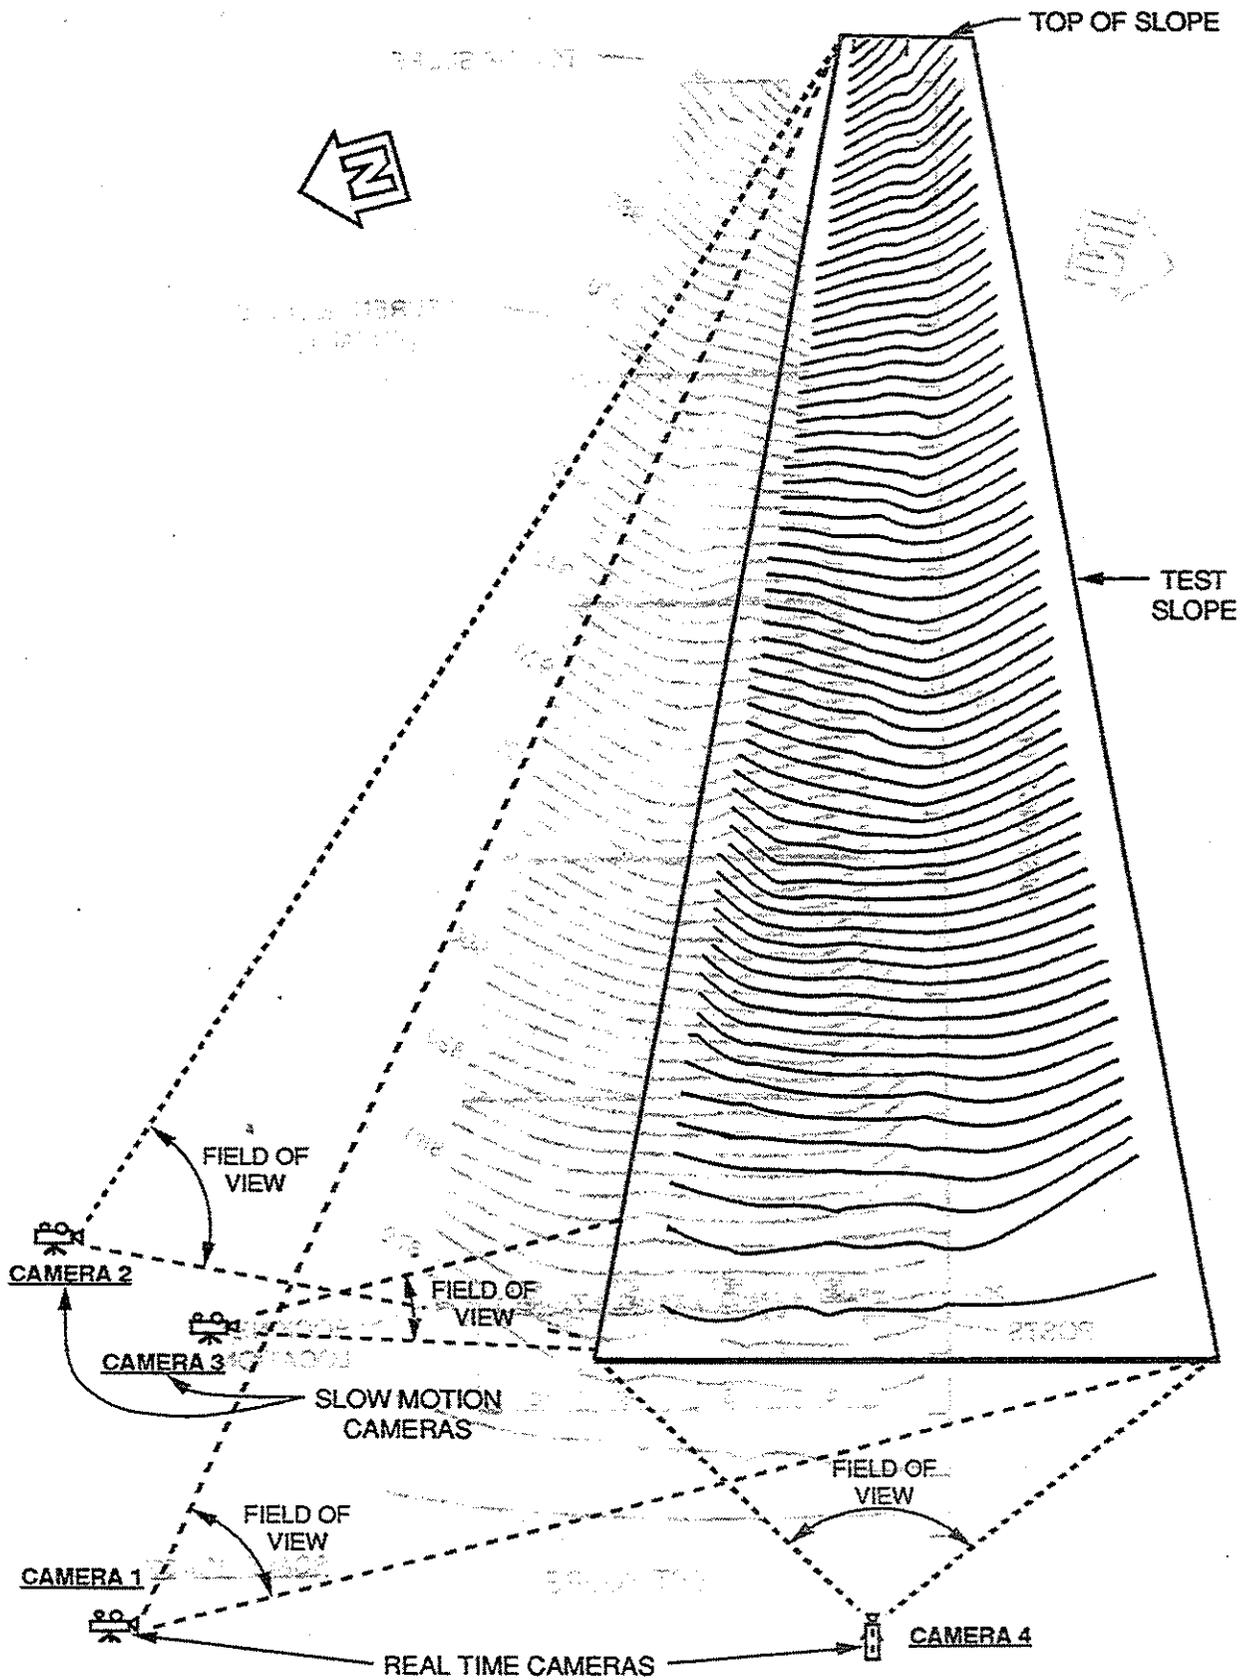
Figure 11. APPROXIMATE CAMERA LOCATIONS FOR FILMING EACH ROCK ROLL

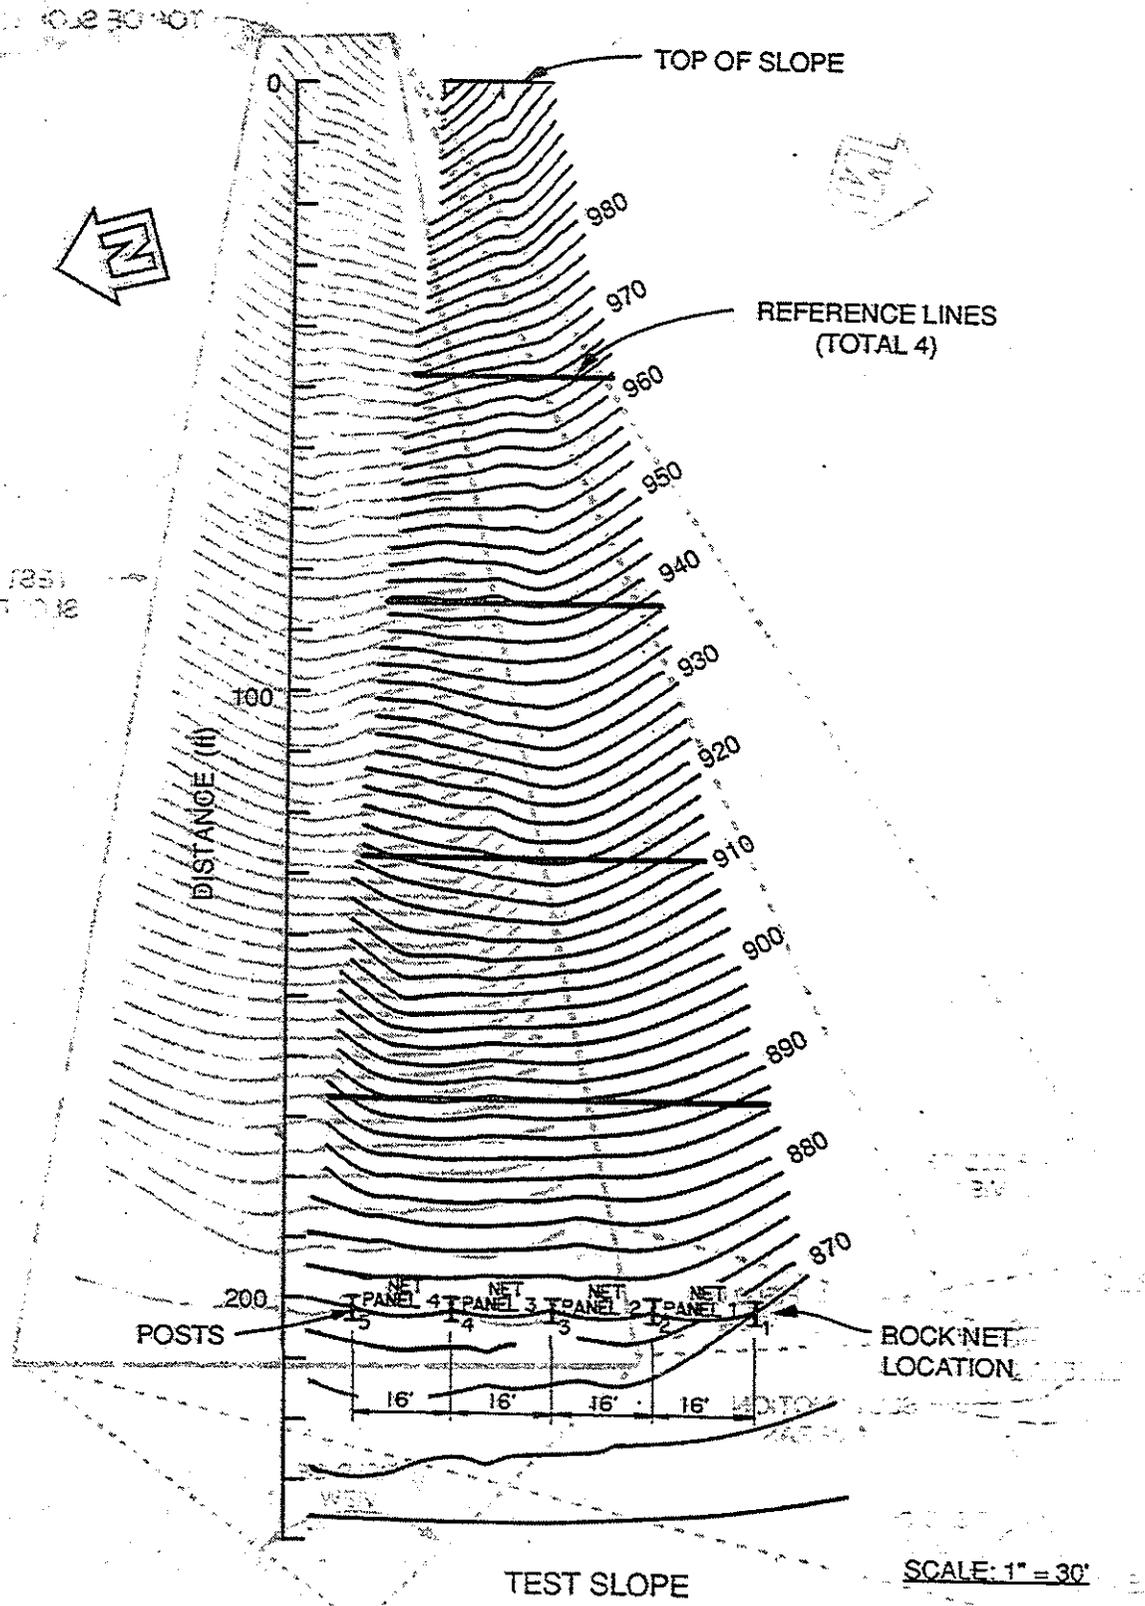
Figure 12. REFERENCE LINE LOCATIONS USED TO ANALYZE IMPACT VELOCITIES DURING TESTS 1 AND 2

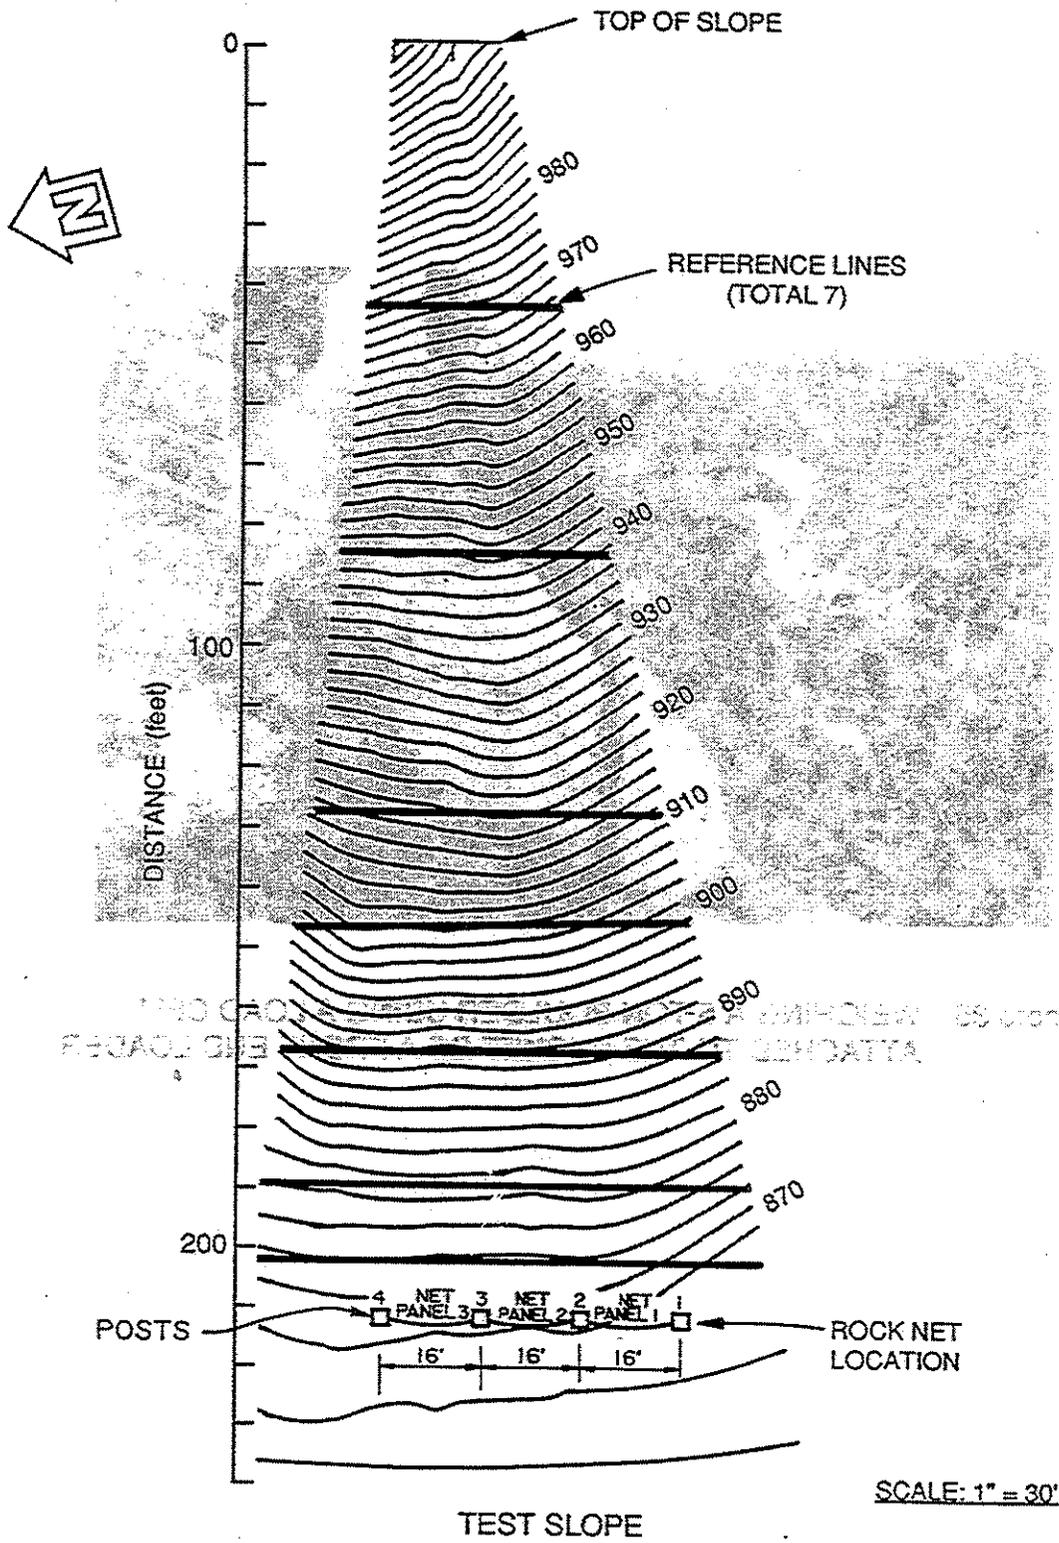
Figure 13. REFERENCE LINE LOCATIONS USED TO ANALYZE IMPACT VELOCITIES DURING TEST 3

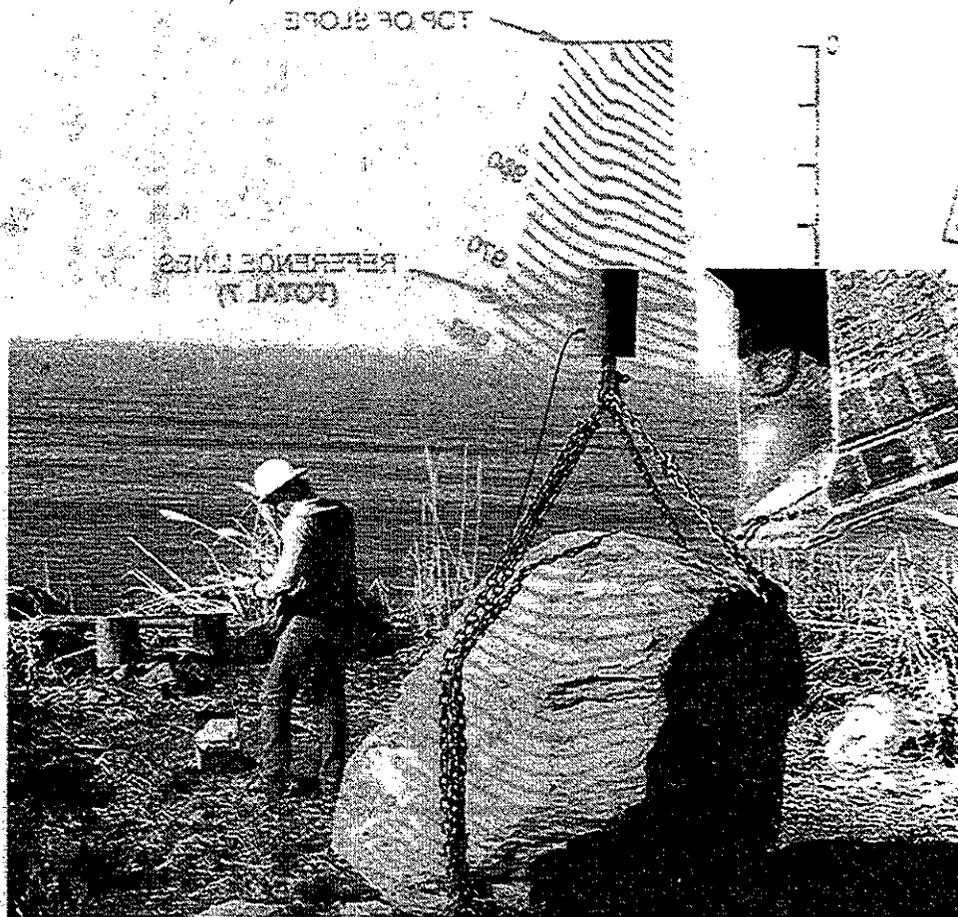
Photo 35. WEIGHING A 5-TON BOULDER USING A LOAD CELL ATTACHED TO THE BUCKET OF A FRONT END LOADER

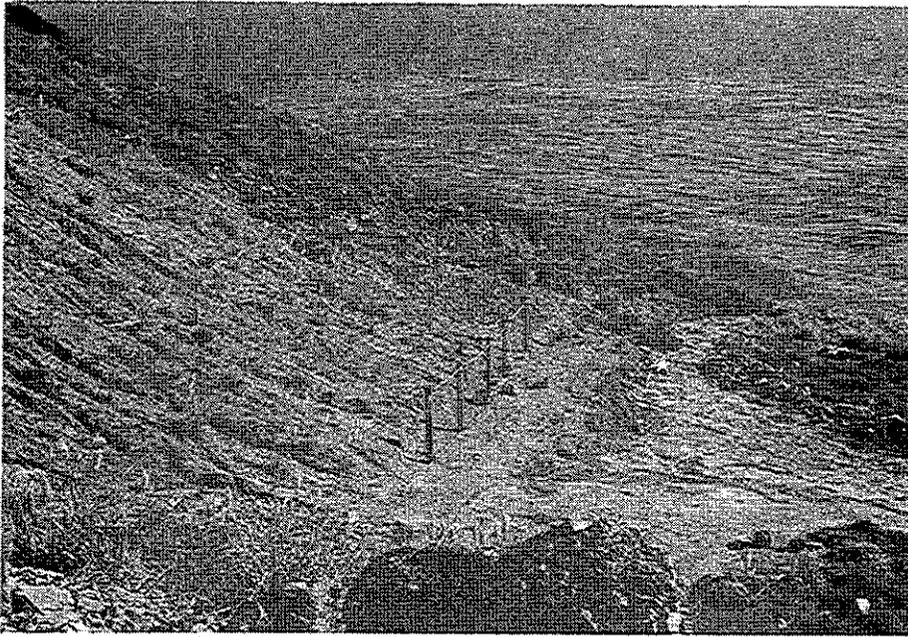
Photo 37. PENETRATION OF THE BRUGG NET BY ROCKS #6 AND #8 AFTER LOOSENING OF THE NET FASTENERS BY PREVIOUS ROCK IMPACTS

Maintenance of the net required replacing missing fasteners with wire rope clips and refitting the wire rope clips on the wire rope lacing.

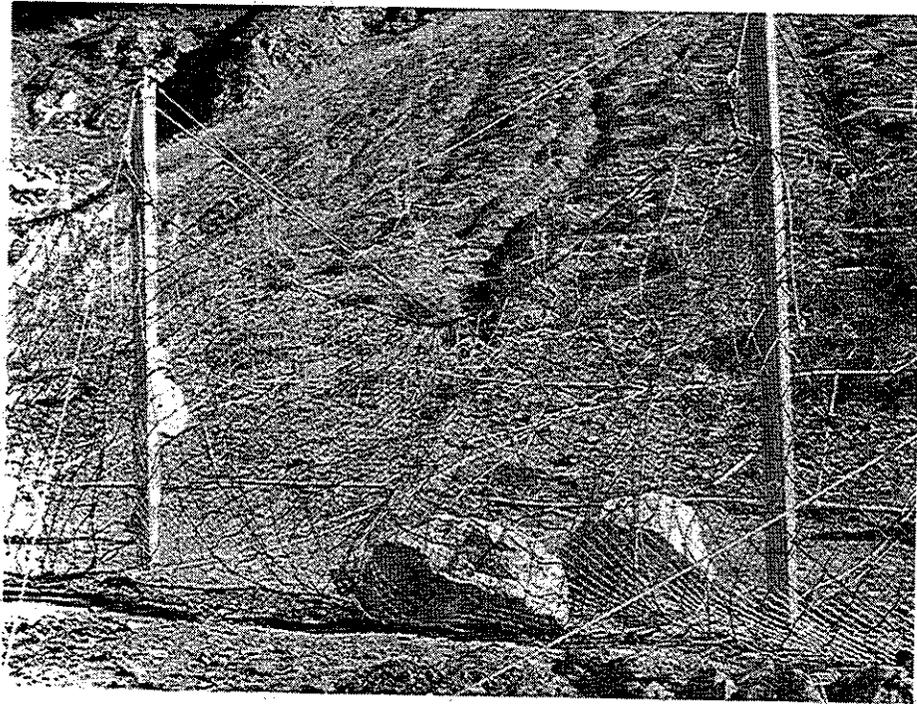
Photo 46. INDUSTRIAL ENTERPRISE ROCK NET PANEL 2 AS VIEWED FROM ROAD LEVEL AFTER ROCK ROLL 1 (1590 POUNDS) AND ROCK ROLL 2 (1860 POUNDS). NOTE CONSIDERABLE SAG IN THE ROCK NET

The sagging net was raised, the net fastening bands replaced, the perimeter wire rope clips repositioned, and rock rolling continued.

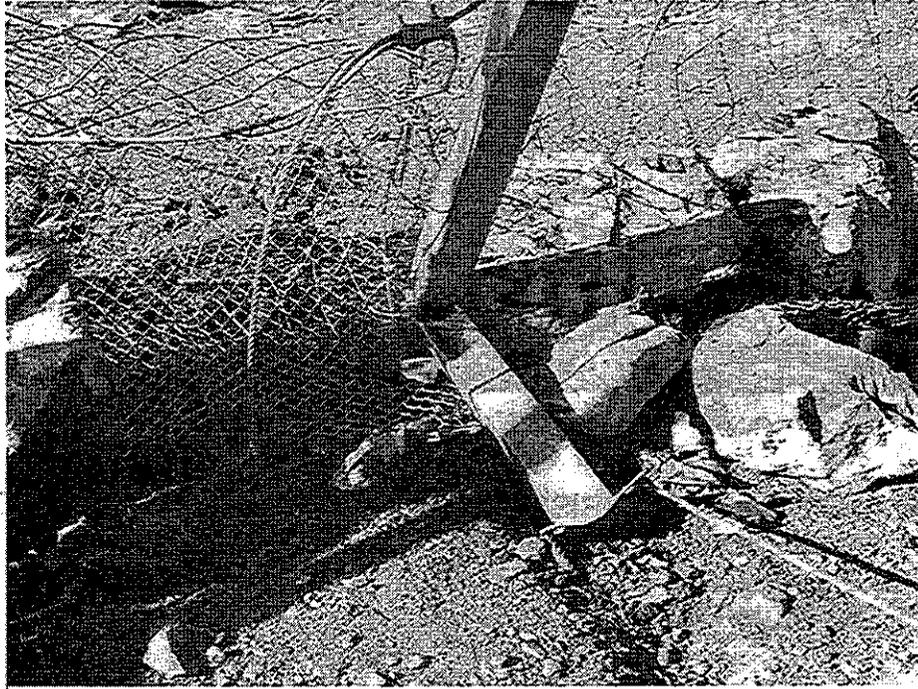
Photo 47. COLLAPSED INDUSTRIAL ENTERPRISE STEEL BOX POST #2 AFTER IMPACT BY A 1 1/4-TON ROCK. NOTE LOW ROCK NET HEIGHT AT TOP OF PHOTO

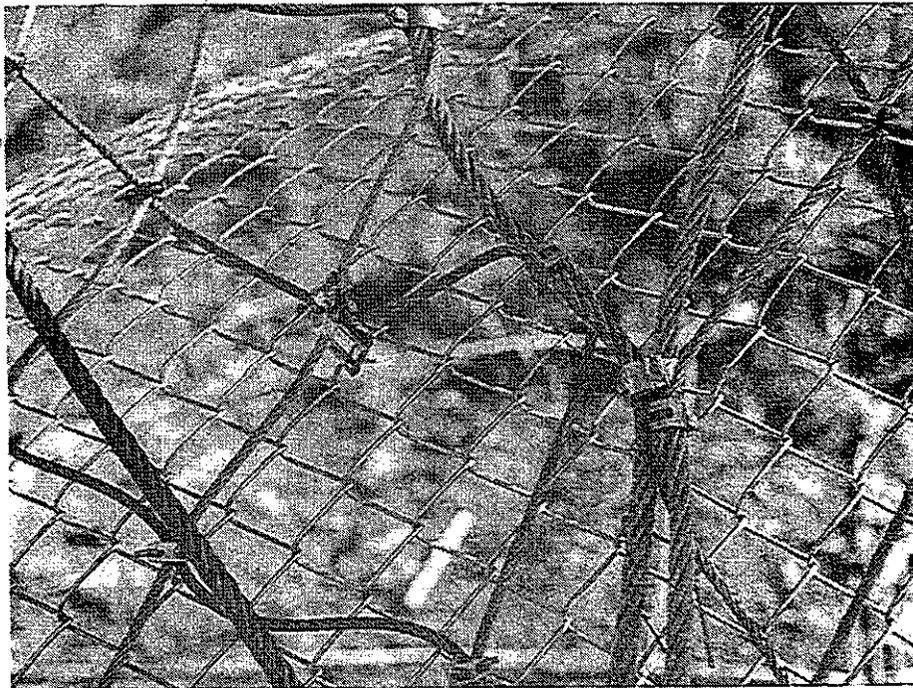
Photo 49. CLOSE-UP OF BROKEN INDUSTRIAL ENTERPRISE NET PANEL FASTENING BANDS. NOTE CHAIN LINK MESH SEPARATED FROM THE NET

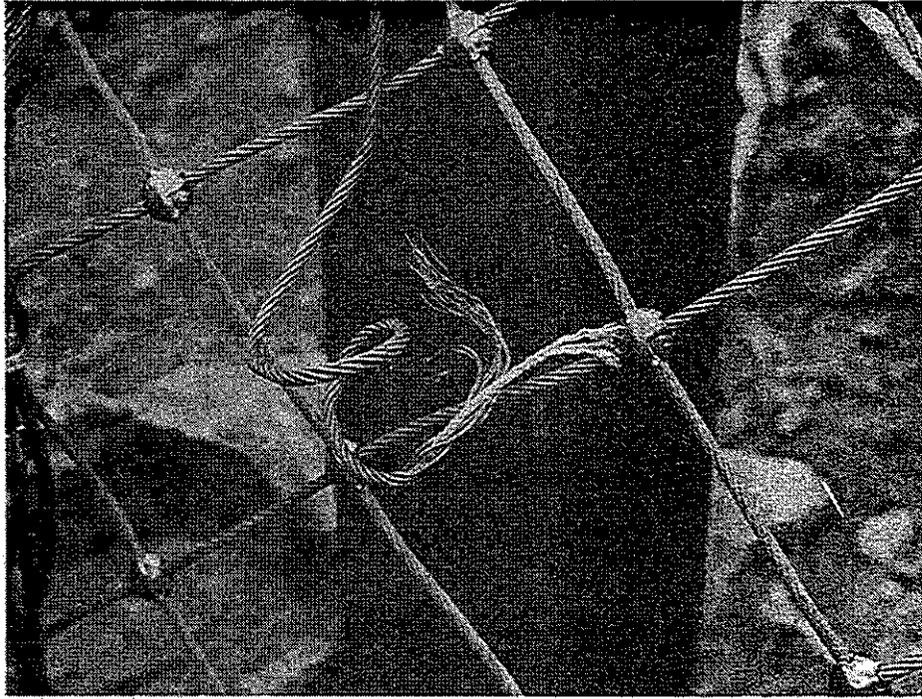
Photo 55. BREAK AND DISTORTION OF WIRE ROPE LACING WHERE IT WAS WRAPPED 3 TIMES AROUND THE PERIMETER WIRE ROPE. NOTE FIBER CORE OF LACING WIRE ROPE EXPOSED IN CENTER OF PHOTO

The lacing wire ropes should be replaced each time they are disassembled because of distortion of the wire ropes near their ends where they are wrapped three times around the perimeter wire rope and the post fittings (Photo 55). After impact, the wrapped lacing wire ropes are permanently distorted with a curl or kink in the rope. Relacing with this distorted rope is difficult and time consuming (Photo 6).

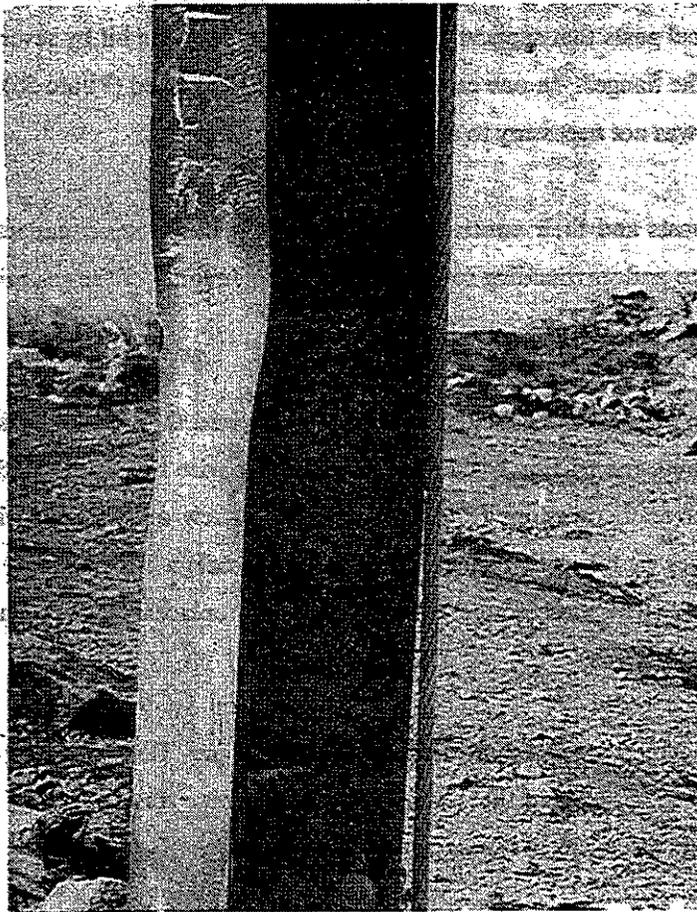
Photo 56. SLIGHTLY BOWED BRUGG 8-X8-INCH-WIDE FLANGE 48 POUND/FOOT STEEL POST AFTER A DIRECT HIT BY A 1 1/2-TON ROCK

The heavy wide flange steel posts that support the restraining system were hit by several rocks causing some local distortion to the flanges. In one case, a post was slightly bowed (Photo 56). Damage in all cases was minimal and it was not necessary to remove or replace any posts.

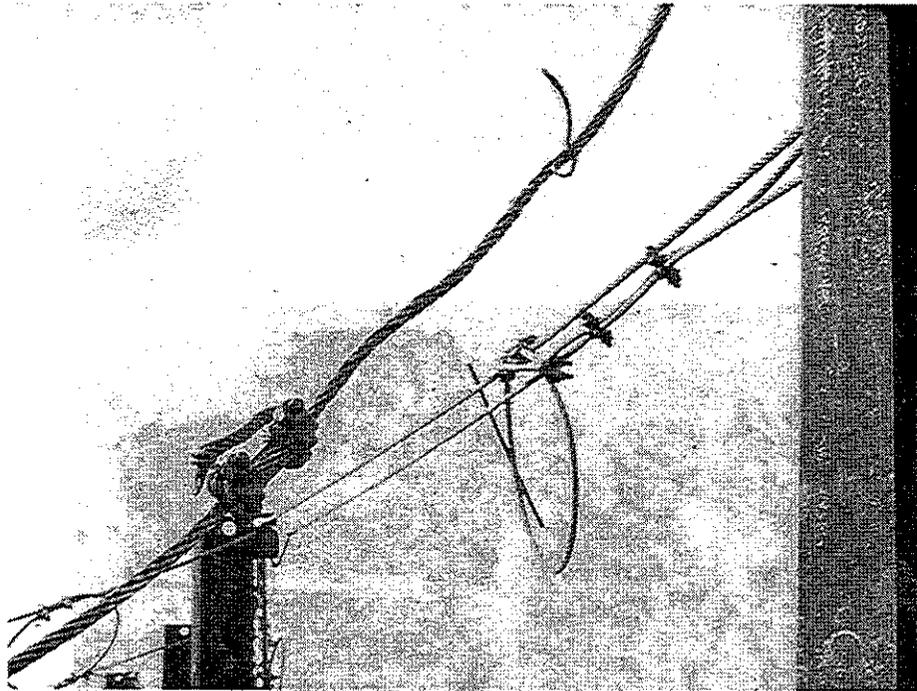
Photo 57. ACTIVATED BRUGG FRICTION BRAKE AND DAMAGED ANCHOR WIRE ROPE CAUSED BY IMPACTING ROCK #32. SEE PHOTO BELOW

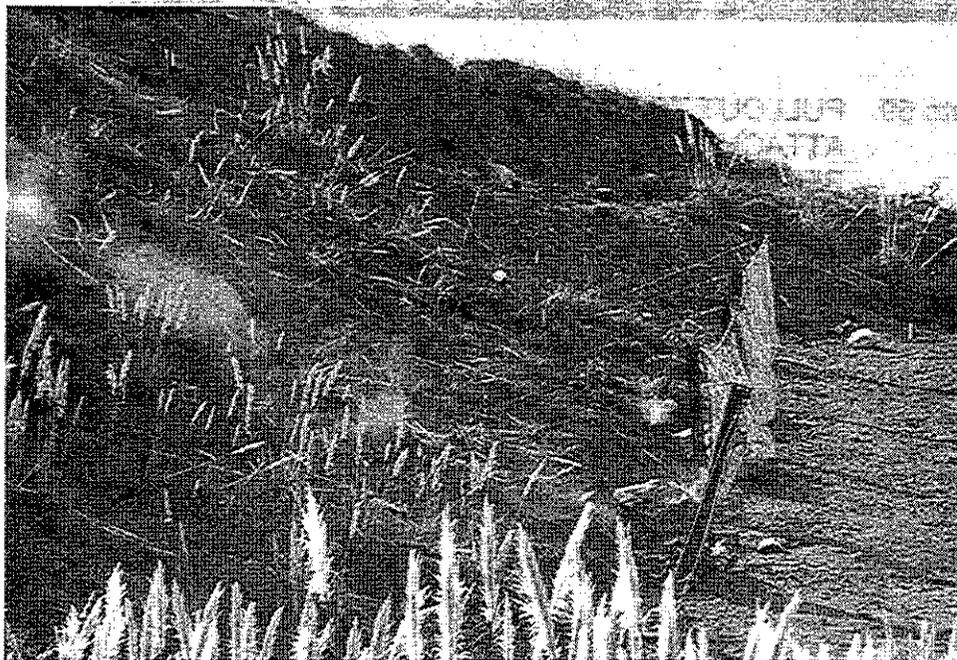
Photo 58. ROCK ROLL 32 HITTING POST #5 AND FULLY ACTIVATING THE FRICTION BRAKE AND TILTING THE POST. (Photo Courtesy of John Walkinshaw)

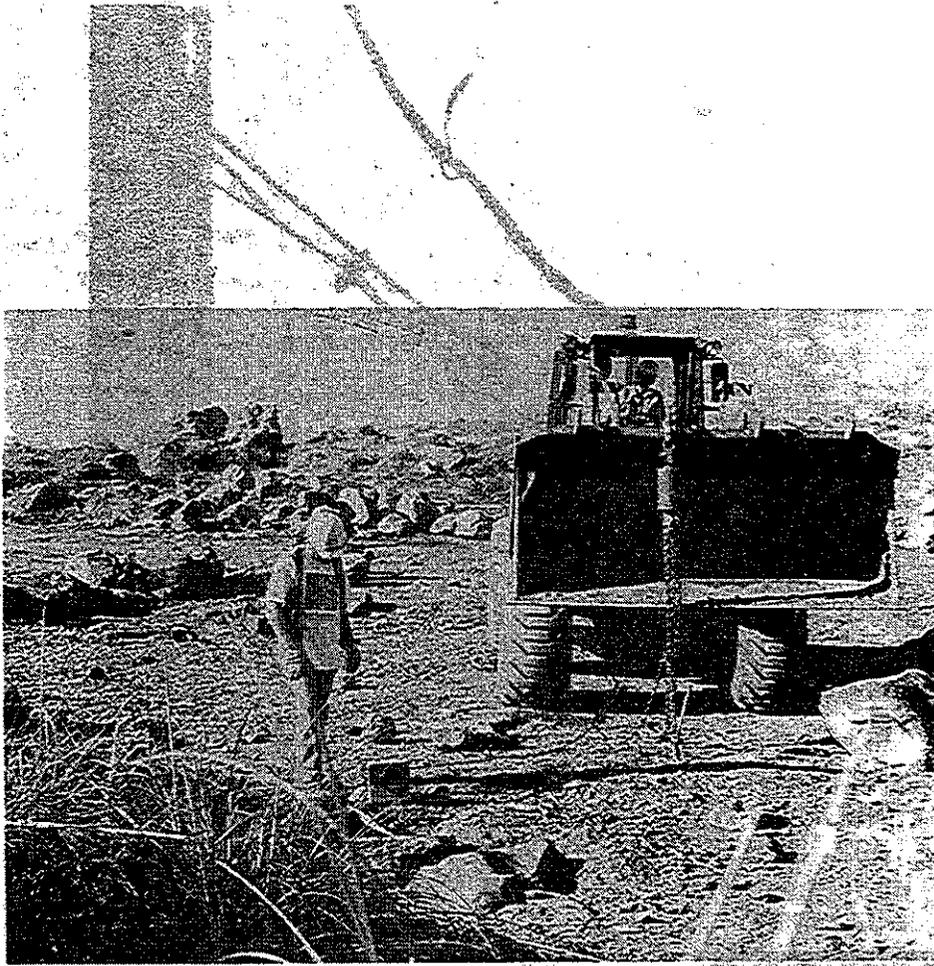
Photo 59: PULLOUT TEST OF ANCHOR USING A LOAD CELL ATTACHED TO FRONT END LOADER. ANCHOR RESISTED 20,000 POUND PULL

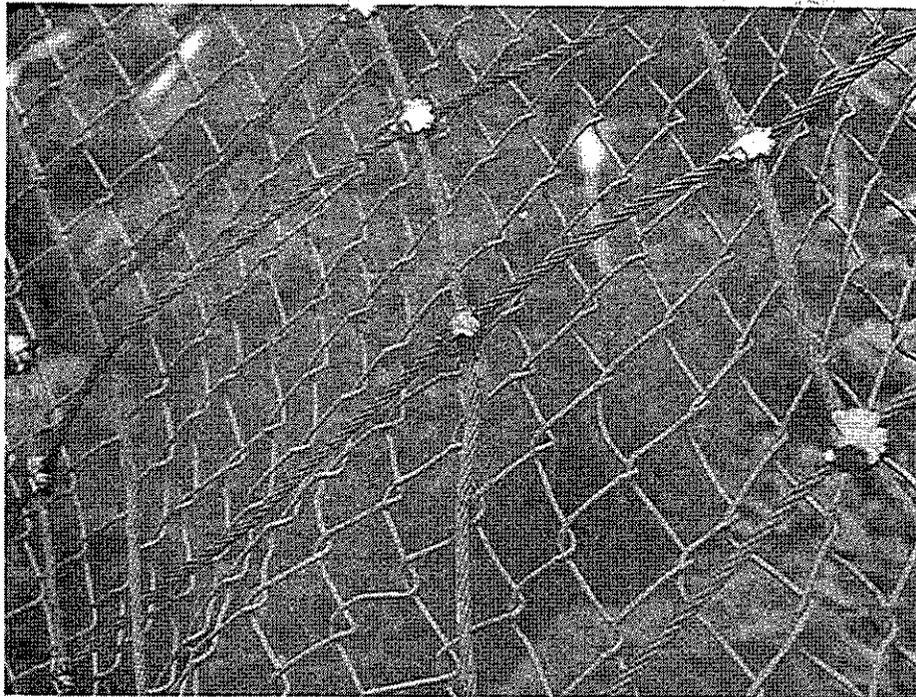
Photo 60. MISSING AND LOOSE BRUGG FASTENERS ON THE NET PANEL

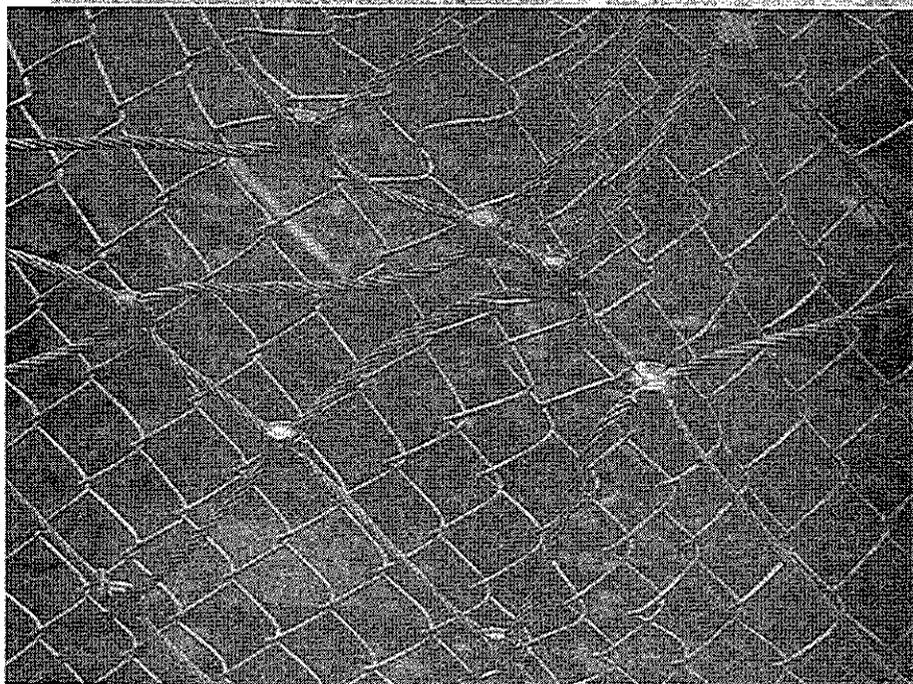
Photo 61. SHIFTING OF LOOSE BRUGG FASTENERS ON THE NET PANEL

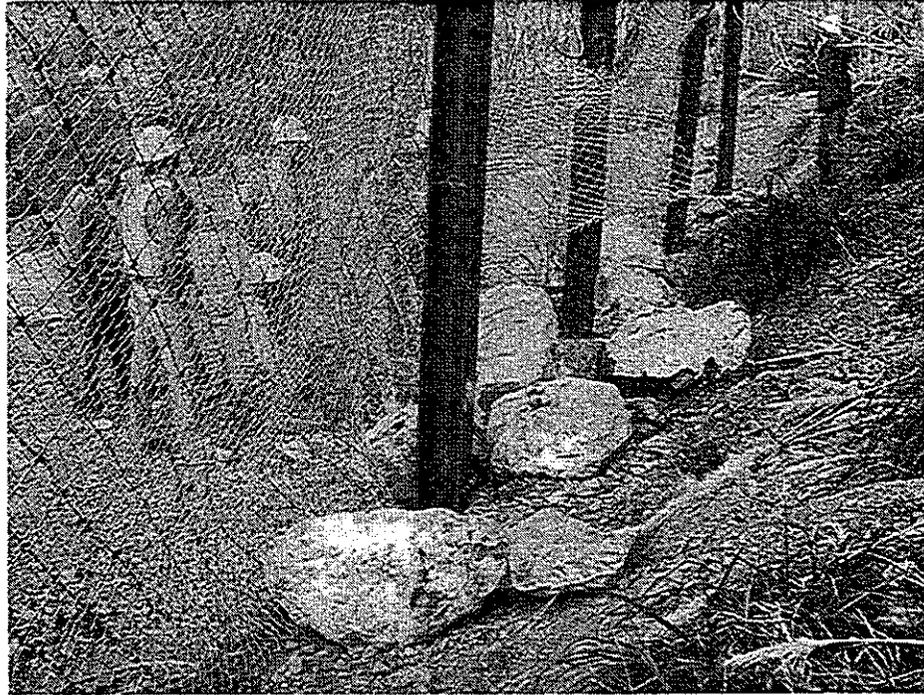
Photo 62. CHAIN LINK MESH SEPARATING FROM NET PANELS
AFTER 7 ROCK ROLLS

The chain link mesh frequently became detached after repeated impacts. Repairs consisted of repositioning the mesh and reattaching it to the panel with wire ties. Severely distorted mesh can be replaced in a few minutes (Photo 62).

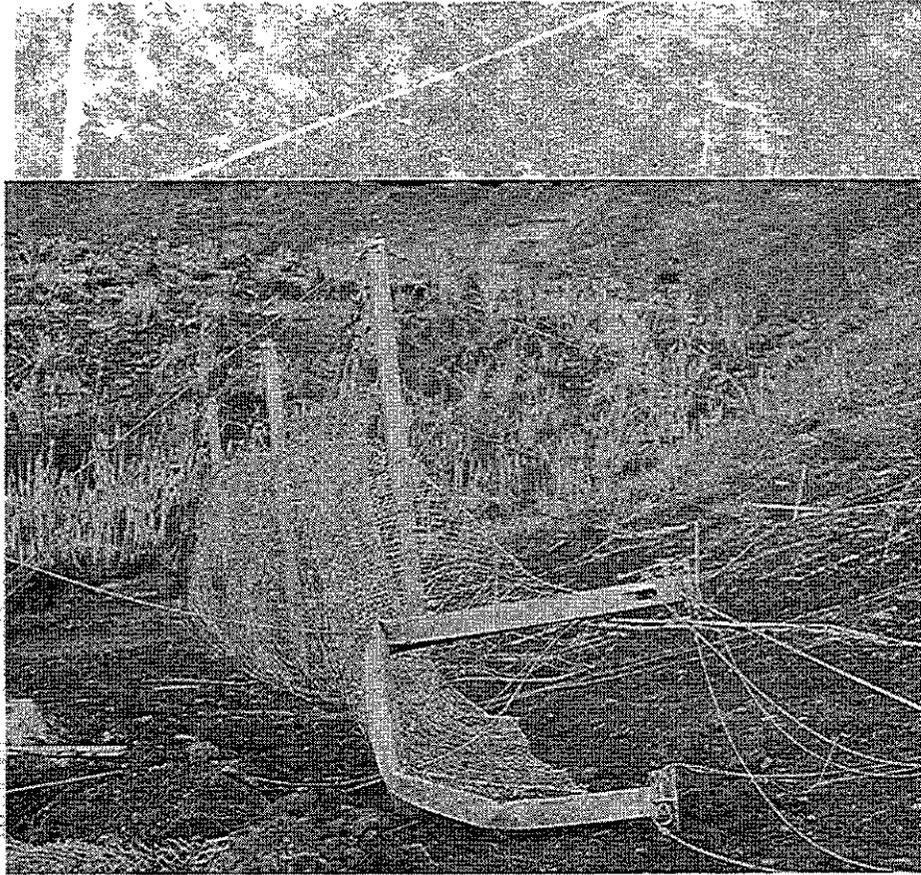
Photo 67. COLLAPSED 5 1/2-x5 1/2-INCH STEEL BOX POST AFTER IMPACT BY 5500-POUND ROCK #9

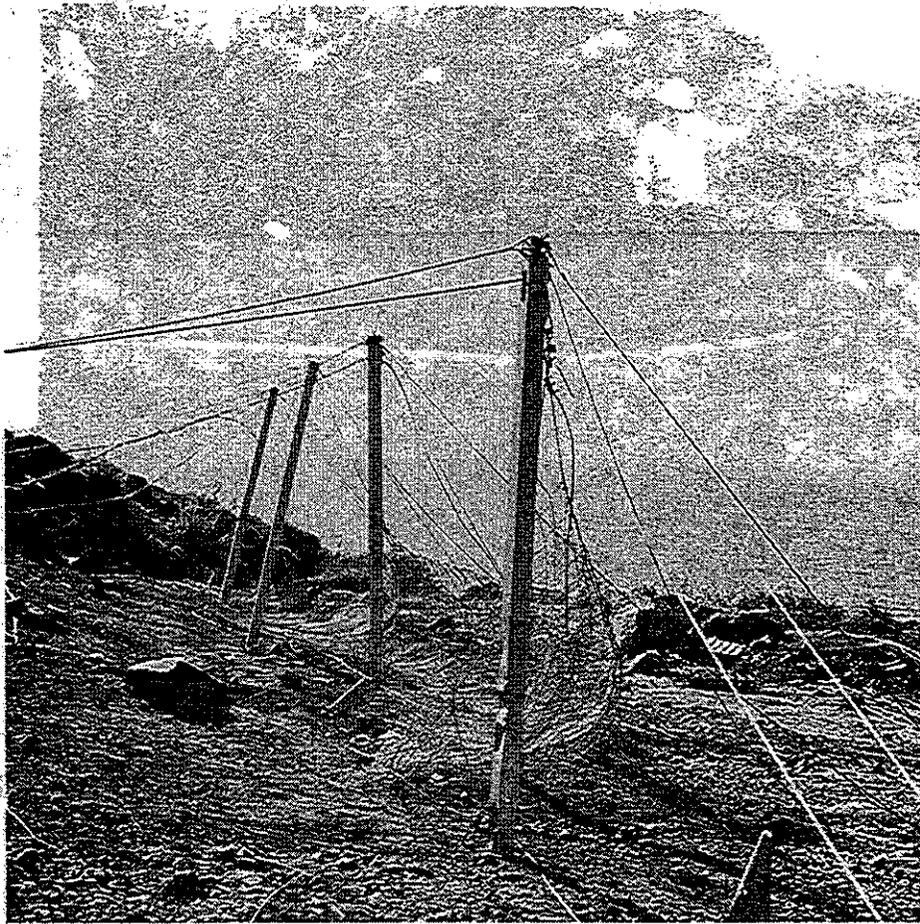
Photo 70: INDUSTRIAL ENTERPRISE ROCK NET AFTER 1300-POUND ROCK #12 IMPACTED THE NET WITH 180 FOOT-TONS OF KINETIC ENERGY. ROCK #12 ROLLED OVER THE NET PANEL.

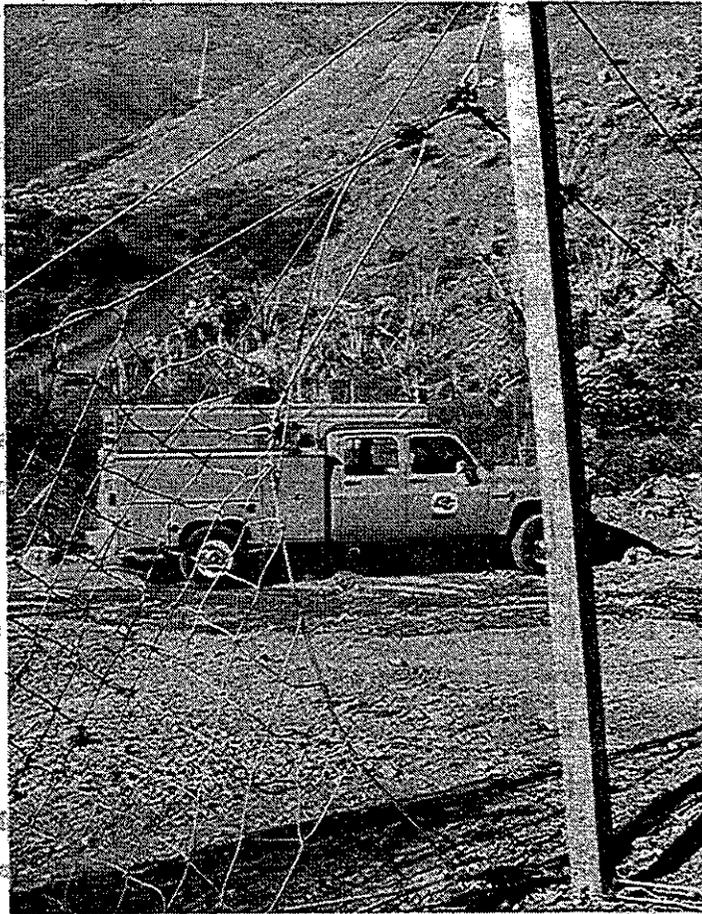
Photo 71. DOWNSLOPE VIEW OF THE RIGHT SIDE OF INDUSTRIAL ENTERPRISE NET PANEL 3. NOTE THE SHIFTING BORDER WIRE ROPE CLIPS AND SAGGING NET

Loose or sagging chain link mesh on the rock nets can be corrected by repositioning the mesh and attaching it to the wire rope panels with wire twists.

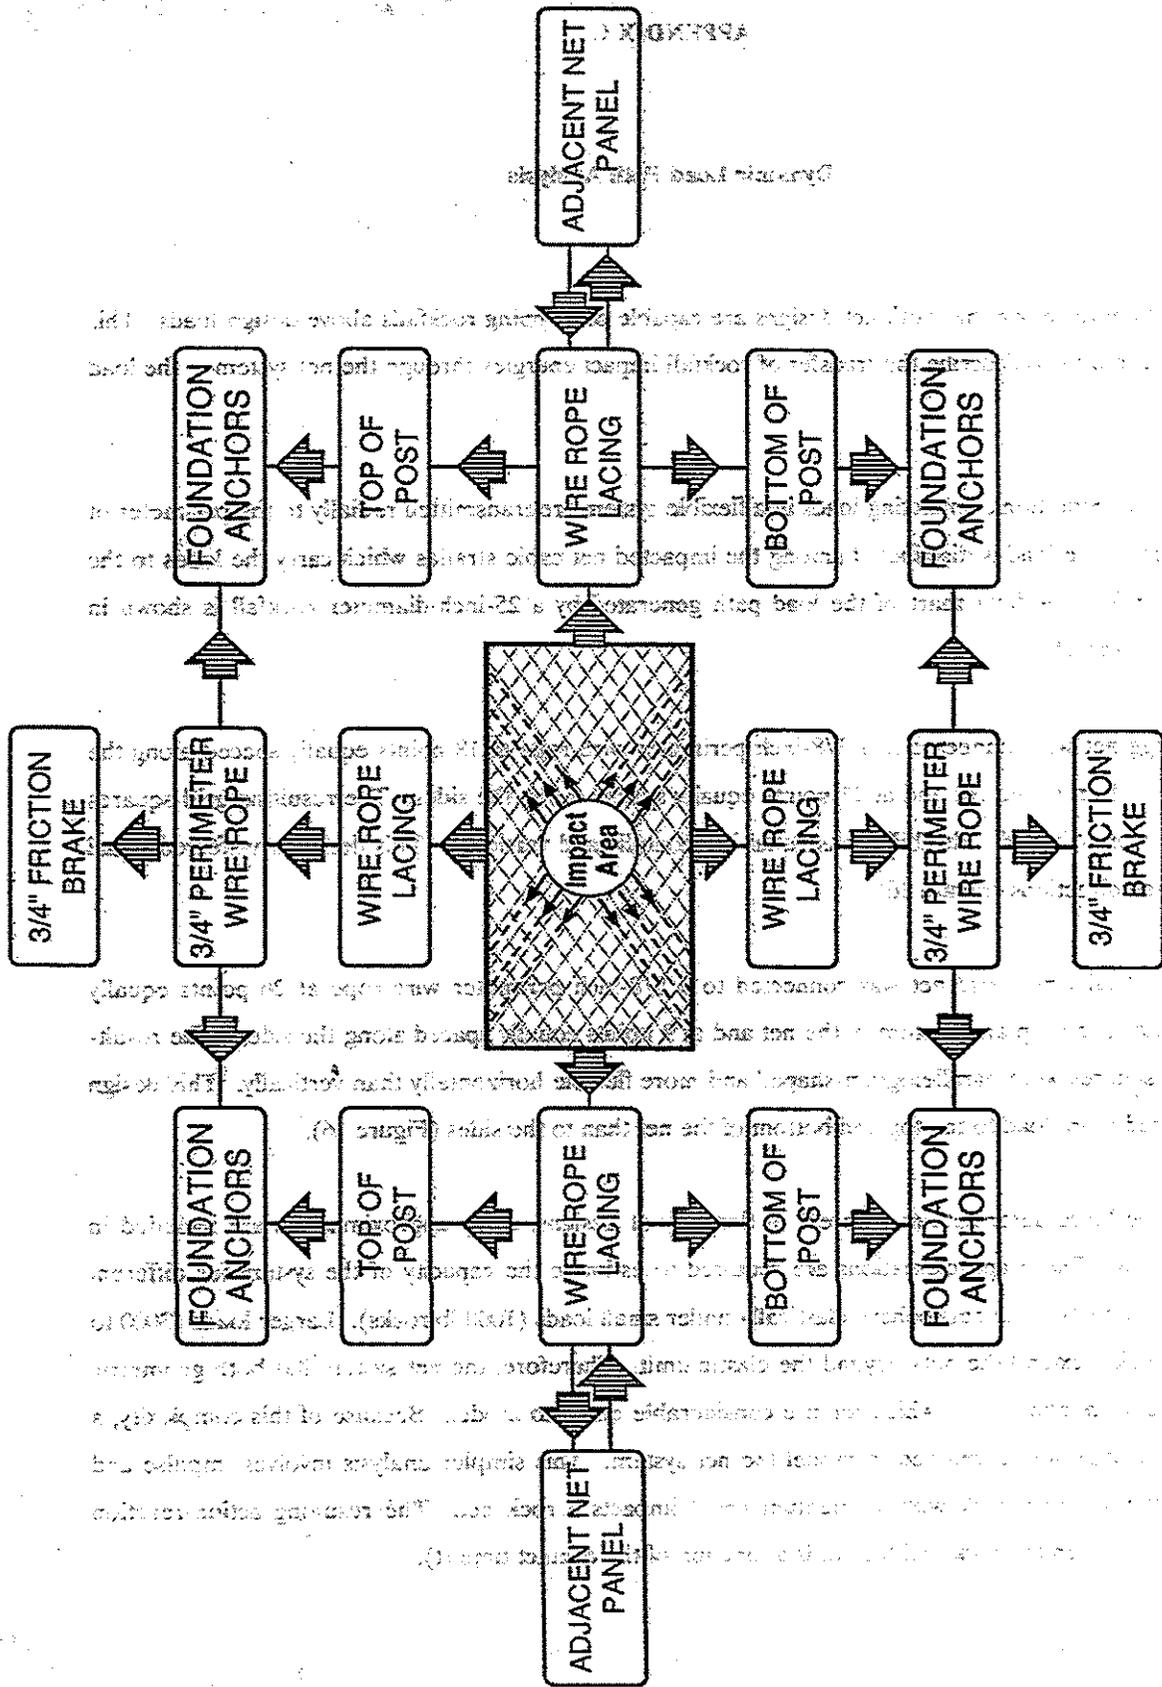
Figure 14. FLOW CHART OF THE BRUGG NET SYSTEM LOAD PATH. SHADED ARROWS INDICATE THE DIRECTION OF ROCK IMPACT ENERGY

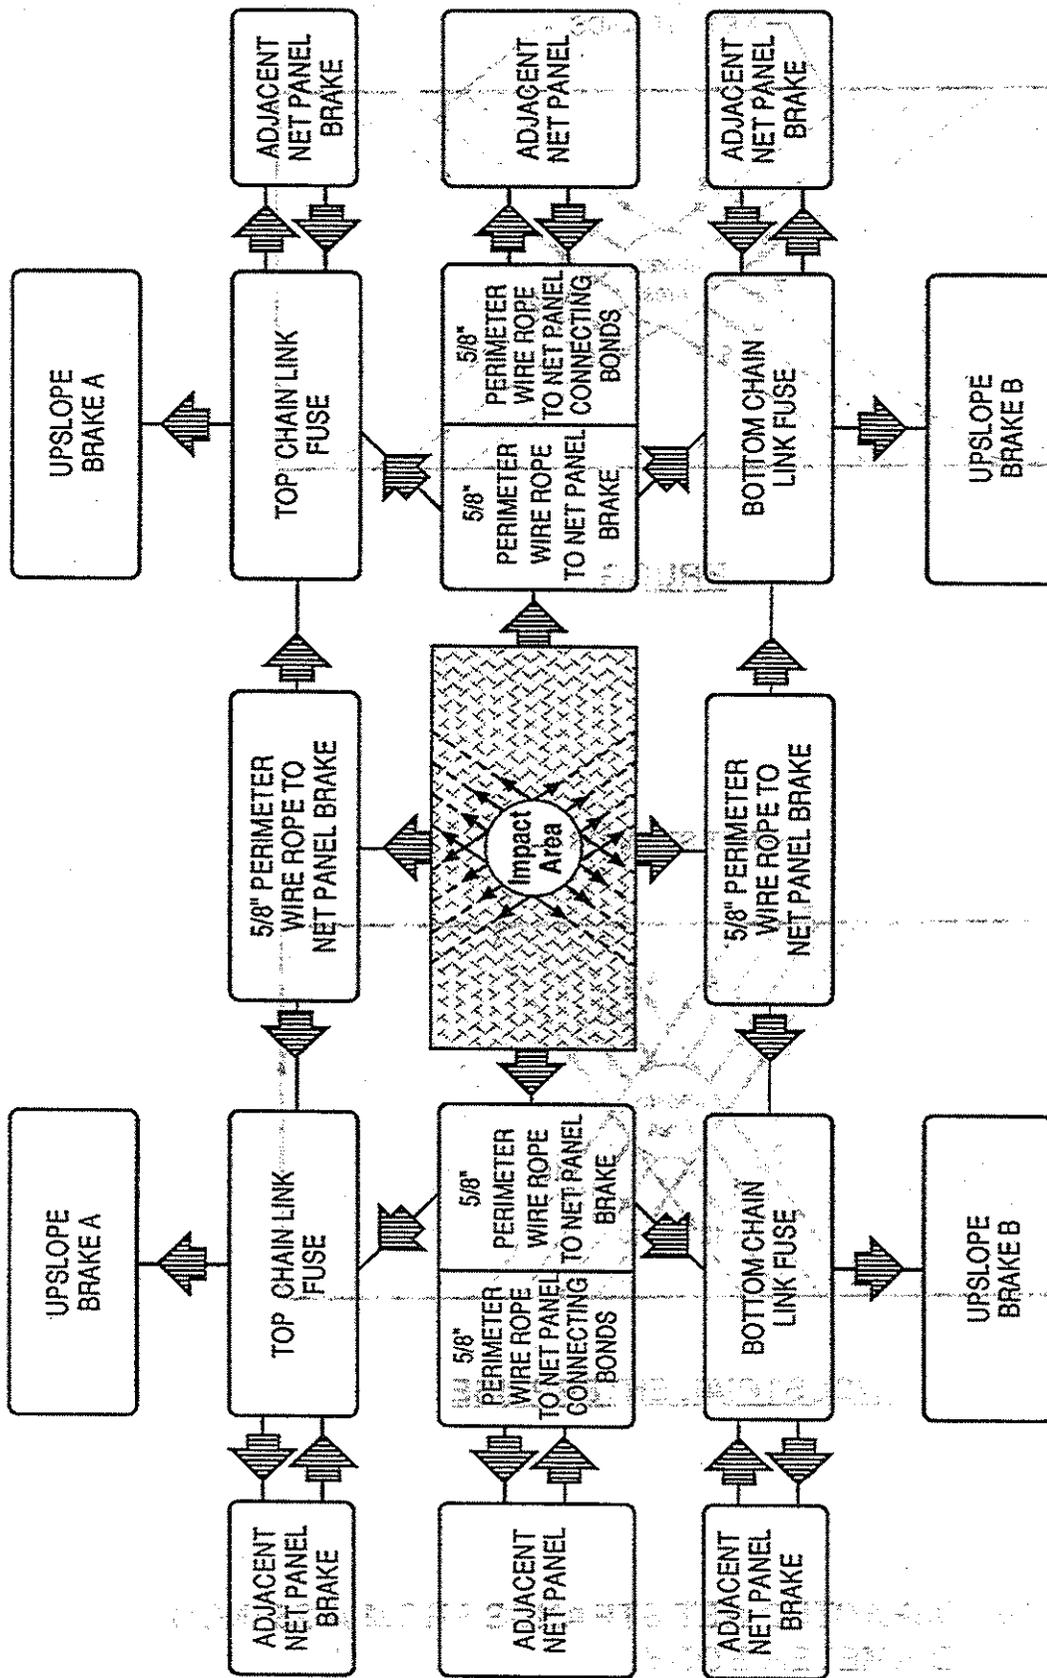
Figure 15. FLOW CHART OF THE INDUSTRIAL ENTERPRISE NET SYSTEM FLOW PATH. SHADED ARROWS INDICATE THE DIRECTION OF THE ROCK IMPACT ENERGY
