CA/TL-90/05

Field Tests and Evaluation of Rockfall Restraining Nets

June 1990

Office of Transportation Materials and Research
California Department of Transportation
Sacramento, California 95819

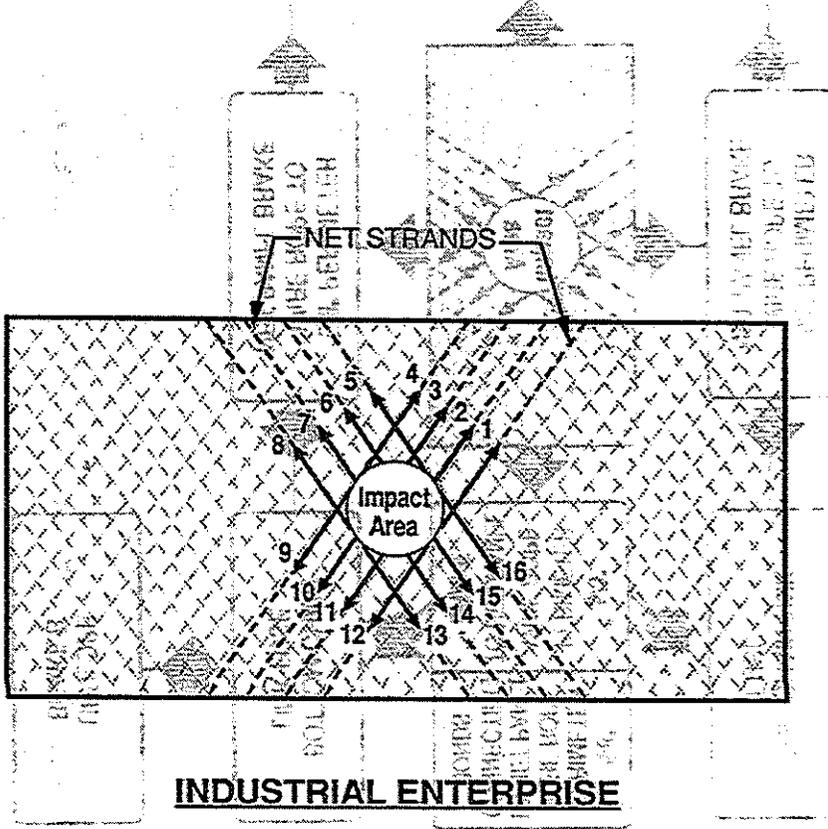
Figure 16. IMPACTED NET STRANDS FROM A 25 INCH DIAMETER BODY

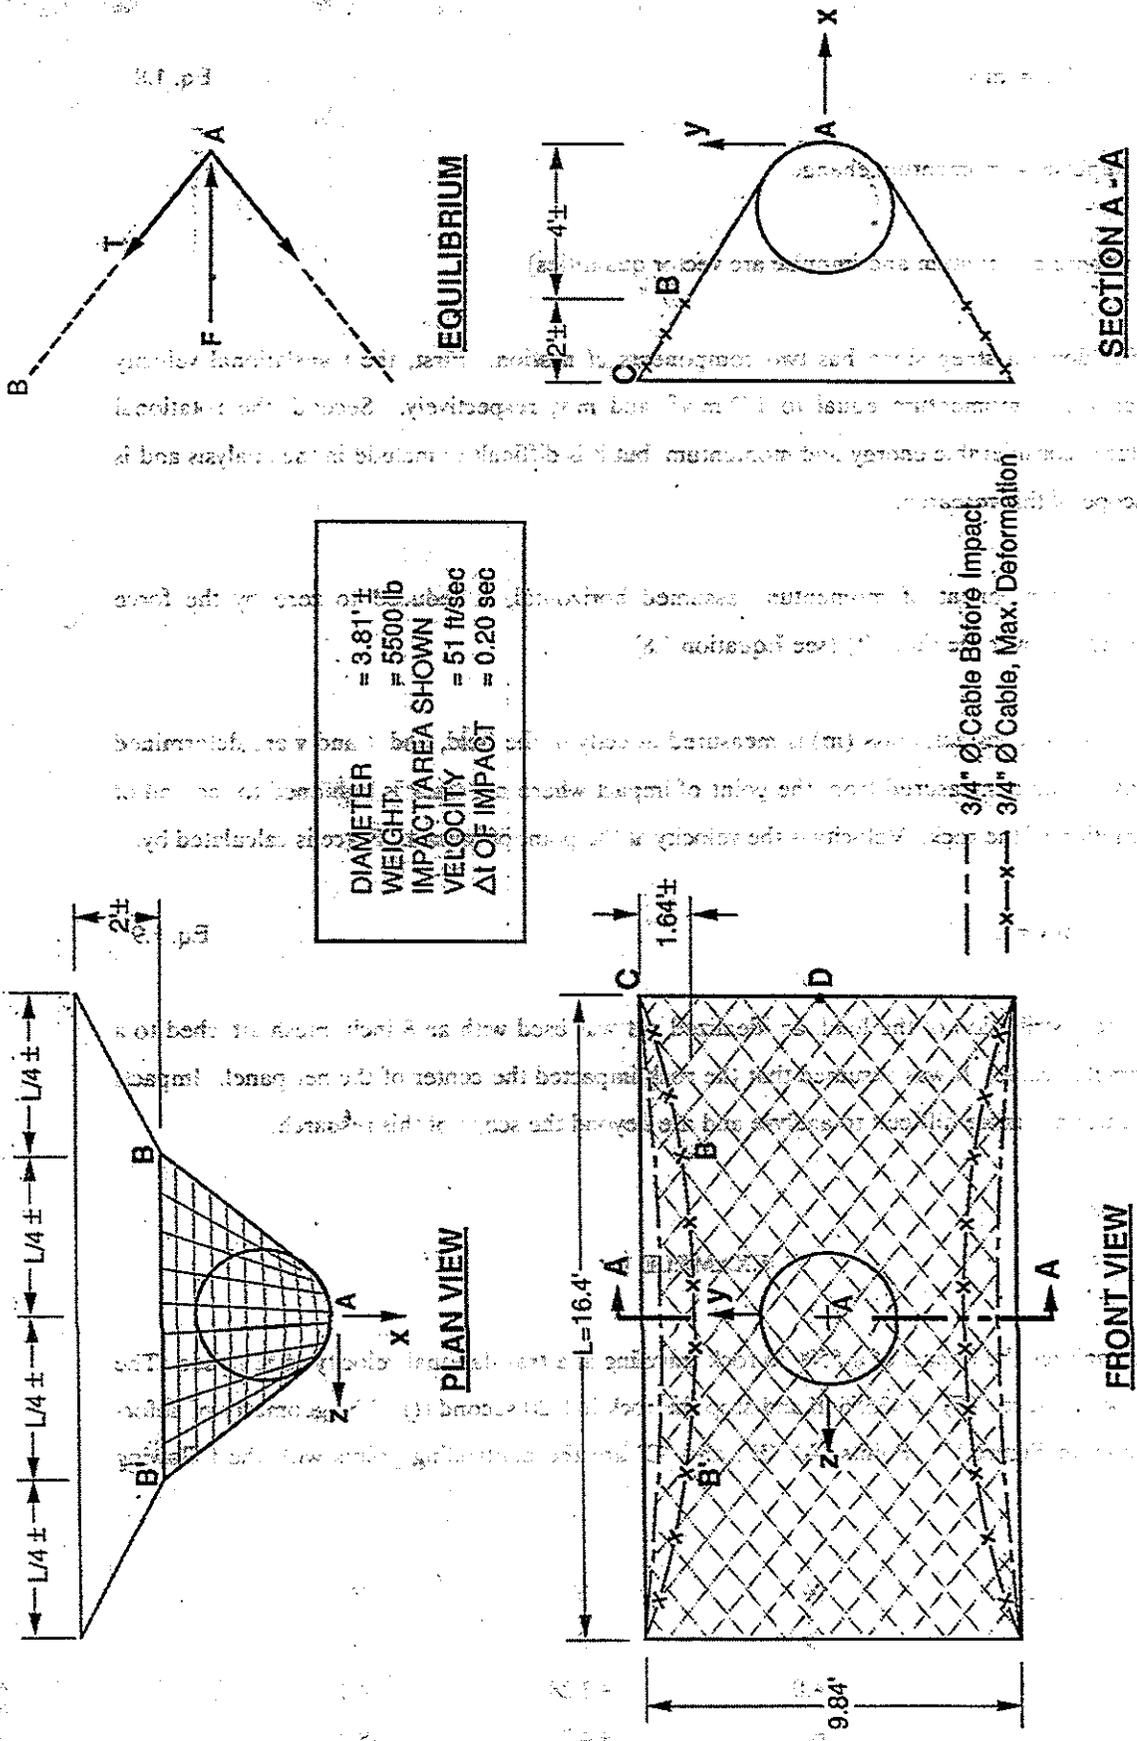
Figure 17. GEOMETRY OF DEFORMATION AND EQUILIBRIUM AT THE POINT OF CONTACT OF THE ROCK BODY

Point	X	Y	Z
A	0	0	0
B	-4.0	+3.28	-4.1
C	-6.0	+4.92	-8.2

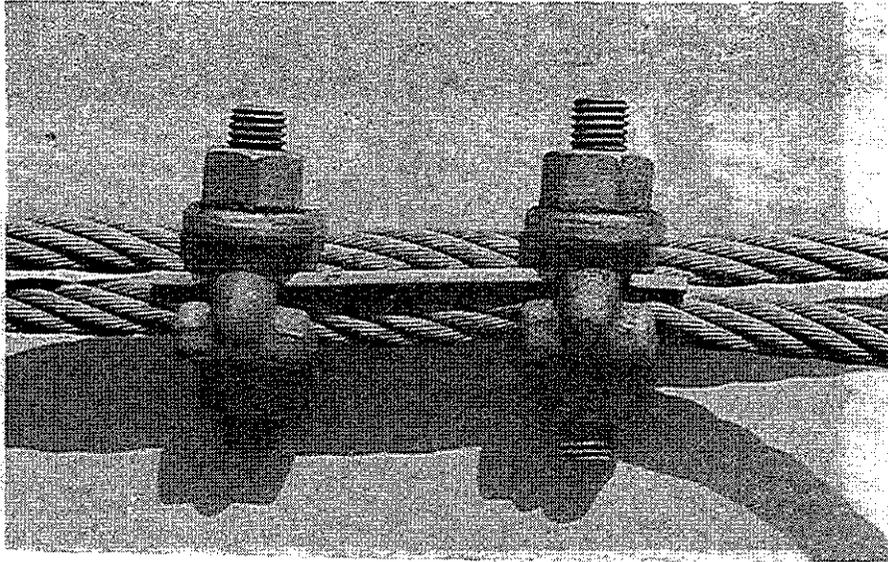
Photo 72. BRUGG FRICTION BRAKE. NOTE DISTORTION OF THE WIRE ROPE IN THE CLAMP

- Heavily torqued friction brakes and minimal friction surface of the Brugg friction brakes caused permanent distortion of the wire rope upon brake activation, requiring replacement.
