FHWA/CA/TL-91/05

Cathodic Protection of Reinforced Concrete Bridge Deck and Soffit Using Metallized Zinc

November 1992

Division of New Technology, Materials & Research
California Department of Transportation
Sacramento, California 95819

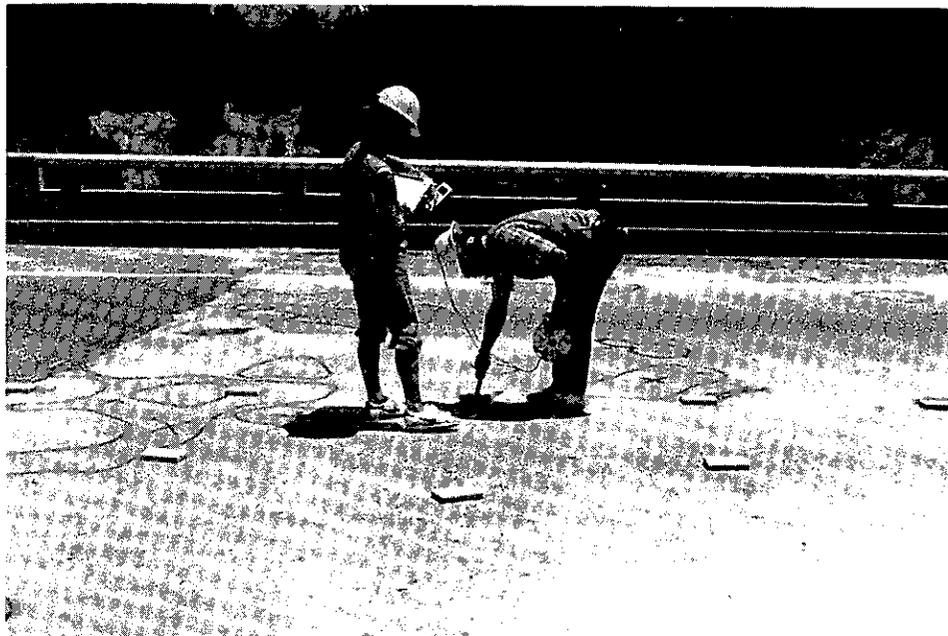
**Figure 6-1, CORROSION POTENTIAL SURVEY,
EAST CAMINO UNDERCROSSING**

A half-cell corrosion potential survey was conducted in April 1985 in accordance with ASTM Designation C-876 (6). Figure 6-1 shows the placement of saturated sponges at each intersecting point of the 4 foot grid pattern and the measuring technique used during the survey.

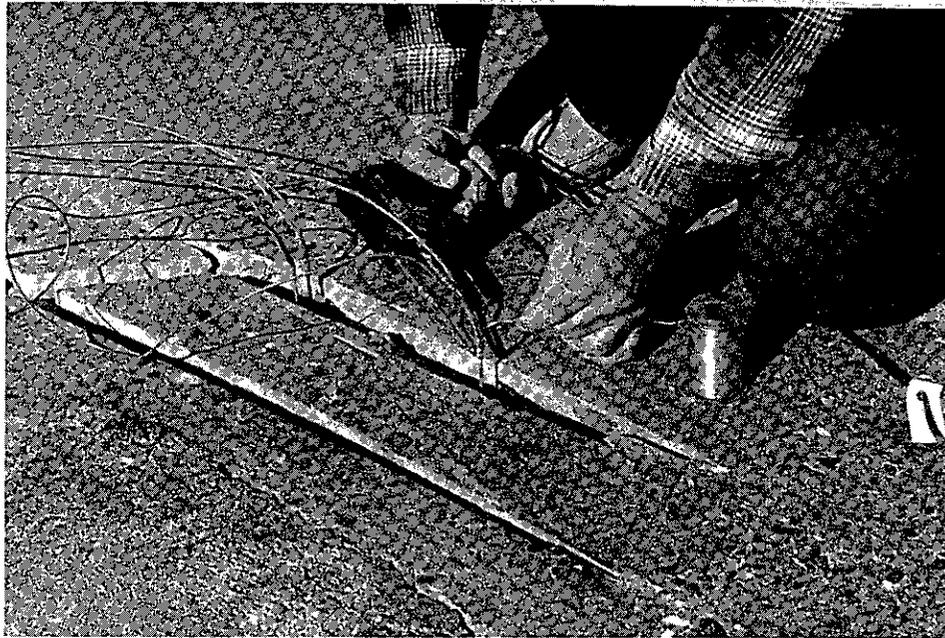
Figure 12-10, TOP REBAR MAT ISOLATED BAR WIRING

The connecting wire leads (extending to the control box) were then soldered to the exposed ends of the pins (Figure 12-10). All pins, wire leads and connectors were then potted with non-conductive epoxy (Concresive AEX 1419) within the saw cuts in the concrete deck.
