Case Study of Urban Concrete Pavement Reconstruction and Traffic Management for the I-10 (Pomona, CA) Project

E.B. Lee, J.R. Roesler, J.T. Harvey, C.W. Ibbs

University of California, Berkeley  
Institute of Transportation Studies  
Pavement Research Center

Report Prepared for  
Innovative Pavement Research Foundation (IPRF)

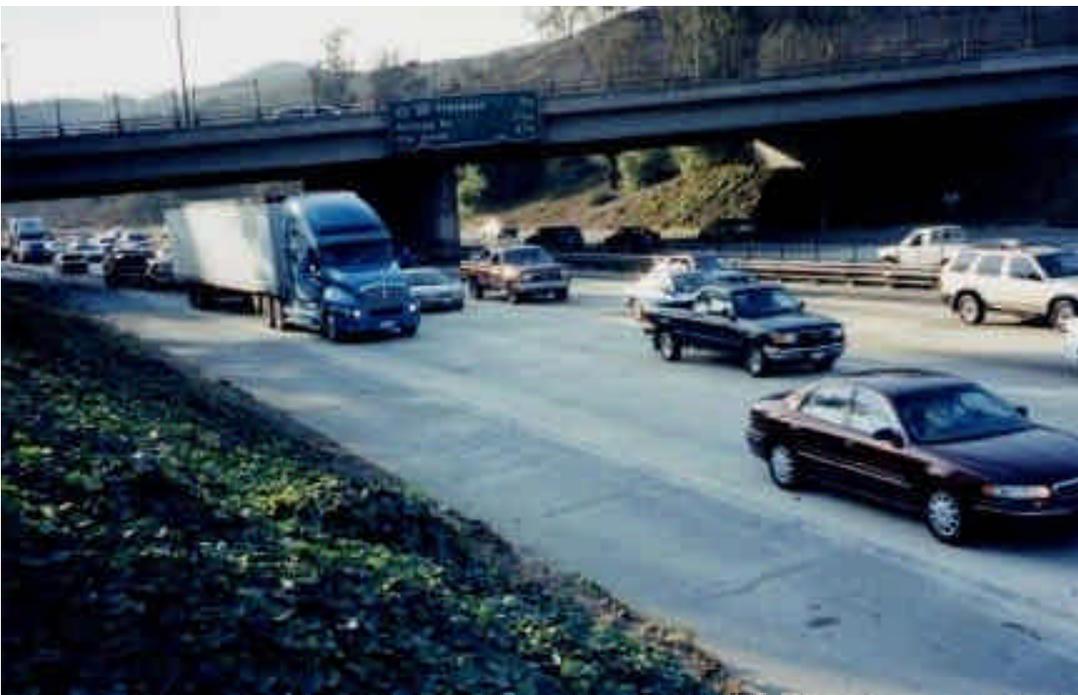
**Figure 3. Typical traffic volume of on U.S. Interstate 10.**

Interstate 10, one of the most important arterial roads connecting the east and west coasts, begins in Jacksonville, Florida and extends throughout the southern United States and terminates in Santa Monica, California. The segment of the I-10 running through Southern California, commonly called the “San Bernardino Freeway,” was built in the early 1960s with a 20-year design life. I-10 has a high concentration of deteriorated concrete pavement with extensive concrete slab failures due to transverse and longitudinal cracks and faulting, as illustrated in Figure 2. Traffic volumes in this stretch of freeway are as high as 240,000 Average Daily Traffic (ADT), as illustrated in Figure 3.

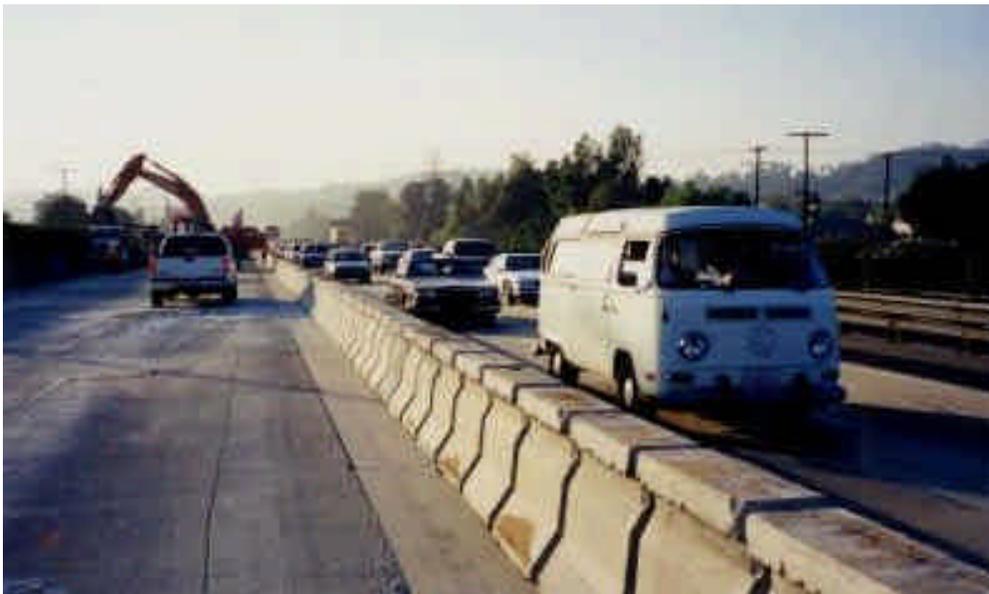
**Figure 18. MCB installed as safety barrier during the weekend closure.**

During the 55-hour weekend closure, the specification required installation of MCB between the traffic and rehabilitation lanes, i.e., Lane Numbers 2 and 3. The purpose of the MCB was to serve as a temporary safety barrier between road users and construction workers. For nighttime closures, rubber cones were used instead of MCB for prompt installation and removal. Figure 17 shows an isometric view of a MCB from the contract drawing with its typical dimensions. Figure 18 shows a picture of the MCB utilized as a safety barrier on the I-10 project.

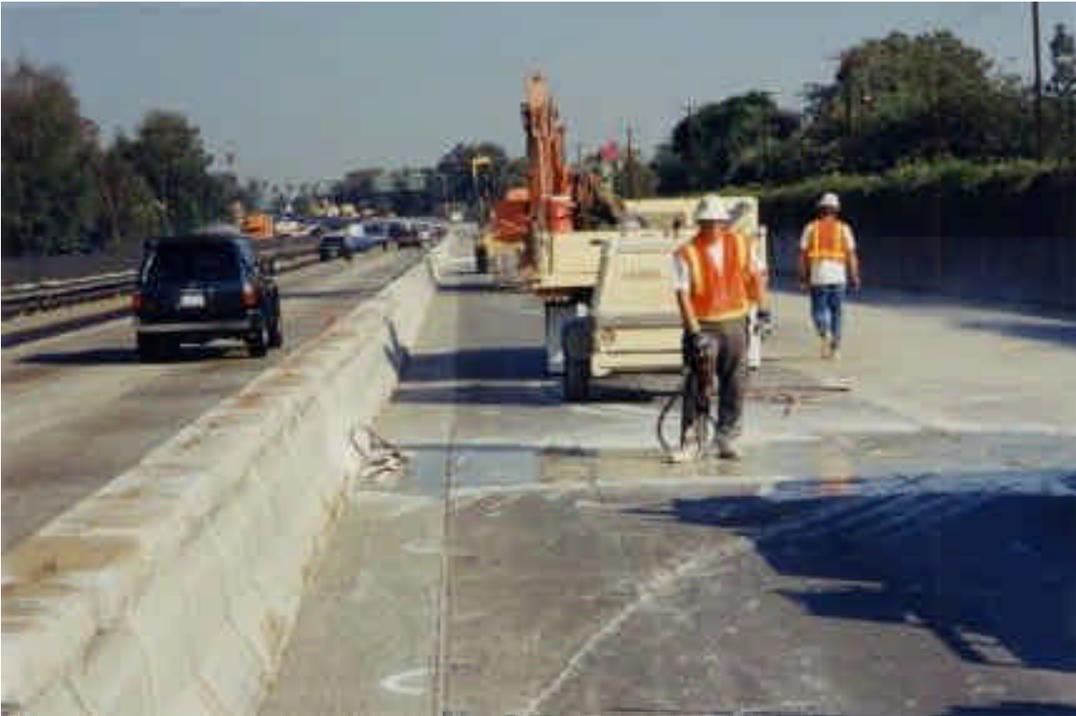
**Figure 22. Breaking the starting point of the slab with a jackhammer.**

One excavator with a 1 m<sup>3</sup> bucket capacity and seven end dump trucks were assigned for each team in the initial demolition plan. End dump trucks were owner-driver trucks and were mobilized throughout the Southern California area. At the start of the demolition, a hand held pneumatic hammer broke up the first slab to allow the blade of the excavator to lift out the first slab, as shown in Figure 22. With the non-impact demolition method, the excavator sat in Lane Number 3 in front of the slabs that it was removing. The excavator then loaded the old concrete

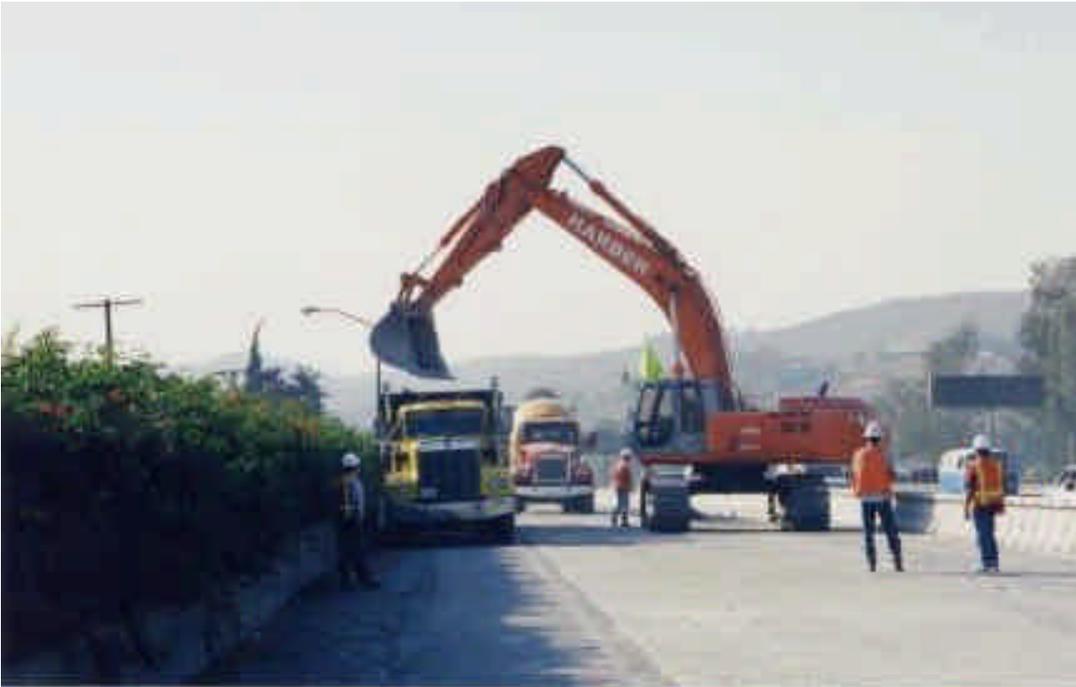
**Figure 24. Concrete mixer truck waiting for clearance to pass behind the demdition operation.**

The passage of an empty concrete mixer truck on the way back to the batch plant had first priority in most cases. The reason for this was that the concrete paving was the critical activity and the contractor wanted to avoid buildup of FSHCC in the mixer truck drums. Occasionally, the laborer assigned to the demolition crew would help direct traffic trying to pass the demolition crew, but this construction site traffic management was almost always left up to the demolition contractor superintendent or excavator operator.

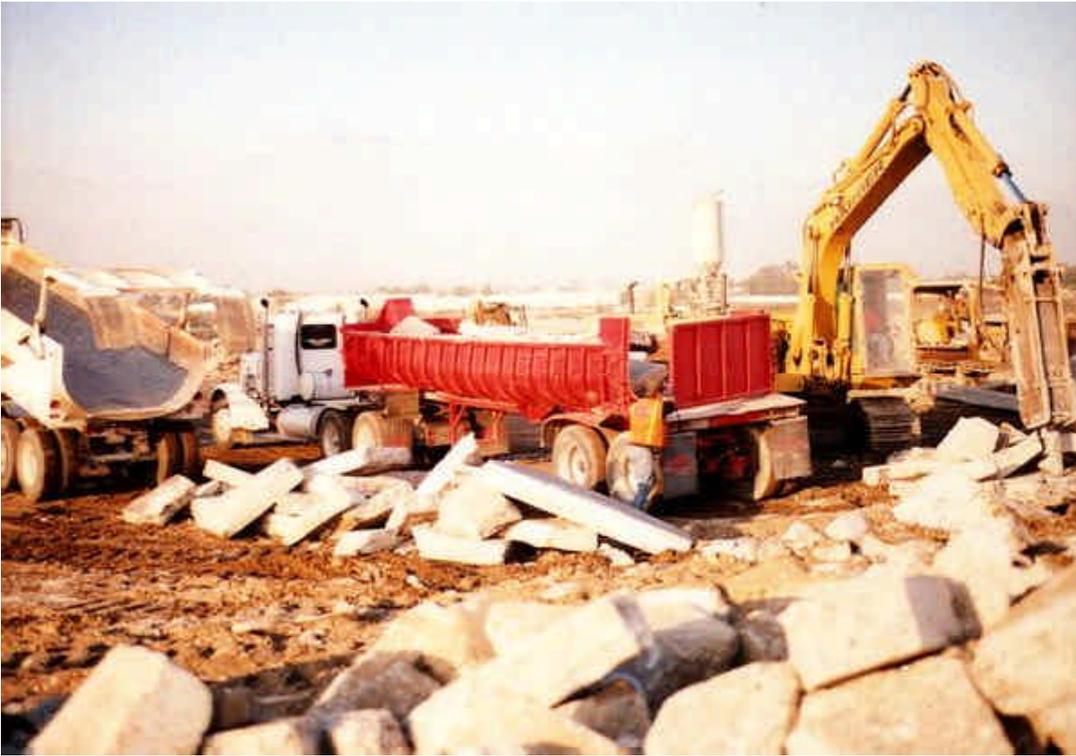
**Figure 26. View of the dumping area with end dump trucks and breaker for rubbleization.**

contractor used a breaker mounted on a backhoe to rubblize slab pieces at the dumping site, as shown in Figure 26. Figure 27 shows the stockpile of rubblized concrete left at the dumping area for future use.

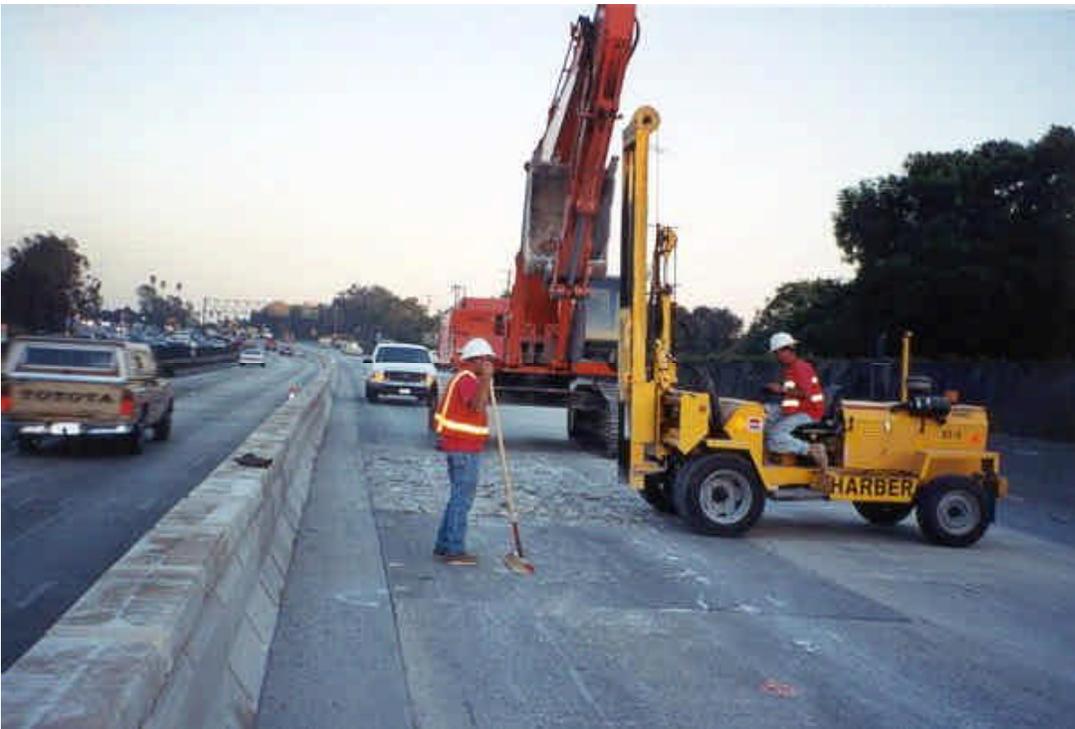
**Figure 29. Impact demdition with a breaker for full dept h replacement.**

Although most of the rehabilitation was limited to slab replacement, in some areas where the base was badly deteriorated, full-depth demolition took place. Figure 29 shows impact demolition through the use of a guillotine breaker. In order to accommodate a thicker CTB and slab in the full-depth option, part of the aggregate subbase had to be removed. After the guillotine hammer was finished, the whole section was taken out with an excavator, as shown in Figure 30. FSHCC was used for the placing the new CTB layer to quickly achieve early strength with the purpose of placing the slab as soon as the CTB achieved the minimum required strength. Placement of the fast-setting hydraulic cement treated base can be seen in Figure 31.

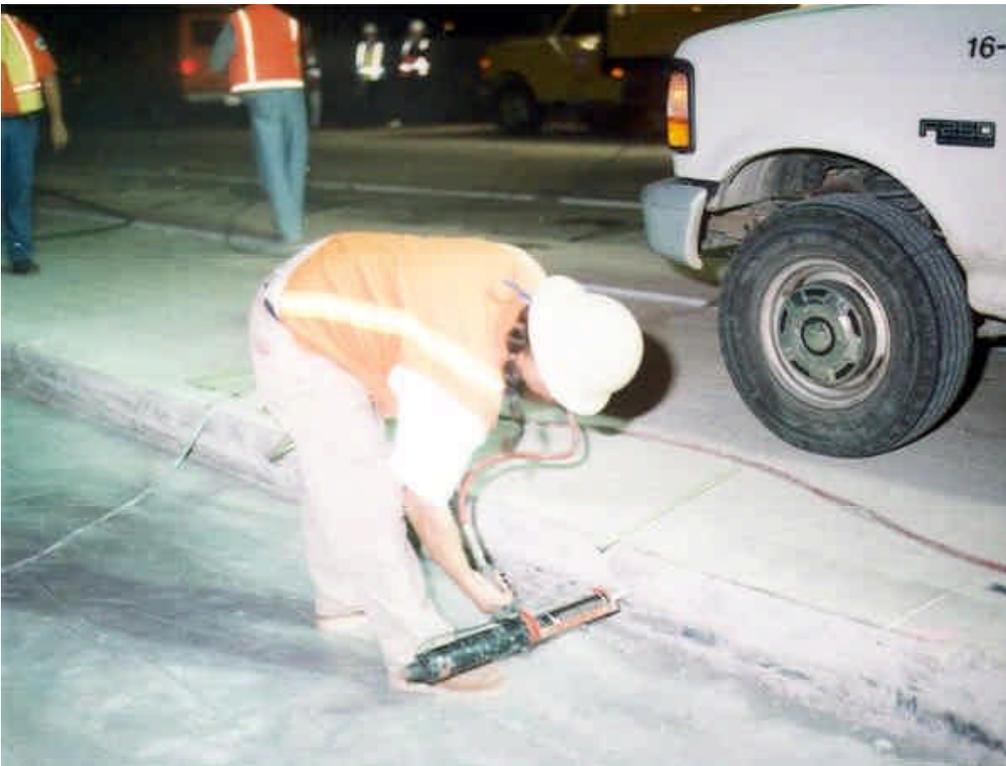
**Figure 37. Injection of epoxy into tie bar holes.**

Historically, the typical concrete pavement in California was jointed plain concrete without tie or dowel bars. In the new design criteria for LLPRS projects, dowel bars at transverse joints and tie bars at longitudinal joints have to be installed in the new pavement structure. Figure 35 shows the implementation of the new design criteria on the I-10 project. The tie bars were installed on both sides of Lane Number 3 during the 55-hour weekend closure. Tie bar holes were bored by a self-propelled gang drill unit. The gang drill created 27-mm diameter holes at a depth of 0.38 m with 0.75-m spacing between bars, as shown in Figure 36. The epoxy coated deformed steel tie bar was 16 mm in diameter by 0.75 m in length and was placed at the middle of the slab thickness. The tie bar was inserted into the hole and secured there by a fast-setting epoxy as shown in Figure 37.

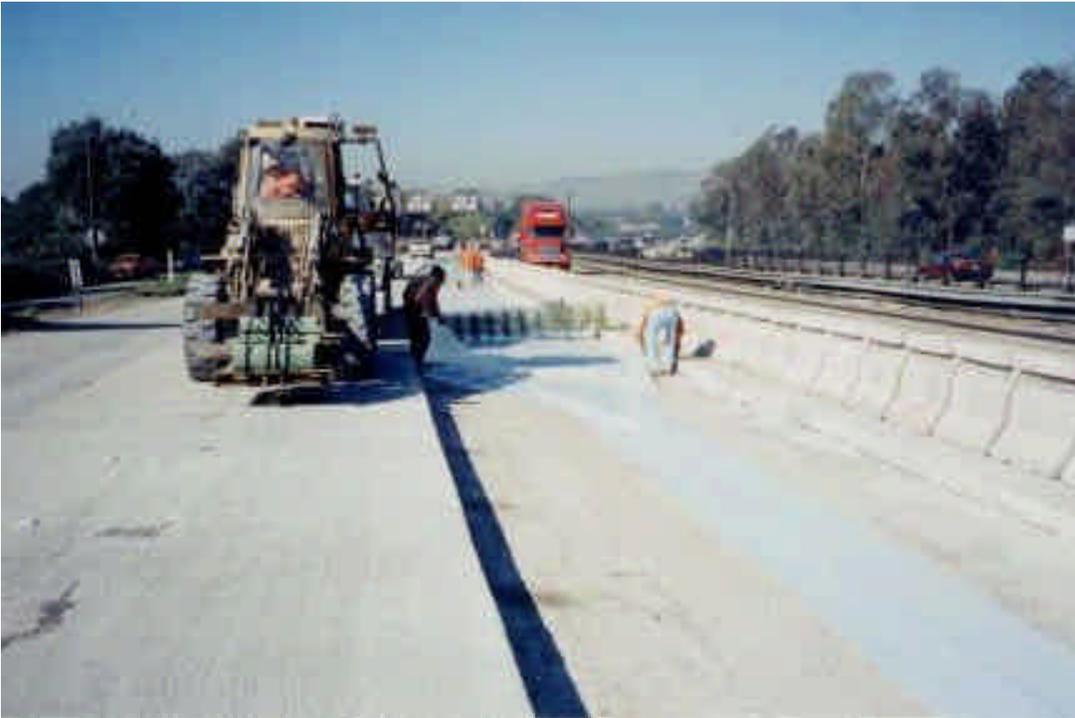
**Figure 38. Placement of polyethylene sheet as a bond breaker between CTB and new slab.**

As soon as the tie bar holes were drilled, a 0.15-mm polyethylene sheet was spread out on the existing CTB to act as a bond breaker between the CTB and new concrete slab, as shown in Figure 38. The bond breaker would reduce friction between the concrete slab and CTB, which would reduce the risk of shrinkage cracking. However, the condition of the existing CTB

probably did not warrant use of a bond breaker. In certain areas, the existing CTB visually appeared to be a lightly cement treated base and in other areas appeared to be a granular base.

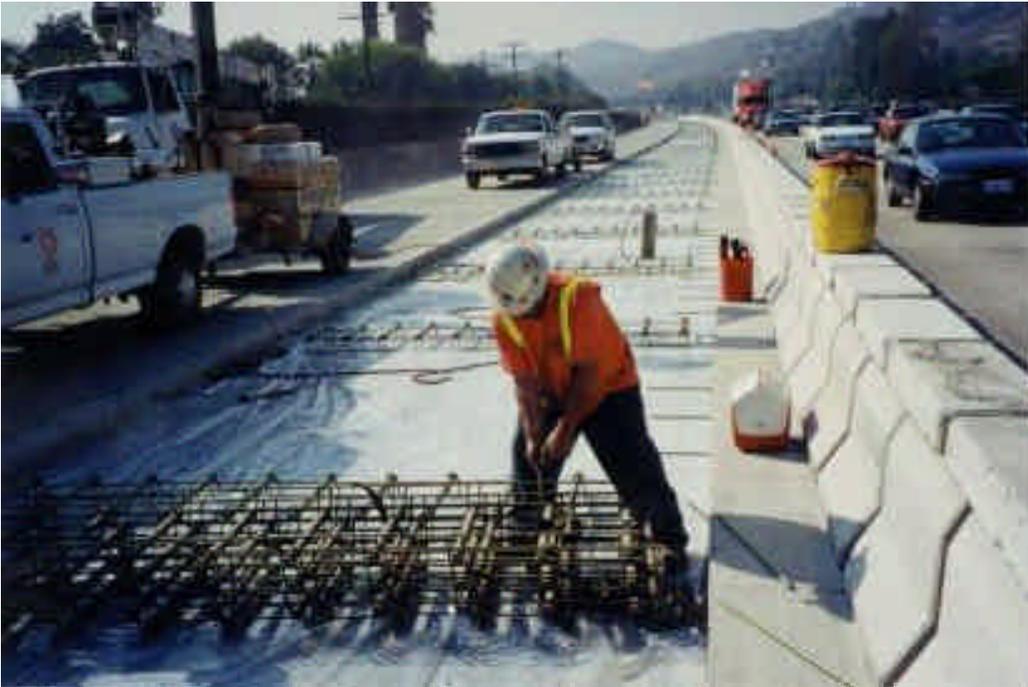
**Figure 39. Installation of dowel bar basket.**

Dowel baskets were pre-fabricated with ten epoxy coated dowel bars per joint with the steel dowel having a diameter of 38 mm and a length of 0.6 m. Dowel baskets were too heavy to be handled manually, so a small crane mounted on a delivery truck was used for unloading and positioning the baskets. The dowel baskets were fixed to the CTB at the proper transverse joint locations, as shown in Figure 39. The joint locations were chosen to match the sawed joint on the adjacent slabs. A chemical release agent was sprayed on the dowel bars to prevent bonding of the dowel bars to the concrete, as shown in Figure 40. At construction joints, the dowel bars

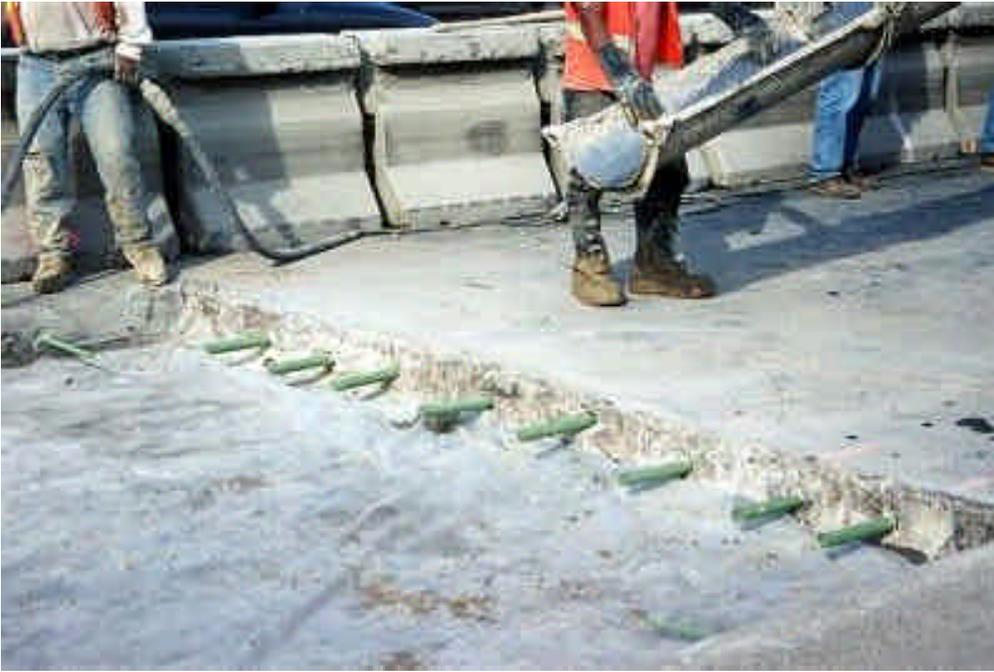
**Figure 41. Placement of dowel bars in existing slab.**

were drilled into the existing slabs, as shown in Figure 41. In some instances during construction, the dowel baskets or drilled dowels were not completely parallel to the pavement surface as seen in Figure 41.

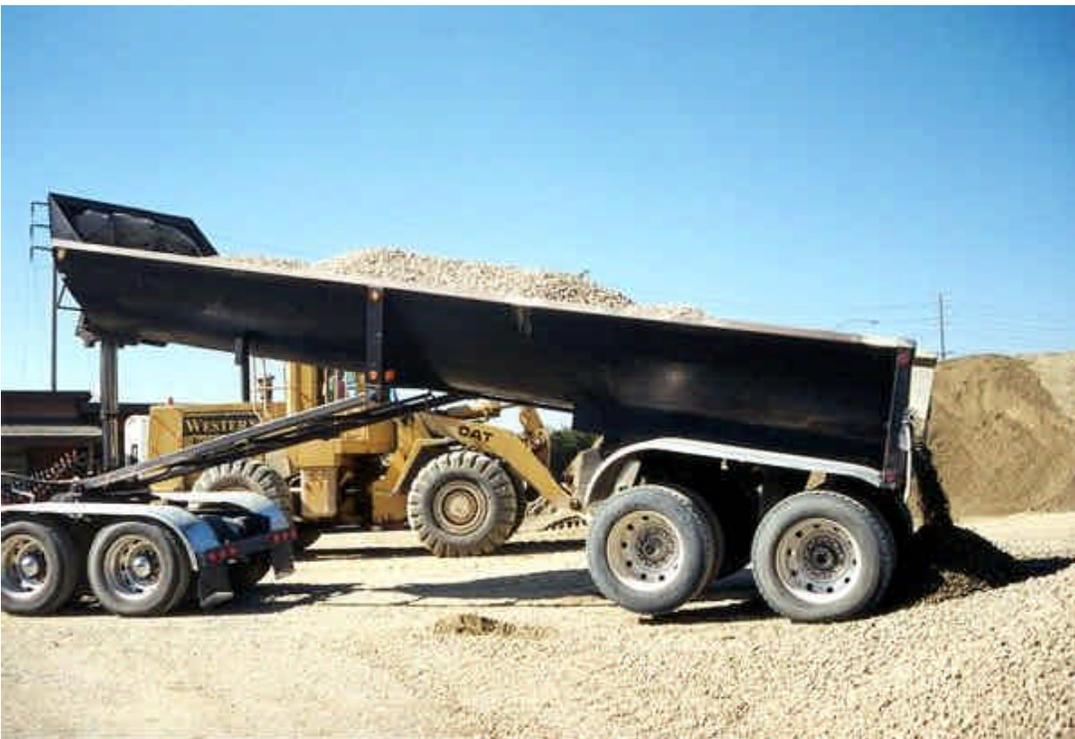
**Figure 44. Delivery of aggregate with 22-ton capacity end dump truck.**

The constituents of the FSHCC were continuously supplied to the batch plant since only a limited storage space existed at the plant. The quantity of stock materials at the plant was enough to produce concrete for a couple of hours before new materials were required. The manufacturer of the cement had to continuously supply the cement silos to keep up with the concrete pavement production. Aggregates materials were supplied to Western Rock continuously during the concrete production from Vulcan Materials, an aggregate quarry and crushing plant, as shown in Figure 43. The aggregate source was located about 10 km from the batch plant. The turnaround time for the aggregate delivery was about one hour using 22-ton capacity end dump trucks, shown in Figure 44.

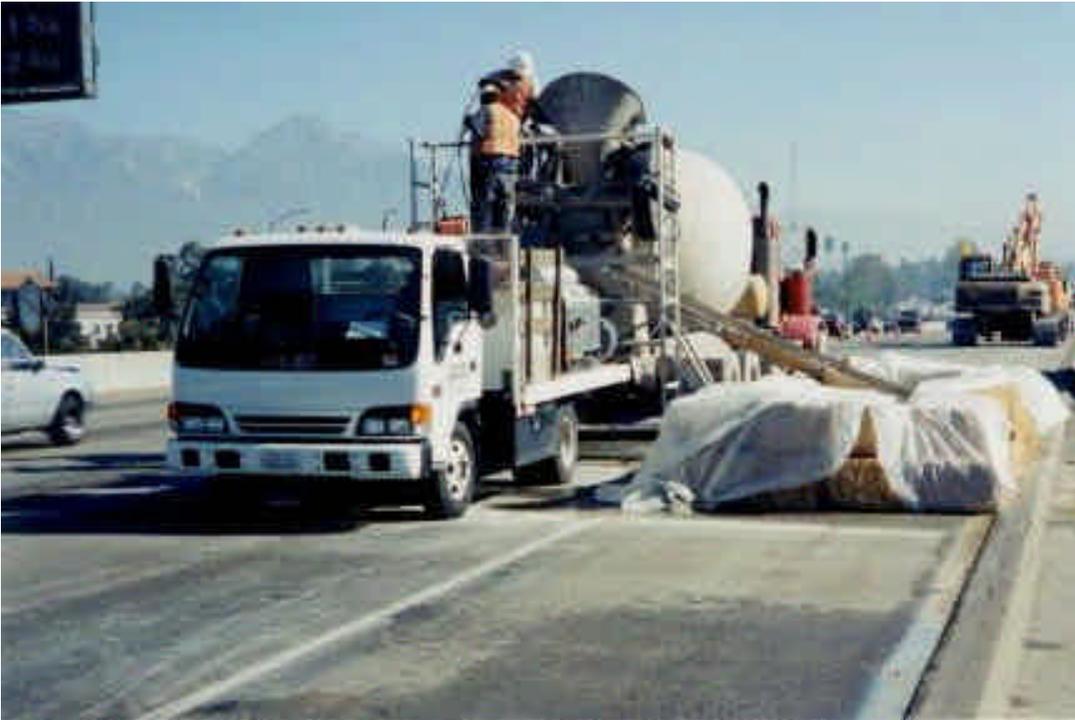
**Figure 45. Temporary washing area for concrete buildup in the mixer drum.**

One of the handling issues with some FSHCC materials is buildup of concrete on metal surfaces, such as the mixer drum, due to the chemistry and viscosity of the cement. The contractor took special precautions to prevent buildup by washing out every mixer drum with a high-pressure water jet after the truck had discharged its load. Figure 45 shows a picture of one of the washout areas. The washout material had to be collected in a trough to prevent contamination of the ground and sewer lines with cement slurry. Although two temporary washout sites were in service during the rehabilitation, mixer trucks were usually queued in a

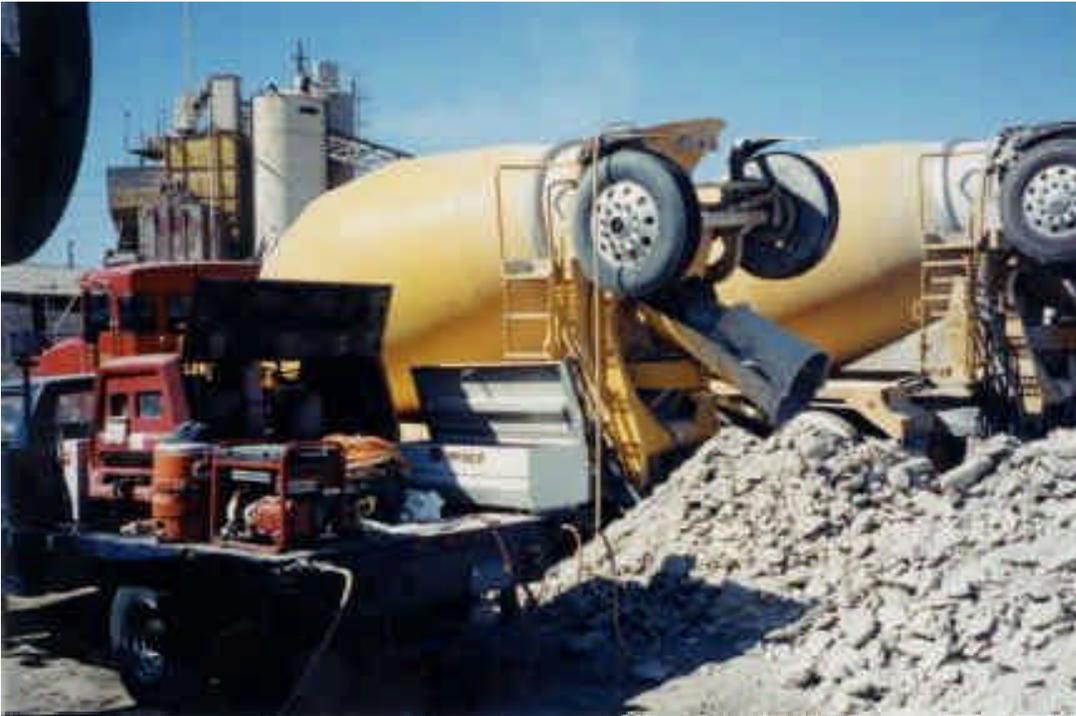
**Figure 46. Chipping area at the batch plant.**

As shown in Figure 46, a laborer had to climb into the mixer drum and chisel the FSHCC stuck to the mixer drum with a pneumatic hammer. The process of chipping out 4 tons of material from the drum took anywhere from one to four hours and resulted in significant costs.

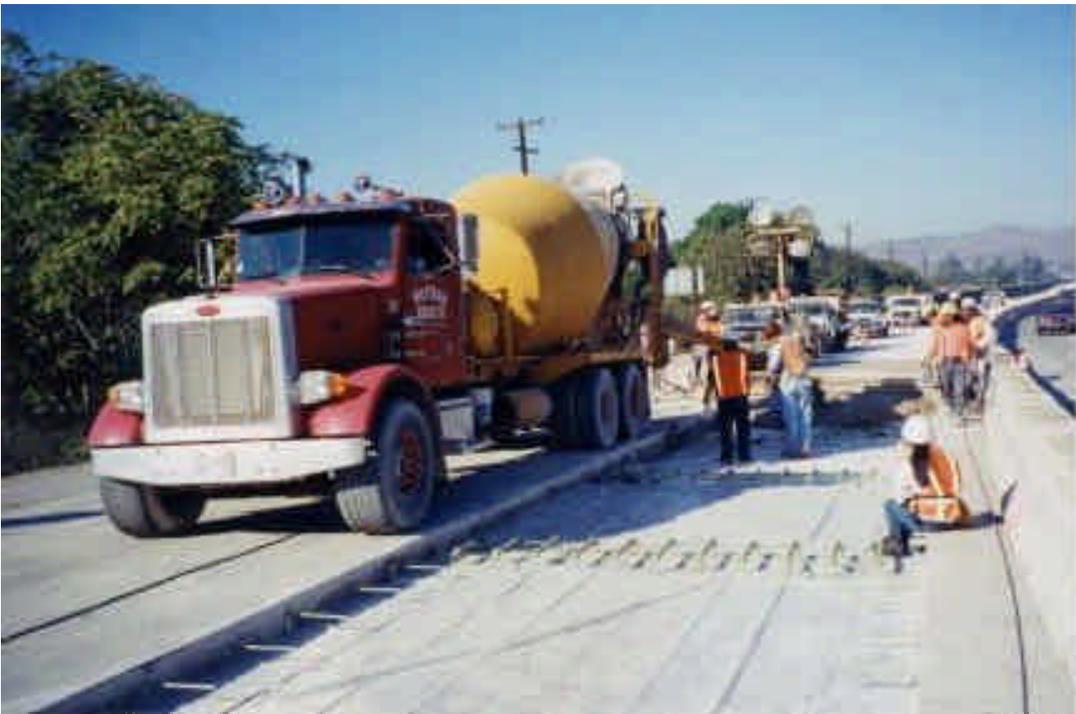
**Figure 47. Concrete discharge and paving operation.**

The concrete delivery trucks and drivers were provided by the Western Rock along with the FSHCC. At the site, the mixer trucks were positioned on Lane Number 4 and discharged concrete into Lane Number 3 in front of the rotating concrete screed, as shown in Figure 47. On the majority of the site, no construction traffic (demolition trucks or contractor vehicles) could

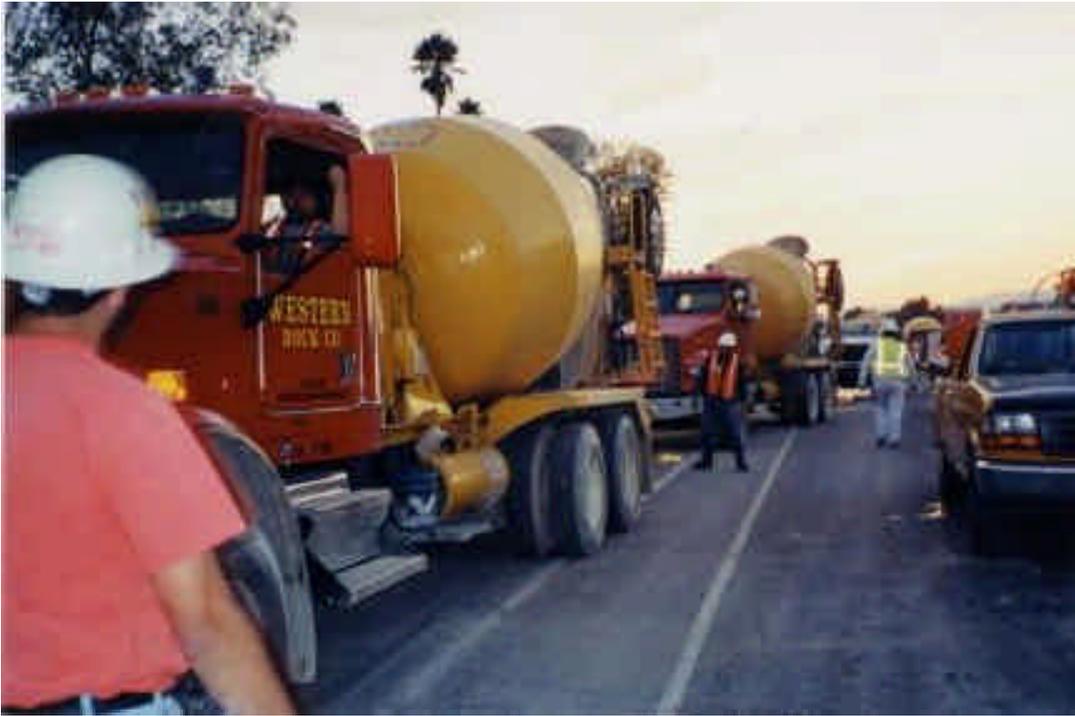
**Figure 48. Queuing of mixer trucks waiting to discharge during screed breakdown.**

Near the end of the paving operation, the screed broke down again. Approximately seven mixers were queued waiting for the replacement of the screed, as shown in Figure 48.

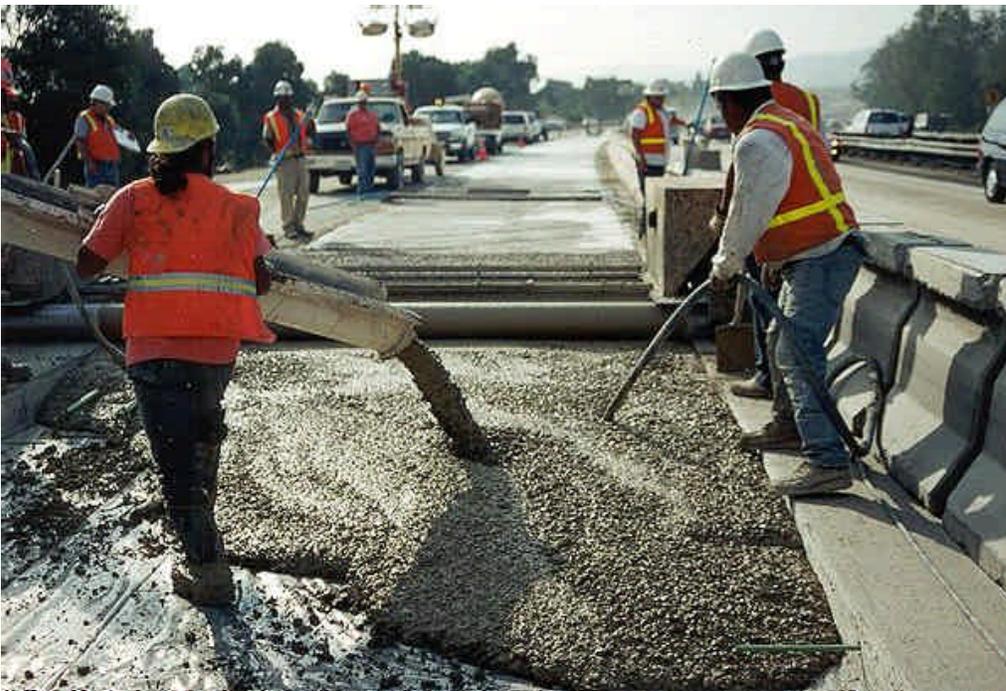
**Figure 54. Example of good quality, fresh concrete.**

The FSHCC had a high slump since it was being placed by hand and Lane Number 3 had the adjacent slabs to act as forms. The overall workability of the fresh concrete supplied was good, as shown in Figure 54, but occasionally the consistency of the concrete was observed to be too wet, as shown in Figure 55.

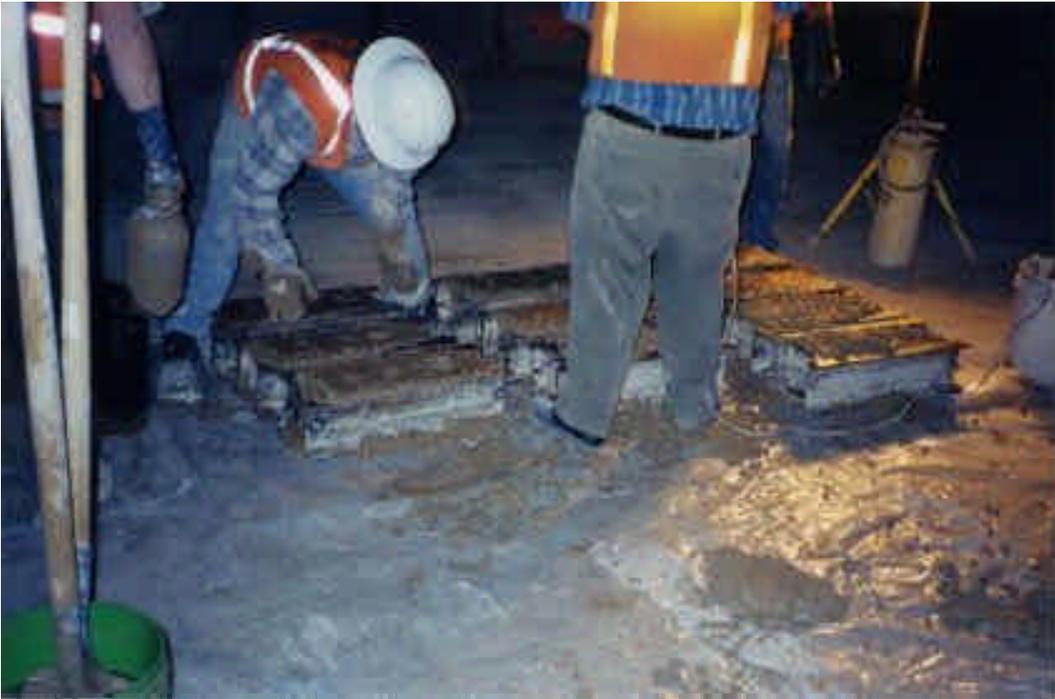
**Figure 57. Ten beam specimens were taken from every 15 mixer trucks for flexural testing.**

Figures 57 and 58 show the subcontractor (Twining Laboratories) sampling the concrete to make specimens for strength testing. Ten beam and six cylinder specimens were cast from every 15<sup>th</sup> mixer truck. The Kelly Ball penetration test was used to measure the consistency of the fresh concrete.

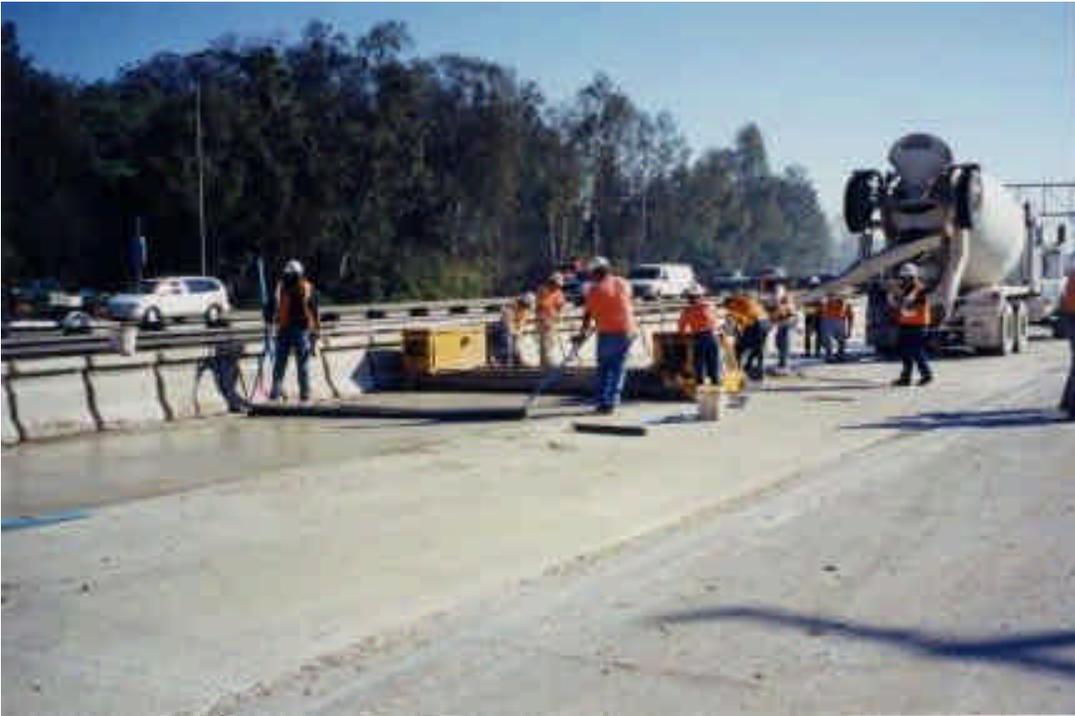
**Figure 59. Manual finishing and texturing of the pavement.**

Finishing and texturing were completed manually by two laborers who floated, trowelled, and broomed the pavement surface behind the concrete screed, as shown in Figure 59. Curing compound was sprayed on the surface immediately after finishing and texturing, as shown in Figure 60. Approximately two hours after the concrete was finished, a 44-mm deep saw cut was made on each transverse joint with a single saw team, as shown in Figure 61. The condition of the finished surface was rough, but the contractor planned to diamond grind the surface during a
