1. Report No. TRP-03-180-06	2.	3. Recipient's Accession No.	
4. Title and Subtitle DEVELOPMENT OF TIE-DOWN AND TRANSITION SYSTEMS FOR TEMPORARY CONCRETE BARRIER ON ASPHALT ROAD SURFACES		5. Report Date February 23, 2007

9. Performing Organization Name and Address Midwest Roadside Safety Facility (MwRSF) University of Nebraska-Lincoln 527 Nebraska Hall Lincoln, Nebraska 68588-0529		10. Project/Task/Work Unit No.

**DEVELOPMENT OF TIE-DOWN AND
TRANSITION SYSTEMS FOR TEMPORARY
CONCRETE BARRIER ON ASPHALT ROAD
SURFACES**

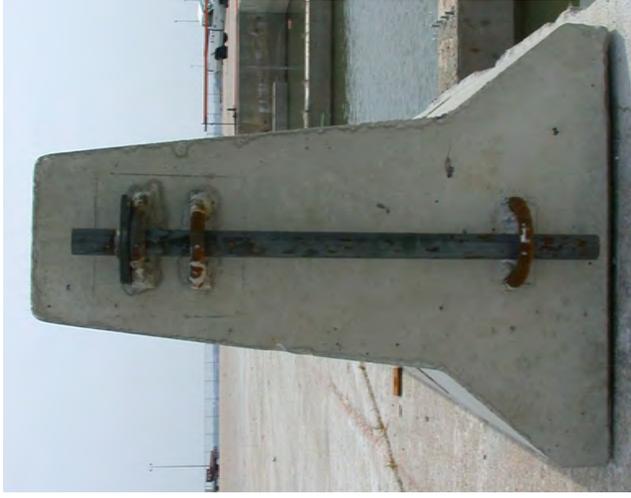
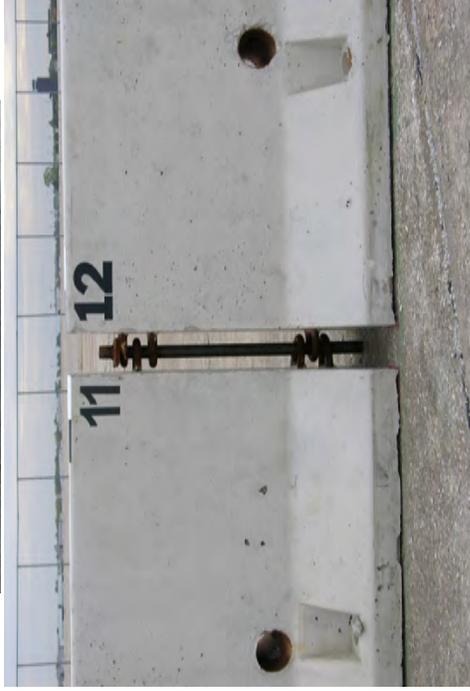
Figure 2. F-shape Temporary Concrete Barrier

The temporary concrete barrier used for this research was the Kansas F-shape temporary concrete barrier, as shown in Figure 2. This barrier had been previously developed during the research for the bolt-through tie-down system for use on concrete roadways. The barrier segments were 3.81-m (150-in.) long and 813-mm (32-in.) tall, and six 51-mm (2-in.) diameter, vertical holes, three holes per side, were cast into the toe of the barrier. Additional steel reinforcement was required around the holes to provide sufficient resistance and containment for the retainer bolts. Adjacent barriers were joined using a pin and loop type connection comprised of three sets of rebar loops on each barrier interconnection. The three loop connection detail provided double shear at two locations on each pin and consequently allowed for the elimination of the retainer bolt at the bottom of the vertical pin.

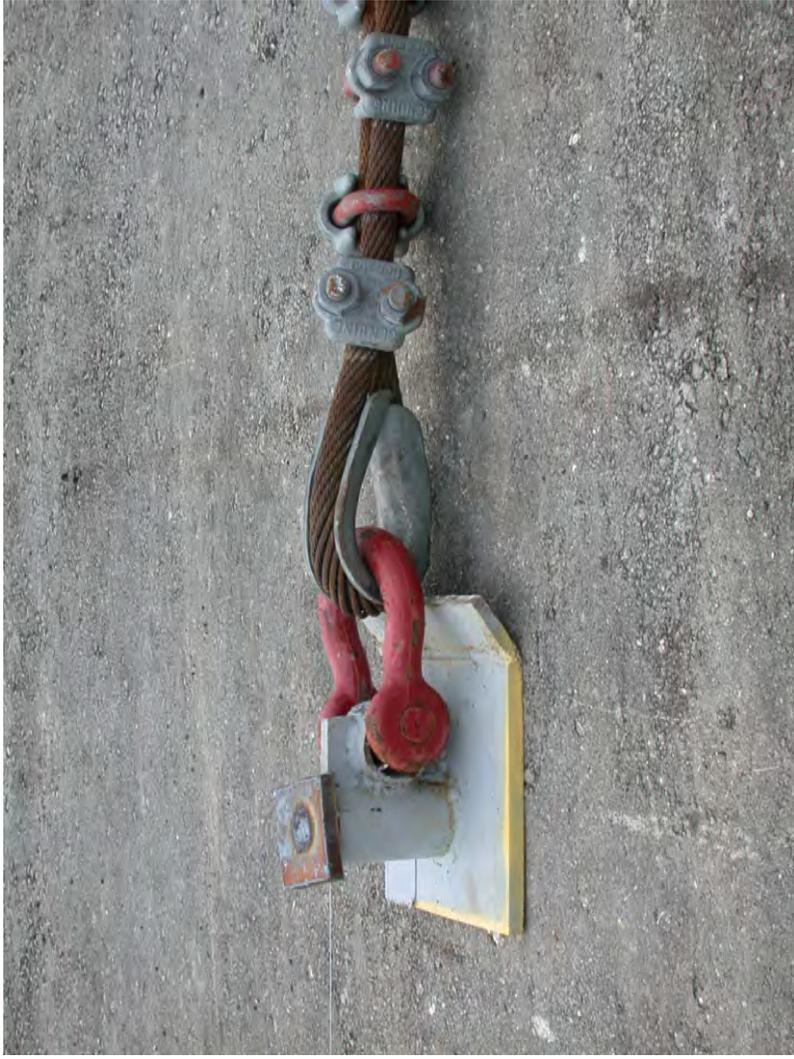
Figure 3. Asphalt Pin Component Testing

Component testing of prototype steel pin tie-downs was conducted to determine the proper size of the pin as well as to investigate the effects of varying asphalt depth. The basic test setup and schematics of the prototype pins are shown in Figure 3. The test matrix for the asphalt pin testing consisted of 914-mm (36-in.) long, A36 steel pins with both 28.575-mm (1.125-in.) and 38.1-mm (1.5-in.) diameters. A 76-mm x 76-mm x 13-mm (3-in. x 3-in. x 0.5-in.) A36 steel cap was welded to the top of each pin in order to provide vertical restraint. The pins were tested with 51-mm (2-in.), 102-mm (4-in.), and 152-mm (6-in.) asphalt cover depths. The initial pin diameters and lengths were based on hand calculations, and the asphalt depths were selected to represent a range of minimum and maximum cover on the roadway. The component test consisted of installing the steel pins in a steel sleeve sized to match the vertical holes in the F-shape barrier. The pin was loaded laterally through the soil and asphalt by pulling on the sleeve with a cable attached to a 2,160-kg (4,762-lbs) bogie sled moving away from the pins at approximately 6.71 m/s (15 mph). Force and deflection of the pin were measured during the pull

test using a load cell and a string potentiometer, respectively.

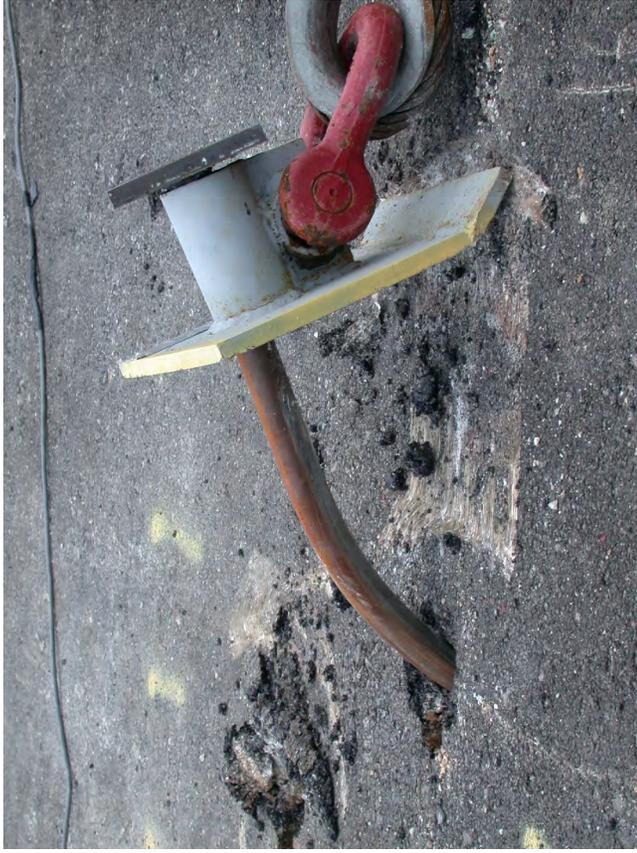
Comparison of the two pin diameters demonstrated a significant difference in behavior, as shown in Figure 4. The 38.1-mm (1.5-in.) diameter pin developed a 91.4 kN (20.54 kip) peak load, which was an 8 percent increase over the 84.6 kN (19.02 kip) peak load of the 28.575-mm (1.125-in.) diameter pin. Previous experience has shown that typical impact loading for rigid, concrete barriers, when impacted with a 2,000-kg (4,409-lbs) pickup truck at 100 km/h (62.14 mph) and 25 degrees, to be in the range of 267 kN (60 kip) to 311 kN (70 kip). If the tie-down system placed three pins on the face of the temporary concrete barrier, then the lateral constraint would be in the range of 254 kN (57.1 kip) to 274 kN (61.6 kip). Thus, it was believed that either pin diameter would possess sufficient capacity to restrain barrier motion. However, it was also noted that the larger 38.1-mm (1.5-in.) diameter pin behavior was more desirable as it provided lower deflection, reduced pin deformation, and less pullout of the pin from the asphalt and soil.

a) 28.575 mm Diameter Pin
Peak Load = 84.6 kN

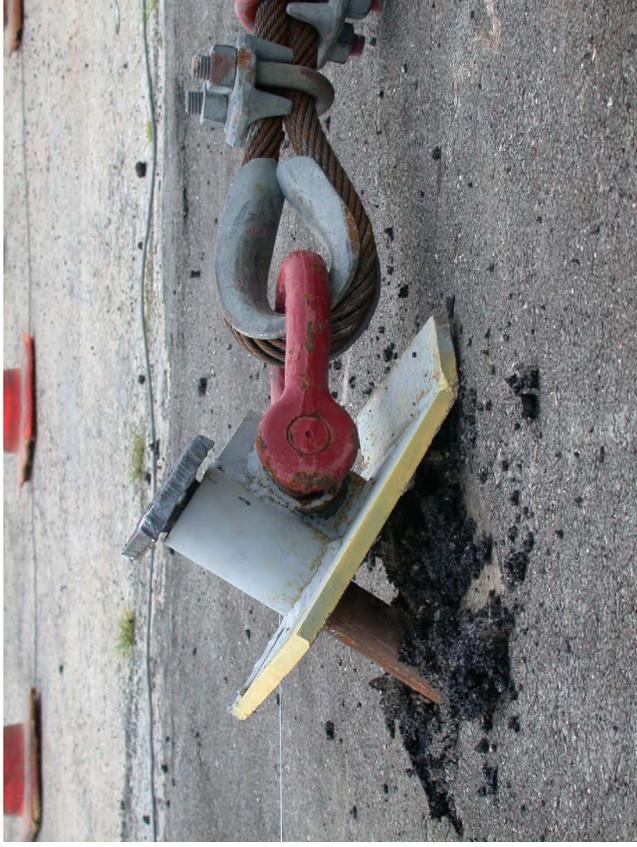
Figure 4. Effect of Pin Diameter on Tie-Down Performance

b) 38.1 mm Diameter Pin
Peak Load = 91.4 kN

Based on the force versus deflection behavior observed during component testing, the 38.1-mm (1.5-in.) diameter x 914-mm (36-in.) long A36 steel pin with a 76-mm x 76-mm x 13-mm (3-in. x 3-in. x 0.5-in.) A36 steel cap was chosen for the asphalt temporary concrete barrier tie-down design.

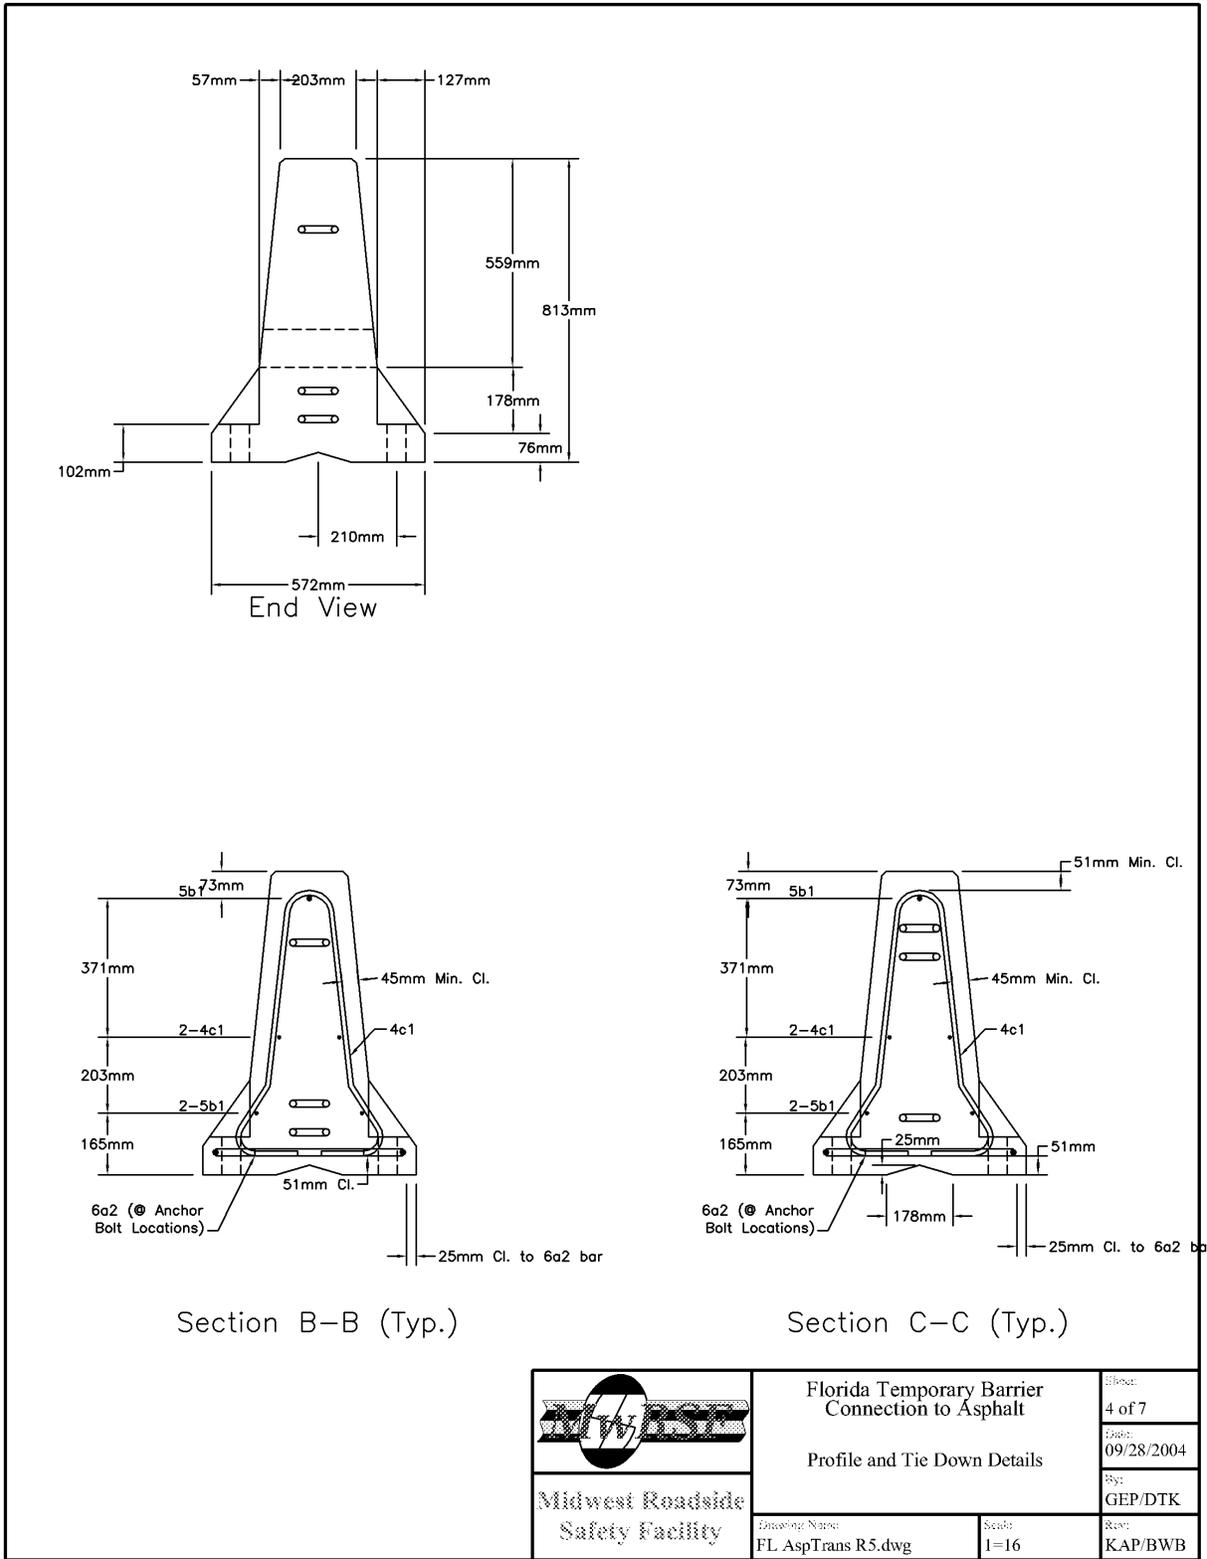
Figure 8. Asphalt Pin Tie-Down Design Details

Barrier reinforcement consisted of three No. 5 and two No. 4 longitudinal bars, twelve No. 4 bars for the vertical stirrups, and six No. 6 bars for the anchor bolt block reinforcement loops. Each of the five longitudinal rebar was 3.71-m (12-ft 2-in.) long. The vertical spacing of the lower, middle, and upper longitudinal bars were 165 mm (6.5 in.), 368 mm (14.5 in.), and 780 mm (29.125 in.) from the ground to their centers, respectively. The vertical stirrups were 1,829-mm (72-in.) long and were bent into the shape of the barrier. Their spacing varied longitudinally, as shown in Figure 7. The anchor bolt block loops were 889-mm (35-in.) long, were bent into a U-shape, and were used to reinforce the anchor bolt area, as shown in Figure 7 through Figure 9.

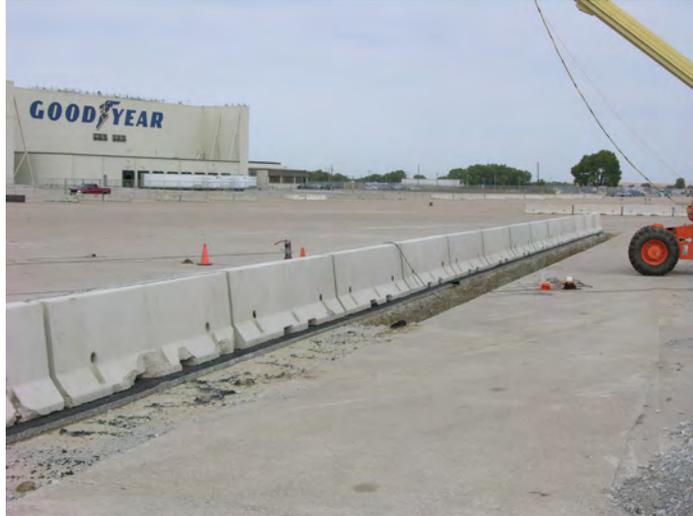
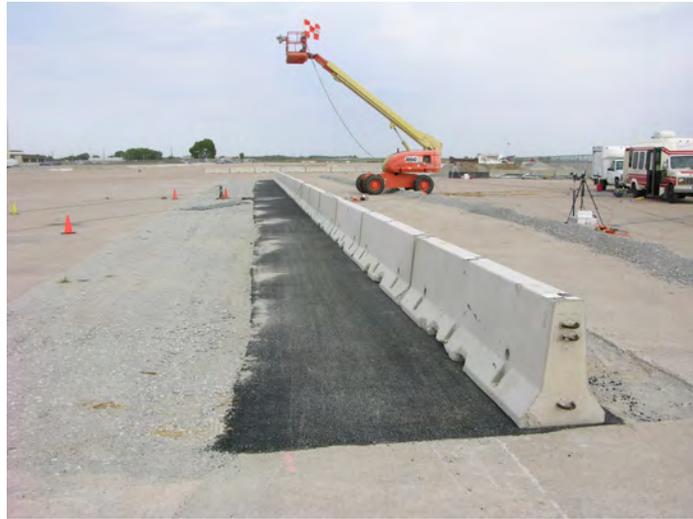
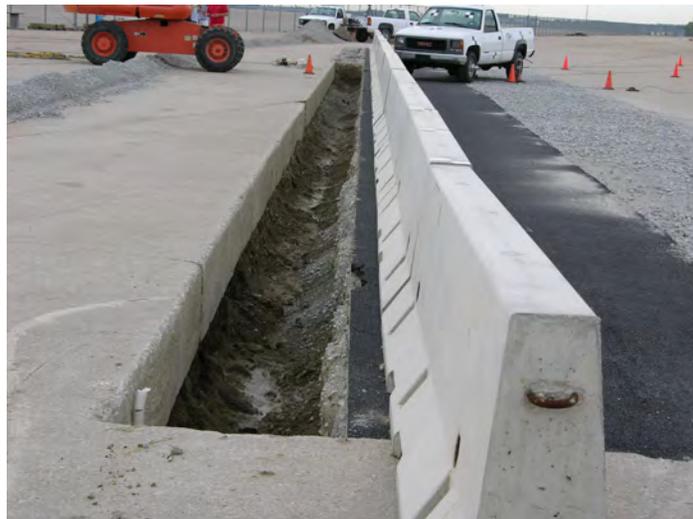
Figure 12. Asphalt Pin Tie-Down Design Photographs

Design details for the asphalt pin tie-down evaluated in full-scale crash test no. FTB-1 are shown in Figure 5 through Figure 11. The design layout consisted of sixteen F-shape temporary concrete barriers placed on a 51-mm (2-in.) thick asphalt pad. The 51-mm (2-in.) asphalt depth was chosen because it was the minimum asphalt cover to provide a reasonable bearing surface for field installations of the system. In addition, component testing had shown that thicker asphalt cover would only decrease tie-down deflection. The back edge of the barrier was installed 152 mm (6-in.) from the edge of a 914-mm wide x 914-mm (36-in. x 36-in.) deep trench. Three 38.1-mm (1.5-in.) diameter x 914-mm (36-in.) long A36 steel pins with 76-mm x 76-mm x 13-mm (3-in. x 3-in. x 0.5-in.) A36 steel caps were installed in the holes on the front face of ten barriers in the mid-section of the installation. The corresponding English-unit drawings are shown in Appendix A. Photographs of the test installation are shown in Figure 12 through Figure 13.

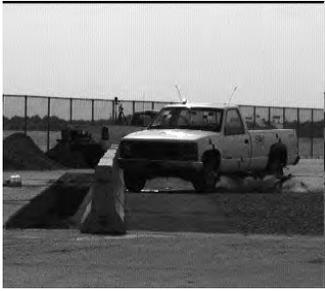
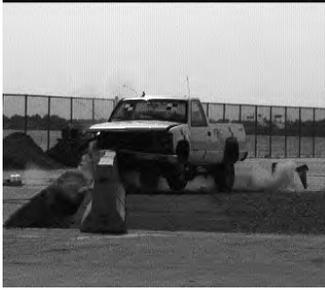
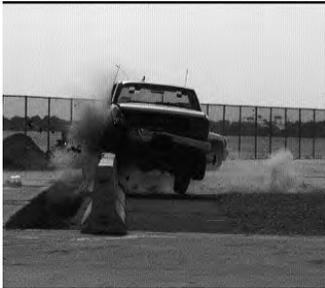
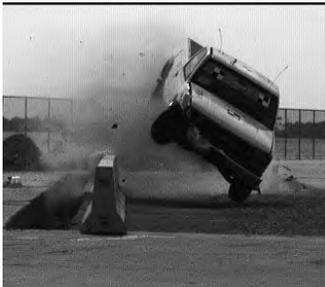
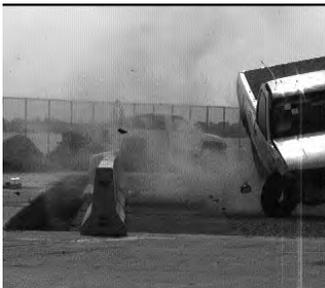
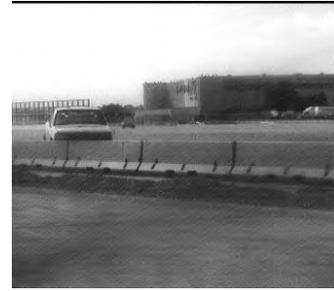
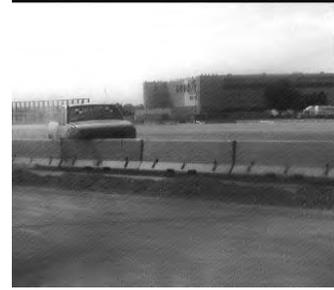
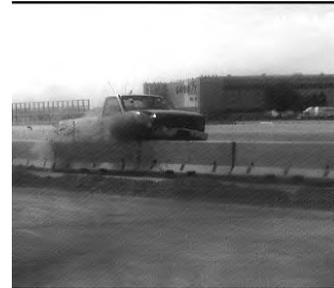
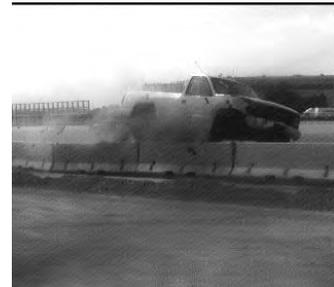
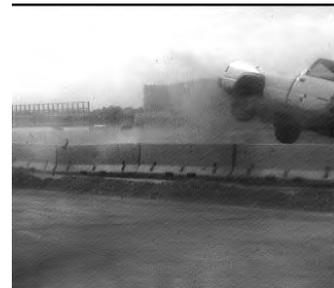
Figure 21. Additional Sequential Photographs, Test FTB-1

For test no. FTB-1, a 2,011-kg (4,434 lbs) pickup truck impacted the asphalt tie-down temporary concrete barrier system at a speed of 98.7 km/hr (61.3 mph) and at an angle of 25.4 degrees. A summary of the test results and the sequential photographs are shown in Figure 20. The summary of the test results and sequential photographs in English units is shown in Appendix B. Additional sequential photographs are shown in Figure 21. Documentary photographs of the crash test are shown in Figure 22 through Figure 25.

The impact point for this test was 1,219-mm upstream of the joint between barrier nos. 8 and 9, as shown in Figure 26. Immediately after impact, the impacted barrier segments began to deflect backwards, and the right-front corner of the pickup truck was deformed inward. At 0.105 sec, the leading edge of the right-front door panel snagged on the joint between barrier nos. 8 and 9. As the vehicle continued to redirect, the asphalt and soil in the impact region fractured and separated from the foundation. However, the separation was not complete, and the barrier segments remained upright and stable on the separated section of roadway. By 0.236 sec, the pickup truck had redirected parallel to the barriers with a speed of 64.9 km/h (40.3 mph). After exiting the barrier at 0.380 sec, the pickup truck continued to move downstream and to the left until coming to rest 69.7-m (228.7-ft) downstream and 6.9 m (22.6-ft) to the left of the original impact point. A summary of the test results and sequential photographs is shown in Figure 20.

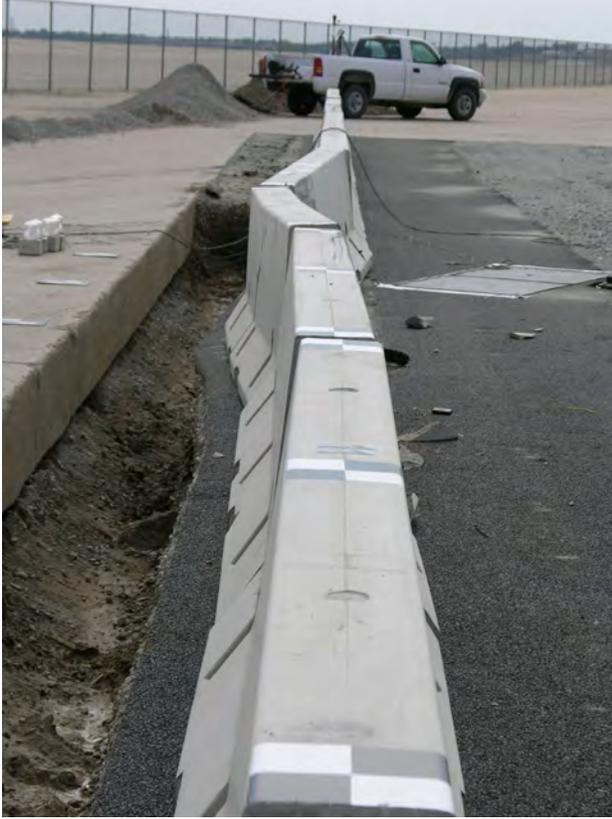
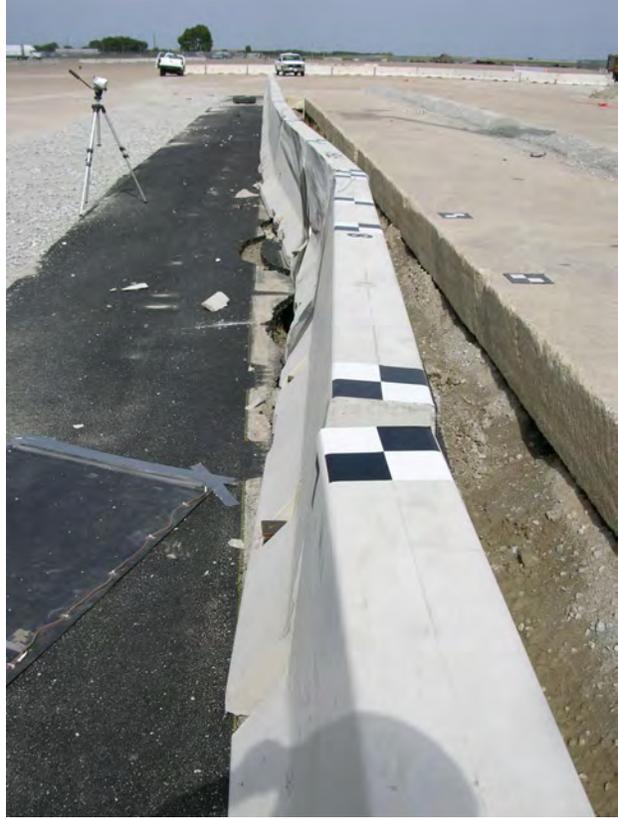
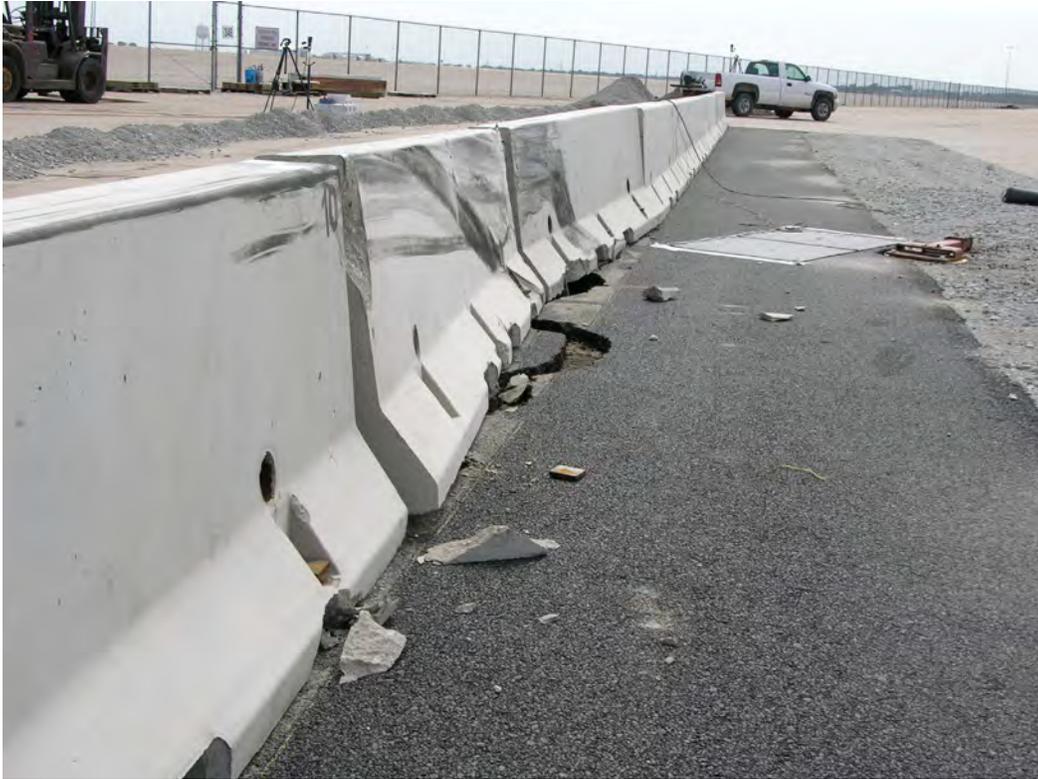
Figure 27. System Damage, Test FTB-1

Damage to the tie-down temporary barrier system was moderate, as shown in Figure 27 through Figure 29. Tire marks, scrapes, and cracking of the concrete were visible on barrier

segment nos. 8 through 10. Barrier section nos. 8 through 10 were deflected laterally. A region of soil and asphalt was observed to fracture and separate from the main road surface beneath the barrier due to loading of the tie-down pins. The separation area was approximately 7.16-m (23.5-ft) long with an average separation of 178 mm (7 in.). Deformation to several of the barrier joints and the tie-down pins was noted in the impact region. Several of the tie-down pins were pulled up between 13 to 51 mm (0.5 to 2 in.) due to barrier rotation. The steel caps on three of the pins in the impact region were disengaged from the top of the pin due to fracture of the welds. No movement of the tie-down pins was noted on the non-impacted barrier segments. Damaged concrete was observed near several of the vertical holes on the front face of the barriers in the impact region, but the reinforcing steel surrounding the holes remained intact and safely around the pins. The maximum permanent set and dynamic barrier deflections were measured to be 283 mm (11.1-in.) and 554 mm (21.8-in.), respectively.

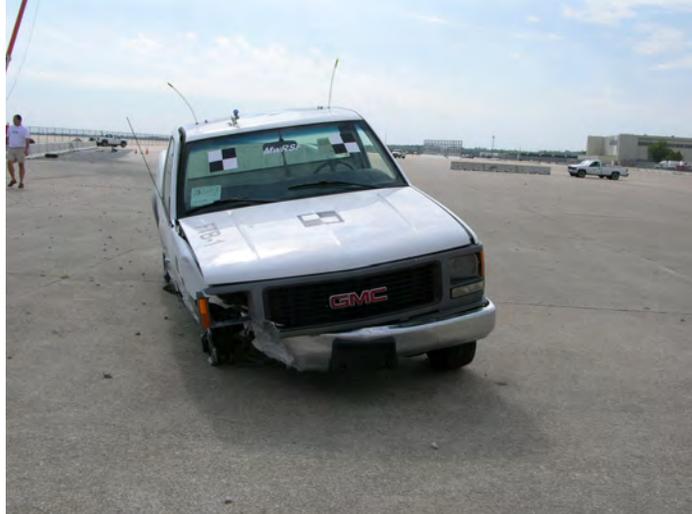
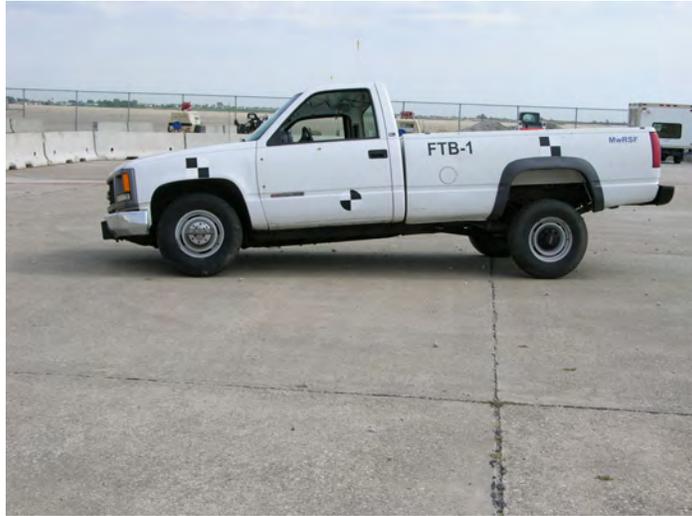
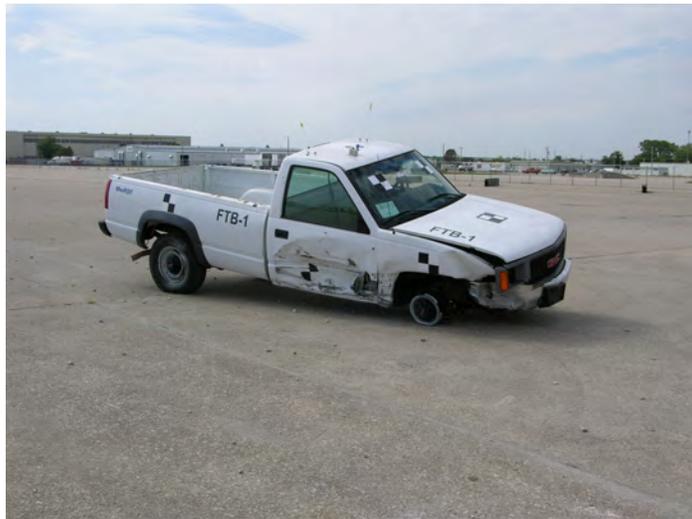
Figure 30. Vehicle Damage, Test FTB-1

Vehicle damage was moderate, as shown in Figure 30 and Figure 31. The majority of the damage to the pickup truck was focused on the right-front corner and right side where the impact occurred, including the right-front bumper, fender, and suspension components. Scrapes and dents from vehicle contact with the barriers were observed on the bottom of the truck bed and the right-side door of the vehicle. A section of the sheet metal on the front edge of the right-side door was torn away due to snagging on a barrier joint. The right-front tire and the outside of the steel rim were disengaged from the main body of the wheel assembly during impact. Minimal damage was observed in the interior occupant compartment of the vehicle, and the maximum deformation of the passenger-side floor pan was 38 mm (1.5 in.). Details from the occupant compartment deformation measurements are located in Appendix C.

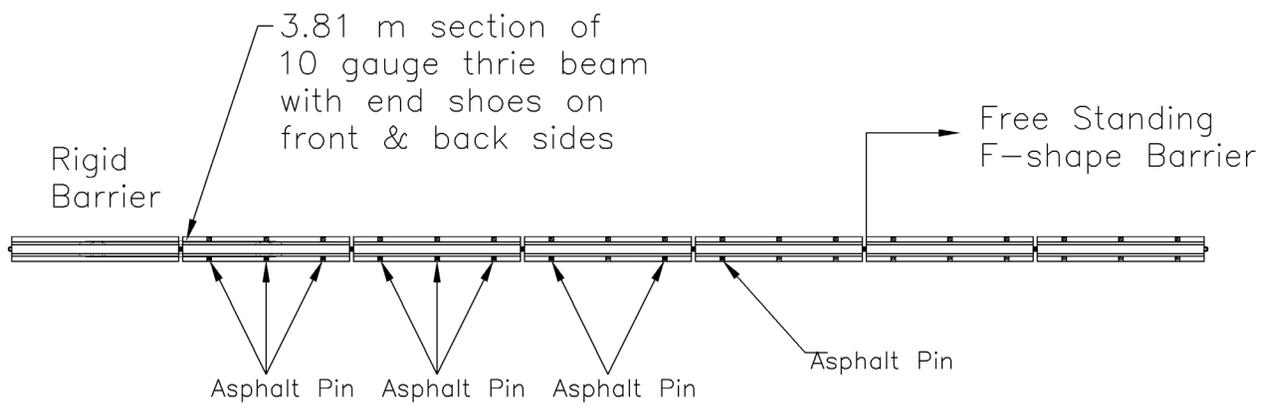
Figure 32. Free-Standing to Rigid Barrier Transition Schematic

Review of the transition design suggested that there were two possible Critical Impact Point (CIP) locations. The first was located at the transition between the free-standing and pinned barriers, and the second was located at the transition from the pinned to the rigid barriers. The researchers believed that the transition from free-standing barrier to pinned barrier was more critical than the transition from pinned barrier to rigid barrier. It was also believed that the

transition from the pinned barrier to the rigid barrier posed little risk of failure and could be waived. The justification for these beliefs was based on the relative deflection of the barriers and the potential for pocketing and snagging at each of the transitions.

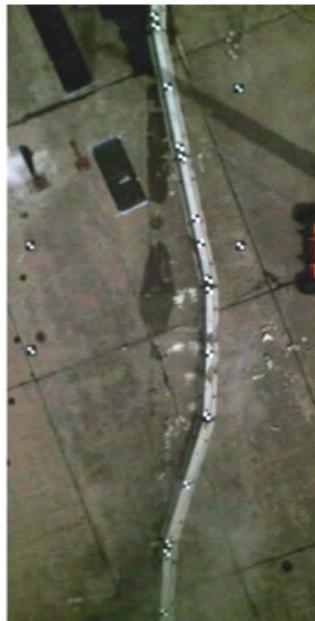
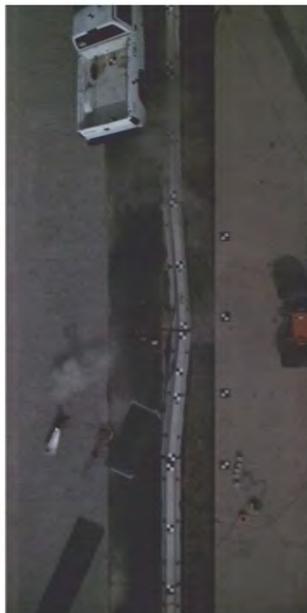
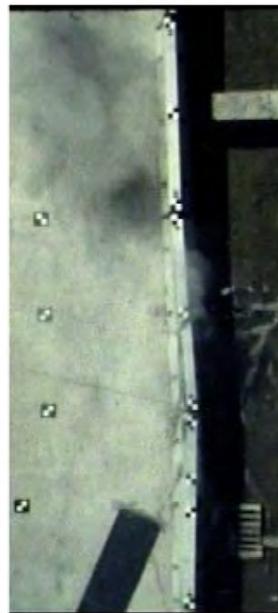
Figure 33. Comparison of F-Shape Barrier Deflections

Figure 33 shows the maximum deflection and deflected shape of the free-standing F-shape barrier, the asphalt pin tie-down system, the bolt-through tie-down system, and a rigid barrier. Review of these deflections and deflected shapes illustrated the critical nature of the transition from free-standing barrier to pinned barrier. First, the difference in the static and dynamic displacements between the free-standing and pinned barriers was much higher than the difference between the pinned and the bolt-through or rigid barriers. The difference in deflection is more pronounced when one considered that the deflection recorded for the asphalt pin tie-down was inflated due to failure of the soil foundation constraining the pins, as discussed previously. Because the difference in the deflection was much higher for the free-standing to pinned barrier transition, there was more potential for pocketing, relative rotation of the barrier joint causing vehicle snag at the joint, and the possibility of the vehicle vaulting the system.

Barrier Type	Maximum Static Deflection at Base of Barrier (mm)	Maximum Dynamic Deflection at Top of Barrier (mm)
Free-standing F-shape	1,140	1,149
Steel pin in asphalt tie-down	283	554
Bolt-through tie-down	89	287
Rigid Barrier	0	0

The second transition in the system, or the asphalt pin tie-down barrier transitioned to a bolt-through tie-down or rigid barrier, had very little potential for pocketing or snag. The difference in the deflections at the base of the barrier was low, which would represent a reduced potential for pocketing. The difference in these deflections is even lower if the soil failure experienced in the asphalt pin tie-down test is not present. In addition, the 10-gauge thrie beam pieces placed across the joint between the asphalt pin tie-down barrier and the rigid barrier would further reduce the potential for pocketing and relative rotation of the barriers at the joint which could lead to vehicle snag. Because the deflection level of the transition barriers and the rigid barrier were relatively close and the addition of the thrie beam across the

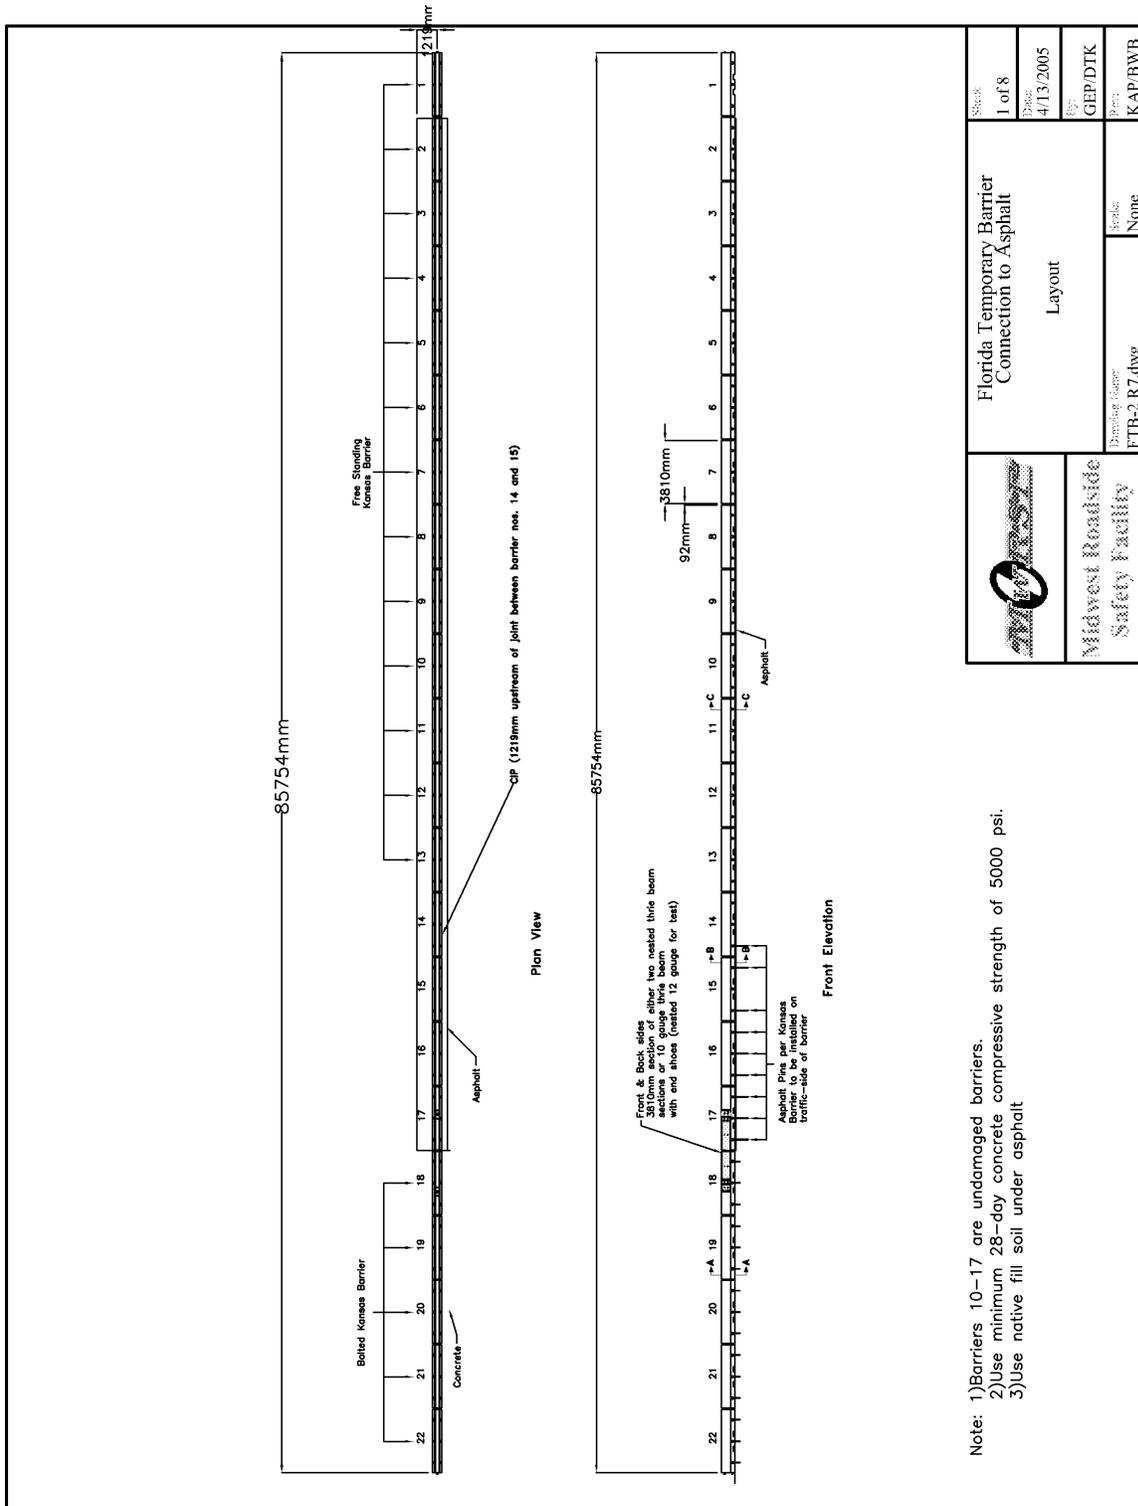
Figure 38. Free-Standing to Rigid Concrete Barrier Transition Details

The transition utilized a varied spacing of the asphalt pin tie-down system to create a transition in stiffness over a series of four barrier segments. The asphalt pins used in the design were 38.1-mm (1.5-in.) diameter x 978-mm (38.5-in.) long A36 steel pins with 76-mm x 76-mm x 13-mm (3-in. x 3-in. x 0.5-in.) A36 steel plates with a 38.1-mm (1.5-in.) diameter hole were

installed in the holes on the front face of the four barriers in the transition section of the installation. It should be noted that the tie-down pins were modified slightly prior to the transition test to prevent the disengagement of the top caps observed in test no. FTB-1. The modified design lengthened the pin 63.5 mm (2.5-in.) and a 38.1-mm (1.5-in.) diameter hole was cut in the steel cap. The cap was then slid onto the pin and welded on both the top and bottom surfaces of the plate 914 mm (36 in.) from the bottom of the pin. This modification strengthened the connection of the cap to the pin but did not change the pin embedment. The modified tie-down pin is shown in Figure 44. The first barrier in the transition had a single pin on the downstream end. The second barrier had pins installed at the two outside hole locations. The final two barriers had all three pins installed. In addition, nested 12-gauge thrie beam was bolted across both sides of the barrier at the joint between the pinned barriers and the rigid barrier system in order to reduce the potential for vehicle snag at the joint. It should be noted that 10-gauge thrie beam could be substituted for the nested 12 gauge in actual installations if desired. The thrie beam was bolted to the barriers using five 19.05-mm (0.75-in.) diameter x 152-mm (6-in.) long, Powers Fasteners Wedge Bolt anchors at each end of the beam.

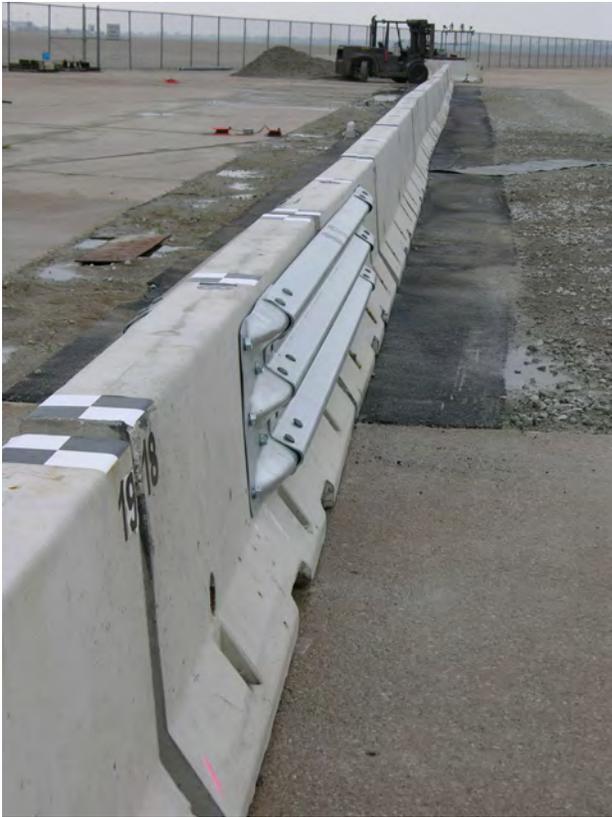
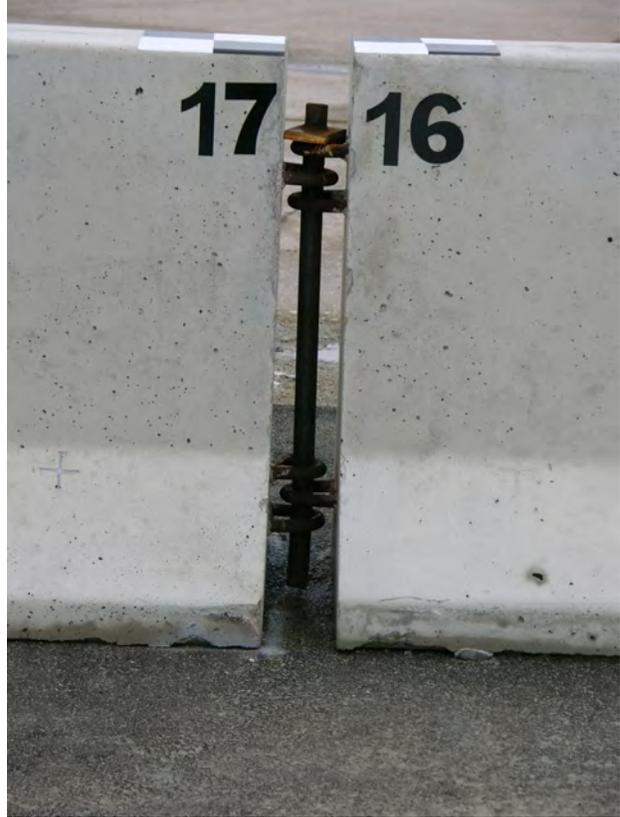
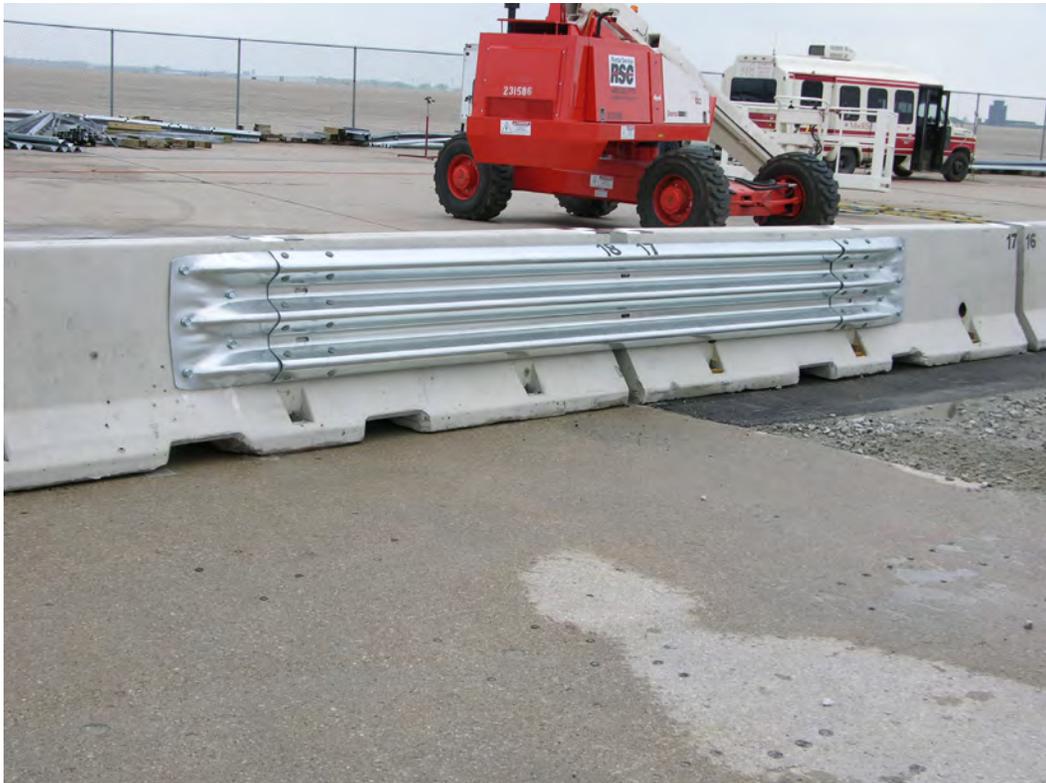
Figure 46. Free-Standing to Rigid Concrete Barrier Transition Photographs

Design details for the transition from free-standing temporary concrete barrier to rigid concrete barrier evaluated in full-scale crash test no. FTB-2 are shown in Figure 38 through Figure 45. The corresponding English-unit drawings are shown in Appendix E. Photographs of the test installation are shown in Figure 46.

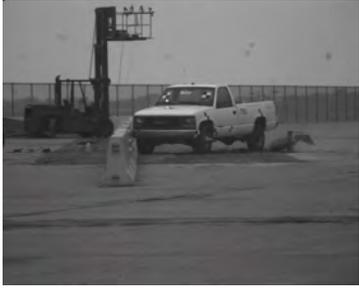
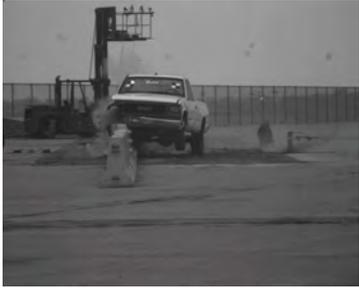
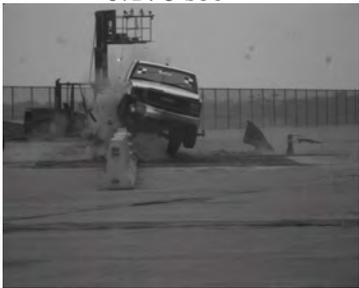
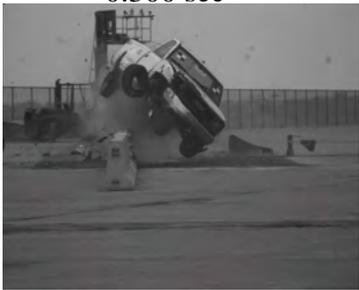
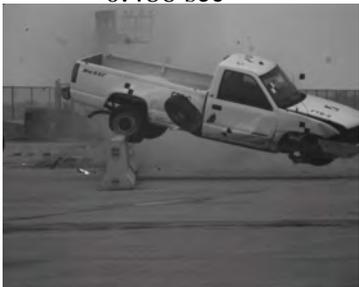
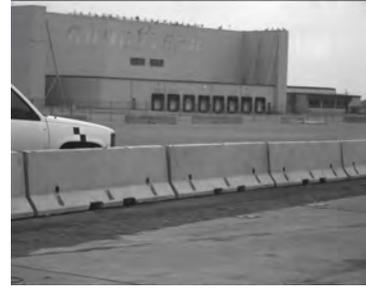
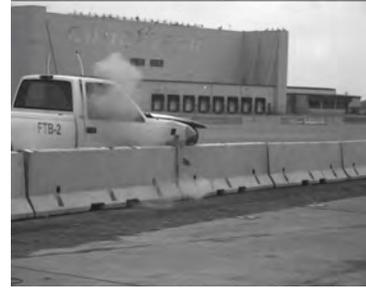
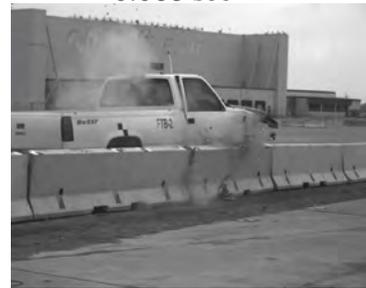
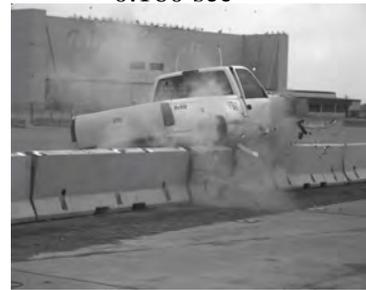
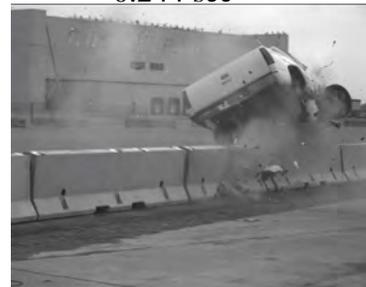
Figure 48. Additional Sequential Photographs, Test FTB-2

For test no. FTB-2, a 2,030-kg (4,475 lbs) pickup truck impacted the asphalt tie-down temporary concrete barrier system at a speed of 102.7 km/hr (63.8 mph) and at an angle of 26.1 degrees. A summary of the test results and the sequential photographs are shown in Figure 47. The summary of the test results and sequential photographs in English units is shown in Appendix F. Additional sequential photographs are shown in Figure 48. Documentary photographs of the crash test are shown in Figure 49 through Figure 52.

The impact point for this test was 1,219-mm upstream of the joint between barrier nos. 14 and 15, as shown in Figure 53. Immediately after impact, the impacted barrier segments began to deflect backwards, and the right-front corner of the pickup truck was deformed inward. The vehicle climbed the face of the barrier as it began to redirect causing it to pitch upward and roll to the left. By 0.242 sec, the pickup truck had redirected parallel to the barriers with a speed of 66.9 km/h (41.6 mph). As the vehicle continued to redirect, the left-front tire of the truck contacted the ground, which caused the vehicle to yaw counterclockwise. At 1.206 sec, the right-rear tire and the pickup truck box landed on the top of the barrier on the traffic side before exiting the system. After exiting the barrier at approximately 1.500 sec, the pickup truck continued to move downstream until coming to rest 62.4-m (204.7-ft) downstream and 1.4 m (4.6-ft) to the left of the original impact point. A summary of the test results and sequential photographs is shown in Figure 47.

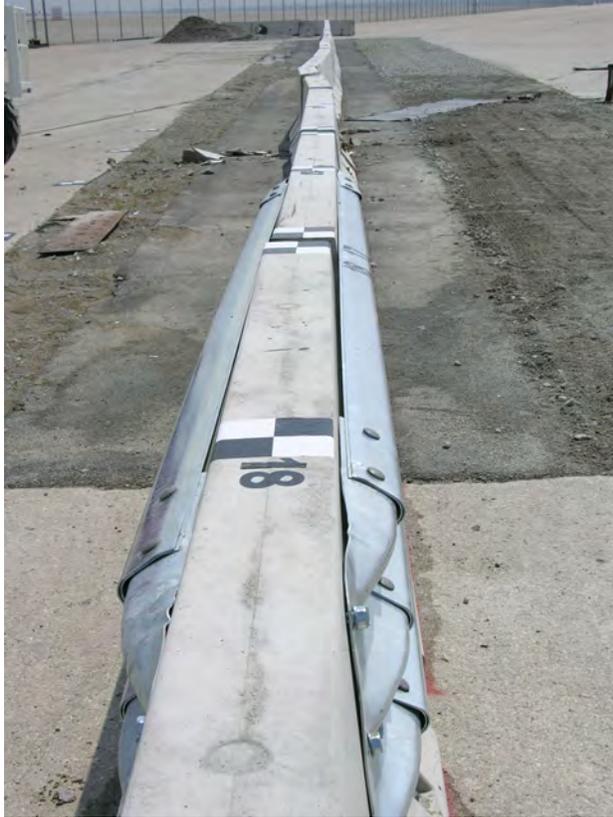
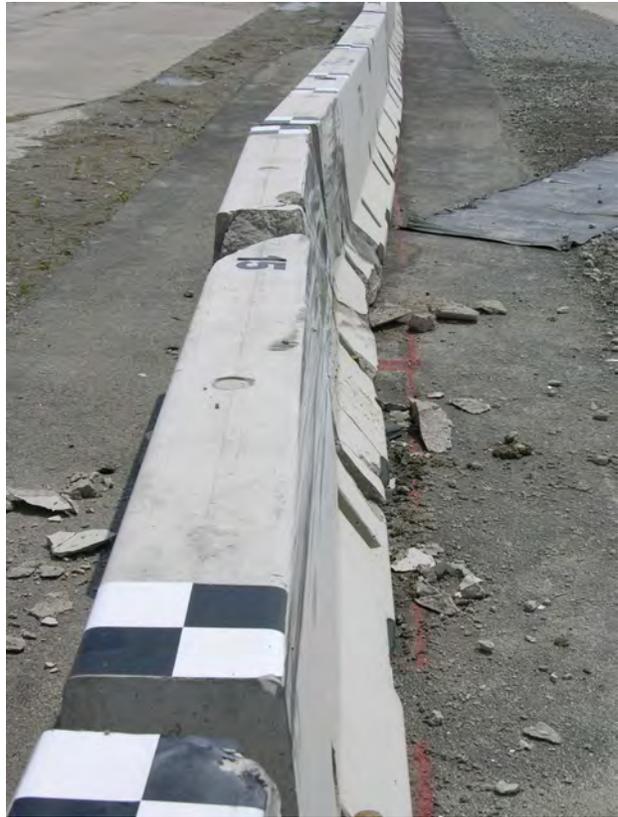
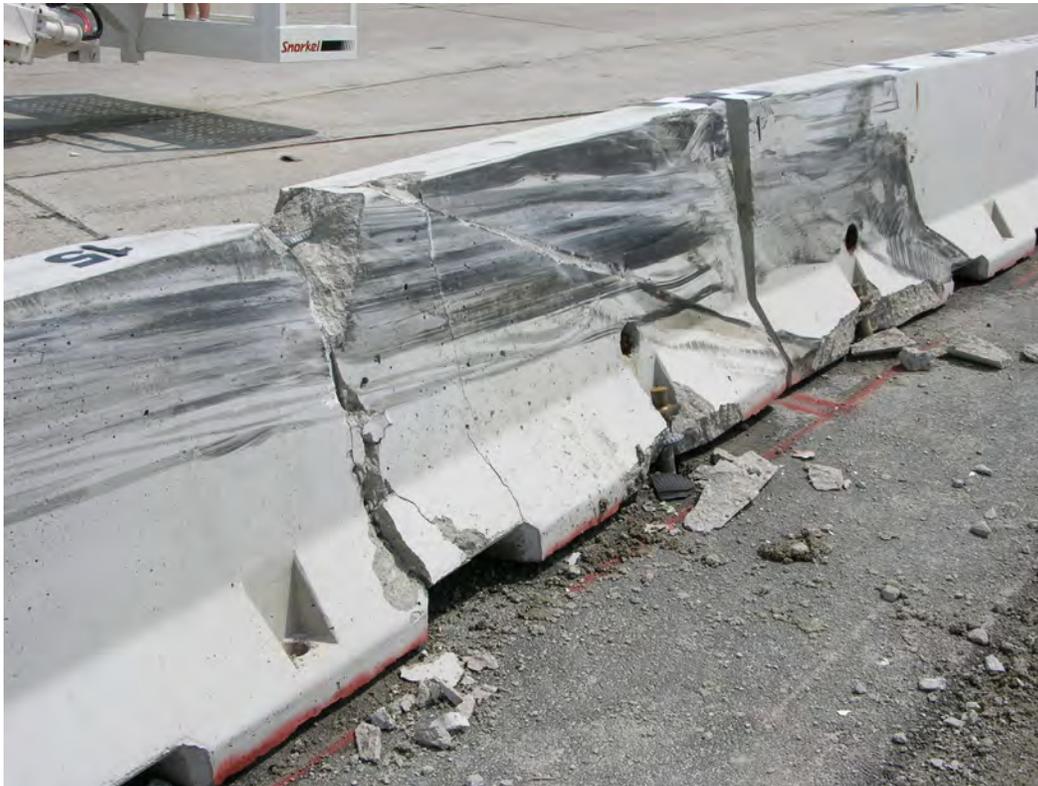
Figure 54. System Damage, Test FTB-2

Damage to the transition was moderate, as shown in Figure 54 through Figure 56. Tire marks, scrapes, and cracking of the concrete were visible on barrier segment nos. 14 through 16. Barrier segment nos. 14 through 16 were deflected laterally. Barrier no. 15 was cracked and completely fractured through the midsection of the barrier, but the reinforcing steel remained intact. Deformation to several of the barrier joints and the tie-down pins was noted in the impact region. Several of the tie-down pins were pulled up between 13 to 102 mm (0.5 to 4 in.) due to barrier rotation. No movement of the tie-down pins was noted on the non-impacted barrier segments. Damaged concrete was observed near several of the vertical holes on the front face of the barriers in the impact region, but the reinforcing steel surrounding the holes remained intact and safely around the pins. The maximum permanent set and dynamic barrier deflections were measured to be 133 mm (5.25 in.) and 467 mm (18.375 in.), respectively.
