1. Report No. TRP-03-180-06	2.	3. Recipient's Accession No.	
4. Title and Subtitle DEVELOPMENT OF TIE-DOWN AND TRANSITION SYSTEMS FOR TEMPORARY CONCRETE BARRIER ON ASPHALT ROAD SURFACES		5. Report Date February 23, 2007

9. Performing Organization Name and Address Midwest Roadside Safety Facility (MwRSF) University of Nebraska-Lincoln 527 Nebraska Hall Lincoln, Nebraska 68588-0529		10. Project/Task/Work Unit No.

**DEVELOPMENT OF TIE-DOWN AND
TRANSITION SYSTEMS FOR TEMPORARY
CONCRETE BARRIER ON ASPHALT ROAD
SURFACES**

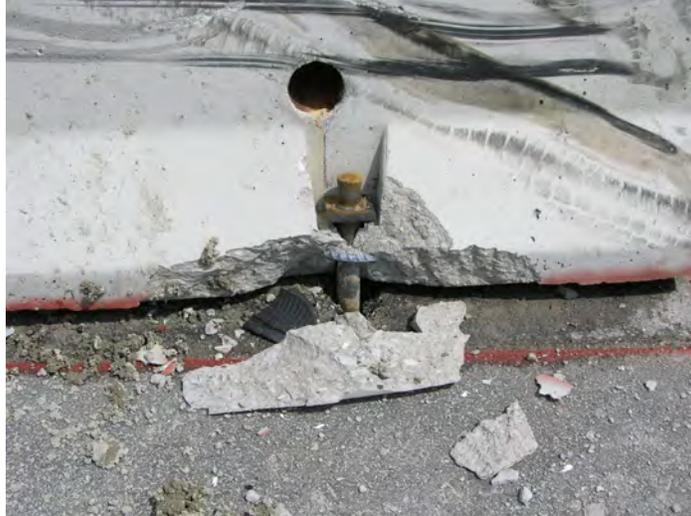
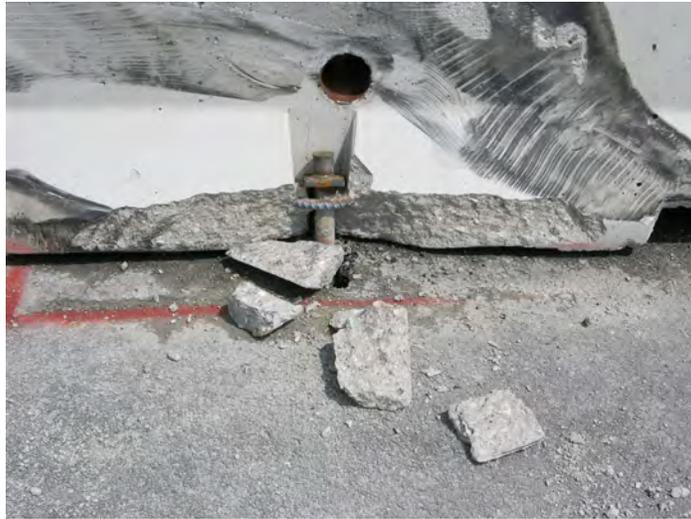
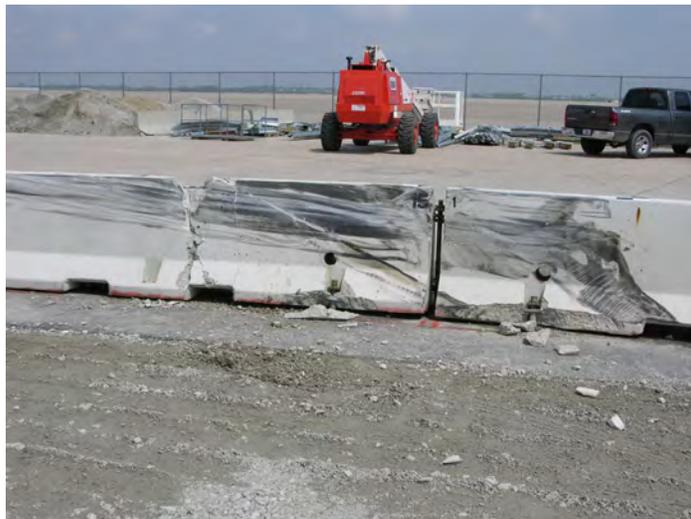
Figure 55. System Damage, Test FTB-2

Damage to the transition was moderate, as shown in Figure 54 through Figure 56. Tire marks, scrapes, and cracking of the concrete were visible on barrier segment nos. 14 through 16. Barrier segment nos. 14 through 16 were deflected laterally. Barrier no. 15 was cracked and completely fractured through the midsection of the barrier, but the reinforcing steel remained intact. Deformation to several of the barrier joints and the tie-down pins was noted in the impact region. Several of the tie-down pins were pulled up between 13 to 102 mm (0.5 to 4 in.) due to barrier rotation. No movement of the tie-down pins was noted on the non-impacted barrier segments. Damaged concrete was observed near several of the vertical holes on the front face of the barriers in the impact region, but the reinforcing steel surrounding the holes remained intact and safely around the pins. The maximum permanent set and dynamic barrier deflections were measured to be 133 mm (5.25 in.) and 467 mm (18.375 in.), respectively.

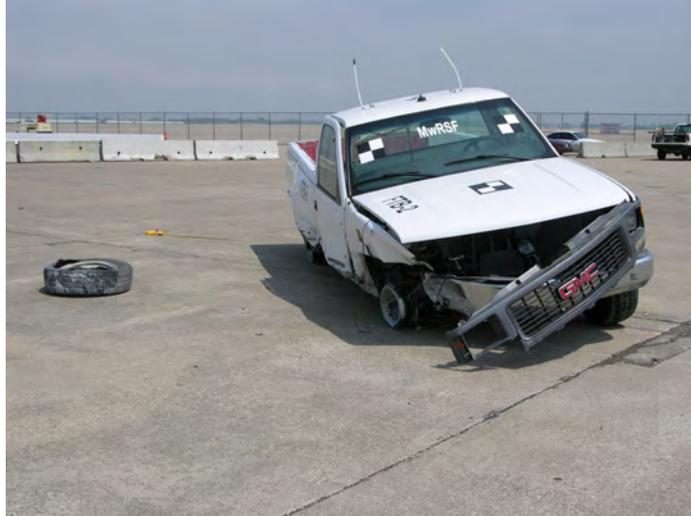
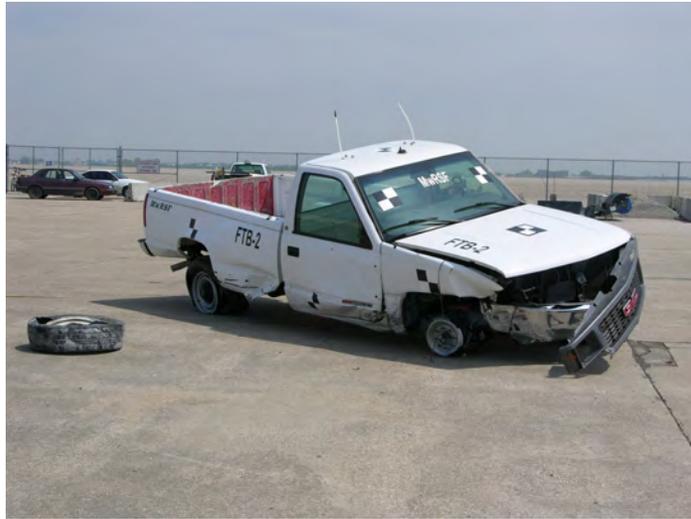
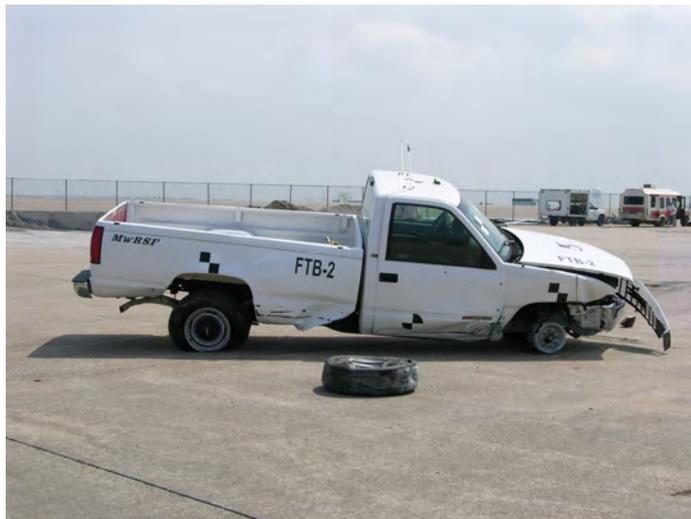
Figure 57. Vehicle Damage, Test FTB-2

Vehicle damage was moderate, as shown in Figure 57 and Figure 58. The majority of the damage to the pickup truck was focused on the right-front corner and right side where the impact occurred, including the right-front bumper, fender, and suspension components. Scrapes and dents from vehicle contact with the barriers were observed on the lower portion of the truck bed and the right-side door of the vehicle. A large indentation was also visible on the right-front edge of the truck box. The right-front tire and the outside of the steel rim were disengaged from the main body of the wheel assembly during impact. Minimal damage was observed in the interior occupant compartment of the vehicle, and the maximum deformation of the passenger-side floor pan was 102 mm (4 in.). Details from the occupant compartment deformation measurements are located in Appendix G.
