Job Stamp 04-0120F4 SFOBB SAS

Report No.	Should be typed			
Date	12/13/2007			
Inspectors	Start	0700	Stop	1500
Hours				
Shift Hours	Start	0630	Stop	1500

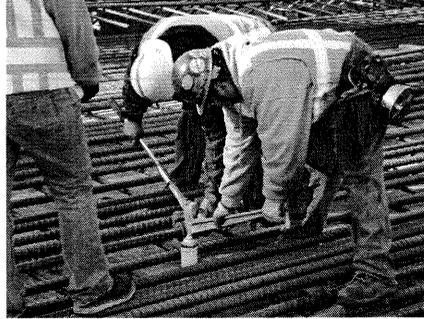
Figure 1

- Tim and Jorge started the coupling with their own risk, because they are waiting approval from Caltrans on certifications (see Figure 1). Make sure that they apply 400 lb torque for the coupling (see Figure 2). Marked with orange painter (see Figure 3)
