Job Stamp 04-0120F4 SFOBB SAS
-------------------------------------

**ASSISTANT RESIDENT ENGINEER'S CONTRACTOR – ABFJV**

**Description of Operation:**

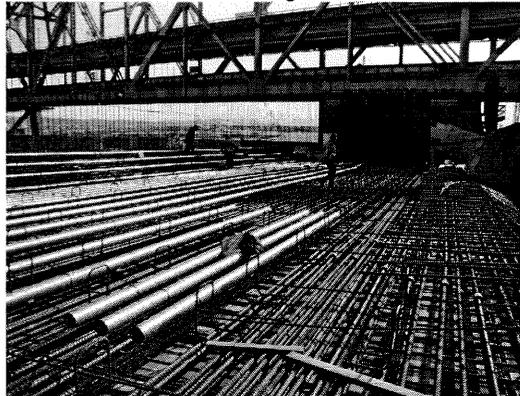
Figure 1

- See Lalit Mathur's diary for ABF labor, equipment, materials and comments.
- **Daily Activity of Regional Steel:**
  - Regional Steel crews start placing P.T. ducts, which are located within Layer B3 (see Fig. 1).

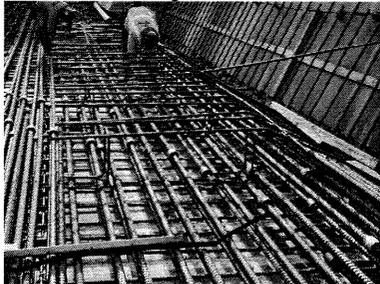
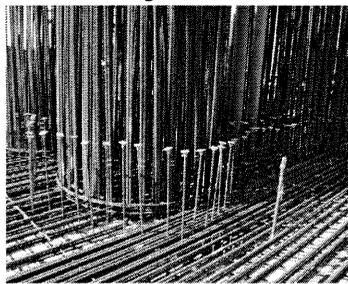
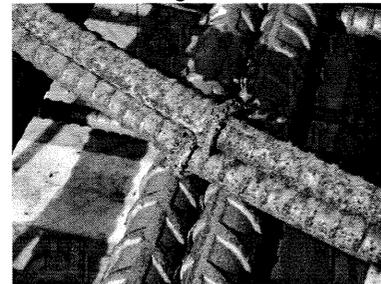
- Place B3 transverse bars, and hoops, which are ultimate butt splices (see Figs 2,3 and 4).
  - Figure 2
  - Figure 3
  - Figure 4

- Found roughly 20 couplers which have been loosed after the torque (see the video which file name is MOV00409.MPG under X:\SAS\Users\Song\Construction Photos\W2 Cap Beam\2007 12 21 directory). Regional steel crews, mainly Jason and John, tighten them together again.
- Inform Daniel Gomez that the splices in adjacent hoops need to be staggered (see Fig. 4).
- See Pamela Gagnier's diary for punch list
- See Matt Bruce's diary for detailed activities and comments related to post-tensioning, e.g. placing ducts.
