STATE OF CALIFORNIA	Job Stamp	7-day Const. Calendar	Day No. 391
DEPARTMENT OF TRANSPORTATION	SFOBB SAS	Project Work Day No.	Day No. 601
Form HC-10A (Rev. 6/80)	04-0120F4	Date	01/08/2008

ASSISTANT RESIDENT ENGINEER'S

Daily for Regional Steel

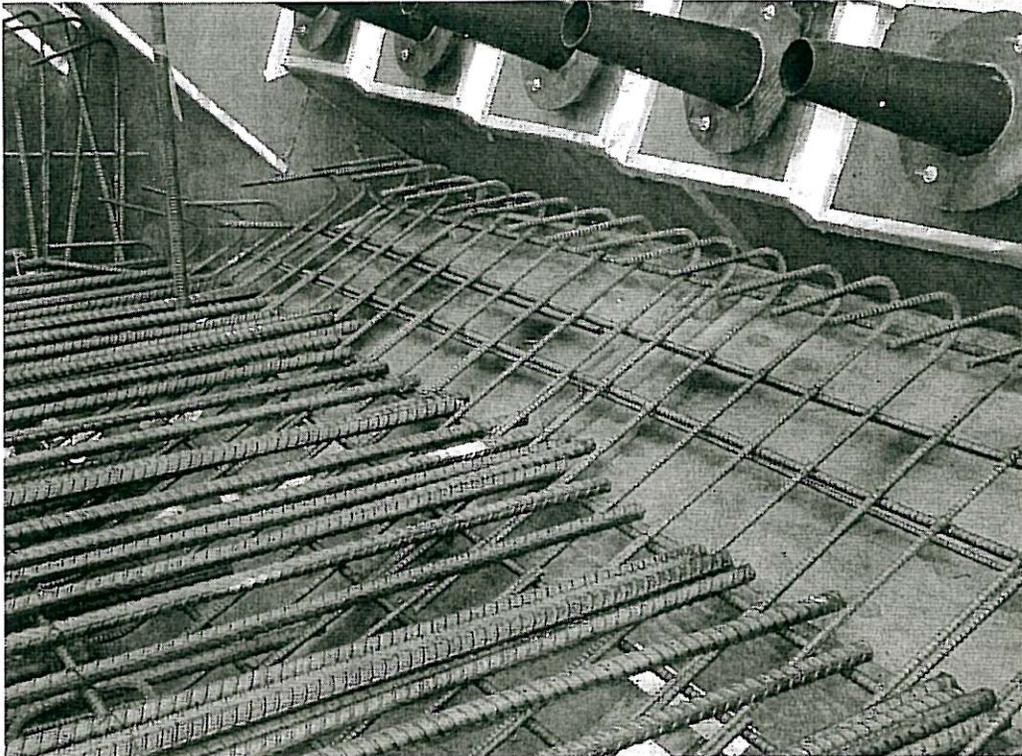
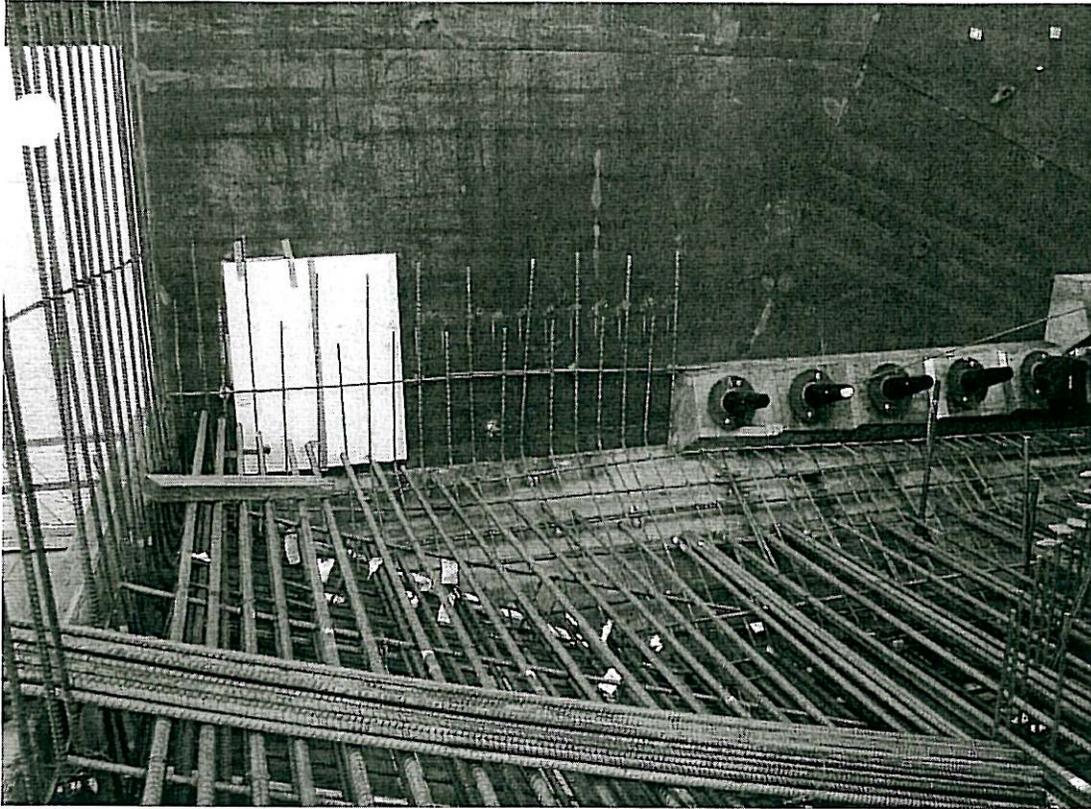
§ Reinforcement:

RSC continues to place pre-fabricated below columns of hoops around columns at W2W. RSC will need to correct the spacing of individual hoops. Approximately 5 – 7 hoops were placed.  
RSC started placing #19 skin rebar at the north end. See sheet 497S12 and 497S13 of 1204. See photo below.  
F started to place east face interior skin bars #25V11. See sheets 497S15 thru 497S17.  
RSC torqued some B2 transverse couplers today using 2007/253082 wrench. See S.H. Song's diary for comments. See photo below.
