STATE OF CALIFORNIA	Job Stamp	7-day Const. Calendar	Day No. 394
DEPARTMENT OF TRANSPORTATION	SFOBB SAS	Project Work Day No.	Day No. 604
Form HC-10A (Rev. 6/80)	04-0120F4	Date	01/11/2008

ASSISTANT RESIDENT ENGINEER'S

Daily for Regional Steel

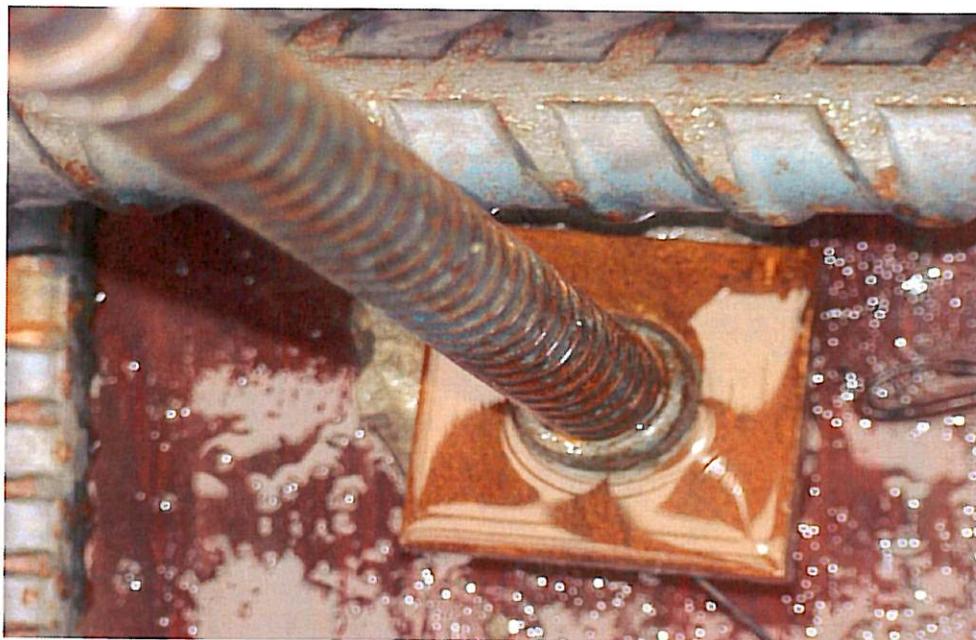
Transverse diaphragm vertical reinforcement - embedded T-head

RSC continue to work on transverse diaphragm reinforcement bars #25VTDO1, #29HVTO1 and #29HVTO2. See sheet 497S2 of 1204. Today they adjusted the elevation of the T-heads to impede into the 80 mm clearance already in place and installed addition bars. See photos below.

2. A. Sanjines and D. Hirschfeld (TYLin) were on site today to discuss and observe vertical transverse diaphragm reinforcement. Discussed with A. Sanjines was the spacing of the transverse diaphragm bars (plans do not indicate spacing). RSC spaced the #25VTDO1 at 250 mm on center and the #29HVTO1 bars at 300 mm on center. By doing this the T-heads do not engage at all intersections of B4 longitudinal and transverse bars but do engage below B4 matt. A. Sanjines accepts the spacing of the bars and the embedded locations because the bars are engaging with the #43 transverse bars. In addition this spacing has increased the number of #25VTDO1 to 41 (plans call for 33) per row and 17 of the #29HVTO1 (plans call for 13) per row this was discussed with A. Sanjines the increased number of bars is accepted in this location however to limit increasing the number of bars through-out the W2. A. Sanjines has requested the percent of T-heads engaging at the intersection of B4 longitudinal/transverse bars after all have been placed.

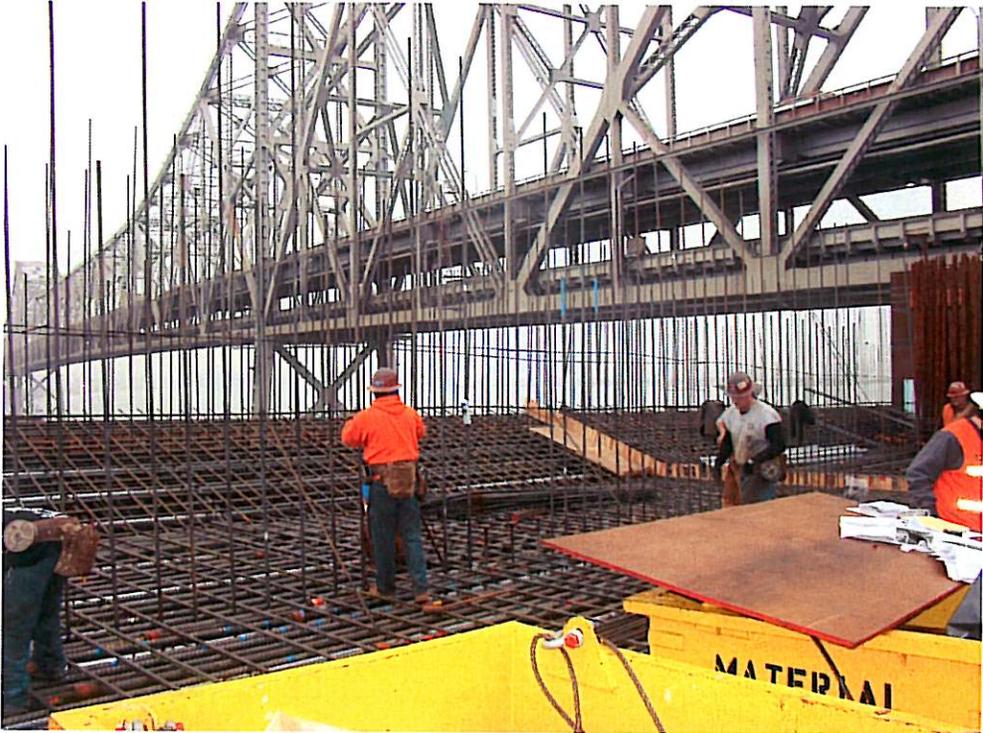
Placing transverse diaphragm vertical bars.

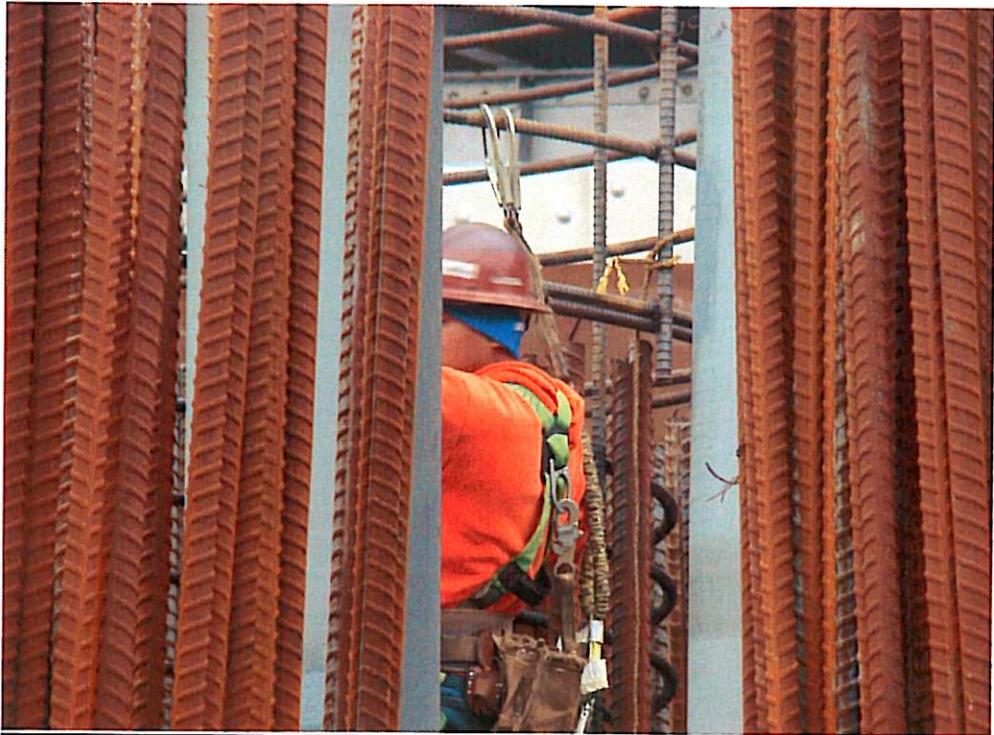
Photo Note 1: Ironworker tied off on column hoop.

1. I discussed with Dave Russ (ABF) about safety issues regarding ironworkers not being tied off or having three-point connection when using the 20' ladder to assist in placing hoops around vertical bars. Dave indicated that RSC is performing proper safety measures on the ladder. Also we discussed utilizing plywood set on top of placed reinforcement to provide safer surface for walking on the rebar. Dave indicated that each time plywood is placed on top of rebar the ironworkers remove it because it is in the way of their work. See photos below of working ironworker on ladder.
