STATE OF CALIFORNIA	Job Stamp	7-day Const. Calendar	Day No. 411
DEPARTMENT OF TRANSPORTATION	SFOBB SAS	Project Work Day No.	Day No. 621
Form HC-10A (Rev. 6/80)	04-0120F4	Date	01/28/2008

ASSISTANT RESIDENT ENGINEER'S

Daily for Regional Steel

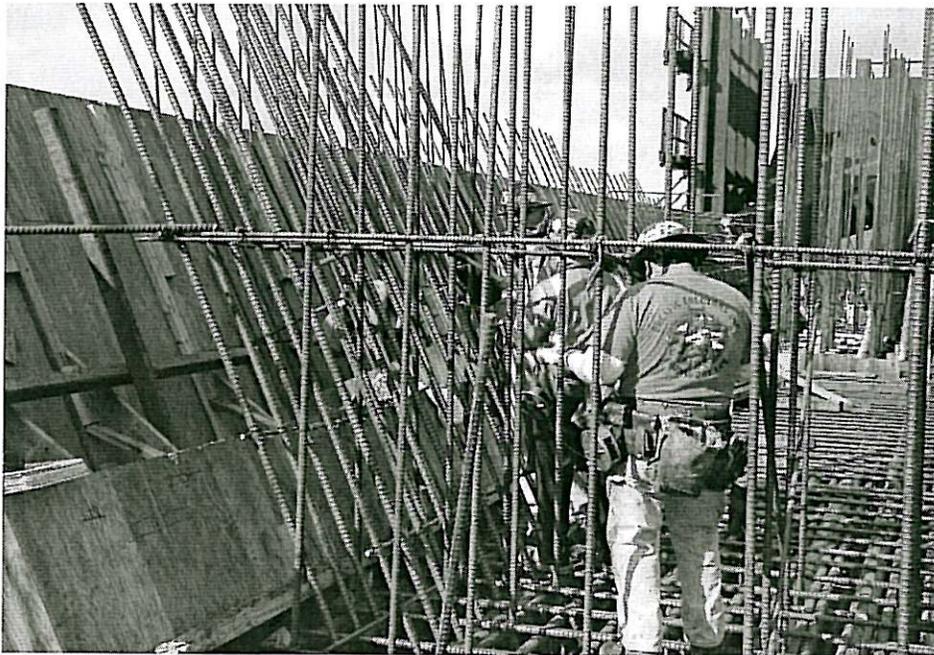
RSC is working on punch list items, profiling PT ducts and finishing vertical stir-ups on the north side. RSC installed jacking saddle rebar 36-#29HVO1 sheet 497S6R1. See photo below.

Jacking Saddle Rebar 36-#29HVO1 sheet 497S6R1

- Bike path rebar
 - Rebar for jacking saddle 36-29HVO1 sheet 497S6R1 and #19 (Total 18) sheet 497S9R1 Section E-E coupled bars embedded into pour 1.
