Job Stamp 04-0120F4 SFOBB SAS

Description of Operations @ W2 Cap Beam:

EA	04-0120F4
Co-Rte-KP (PM)	SF-080-13.2/13.9 (8.2/8.7)
Structure Rep.	Rick Morrow

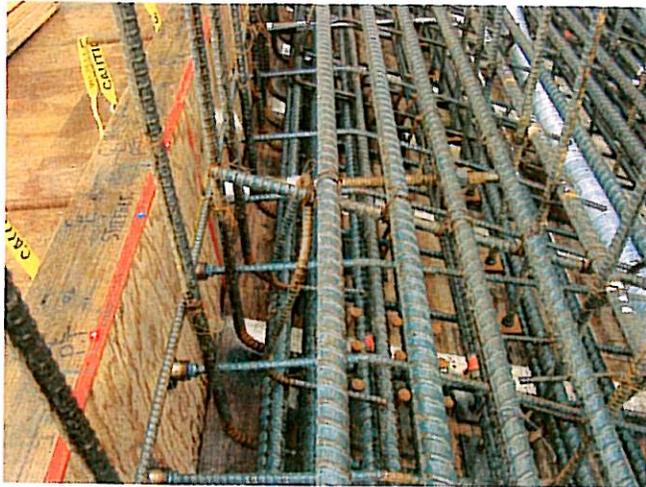
File Name:	DSC00775		
Date:	02-01-08	By Int:	S Song

- Placed #16 angle bars near the trumpet near the CBT blockouts in the south. See sheets 499R2, 504R1, 505R1, and Pamela's diary for more details
- Continued to address punchlist items see Pamela's diary for details.
- Spirals still need to be centered over the bearing plate, the spiral pitch needs to be adjusted, and the proper distance between the bearing plate and the spiral reinforcing needs to be maintained.
- Installed #19 formsavers at the W2E bulkhead, see picture below.

Description: Installation of #19 form-savers near W2E OBG bulkhead.

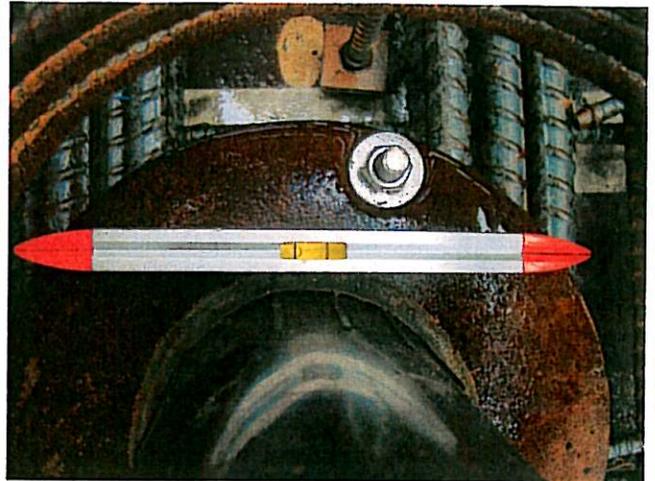
File Name:	DSC00789		
Date:	02-01-08	By Int:	S Song

Description: VT near W2E bearing plate not plumb.

- Clean-up of forms (picking-up tie wire, vacuuming) in the south 1/3 section in preparation for the concrete placement scheduled for Tuesday February 5th.
- Continued to address falsework punchlist items.
- Construction of the stay-form blockout for the vertical bars continues in the northwest corner of the W2 cap beam. Also construction of stay forms continued on the north 1/3 section.
- Installed Hinge K embedded plates used to support Macalloy bars.
- Notified Branden Bedwell that VT 1, 7, 14, & 16 blockouts/bearing plates near W2E marked in yellow on the duct need to be plumb, see picture below. He indicated that RPS is aware that the spirals need to be fixed in addition to the bearing plate being plumb.

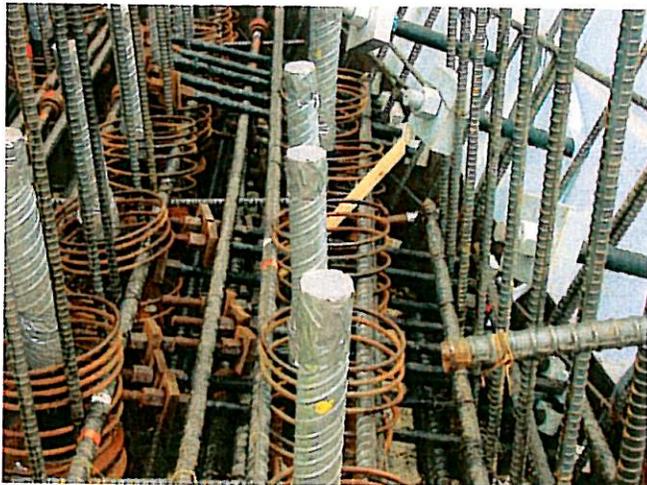
File Name:	DSC00790		
Date:	02-01-08	By Int:	S Song

Description: Bearing plates/blockouts that were not plumb and marked yellow as seen on the duct.

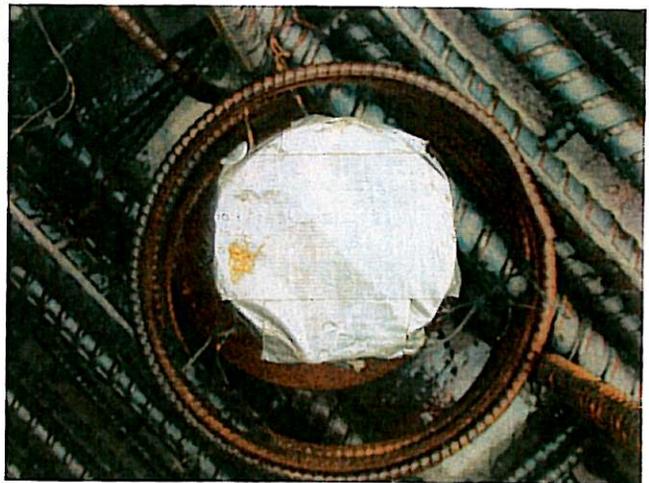
File Name:	DSC00783		
Date:	02-01-08	By Int:	S Song

Description: Spiral not centered over the bearing plate
