Job Stamp 04-0120F4 SFOBB SAS

ASSISTANT RESIDENT ENGINEER'S **CONTRACTOR – ABFJV, Sub RPS & Conco**

Description of Operations @ W2 Cap Beam:

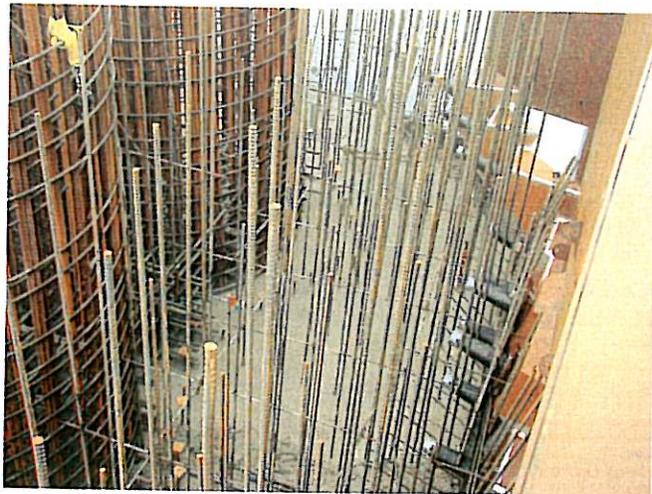
File Name:	DSC001
Date:	02-08-08
By Int:	M Bruce

Description: Concrete placed in the northwest corner. Conco started to place concrete around 7:30am.

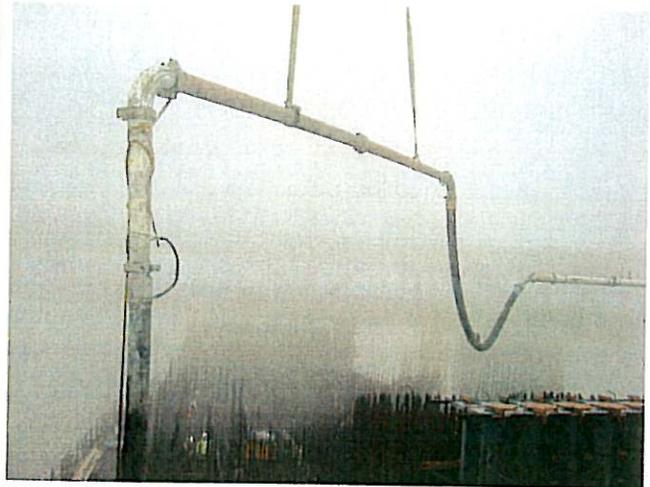
File Name:	DSC005
Date:	02-08-08
By Int:	M Bruce

Description: A boom extension was installed around 10:45am to reach the east sections of the W2 cap beam. The Liebherr crane (located to the west of the W2 cap beam) was used to spot the boom extension as seen in the photo above.

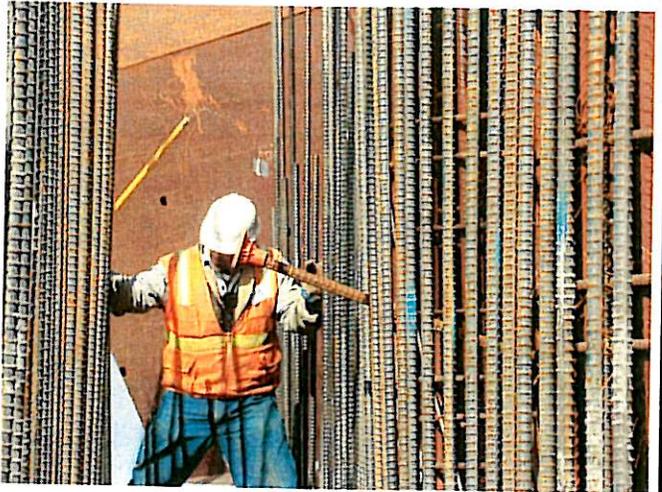
File Name:	DSC008
Date:	02-08-08
By Int:	M Bruce

Description: Water spraying operation began at 12:40pm in the northwest corner.

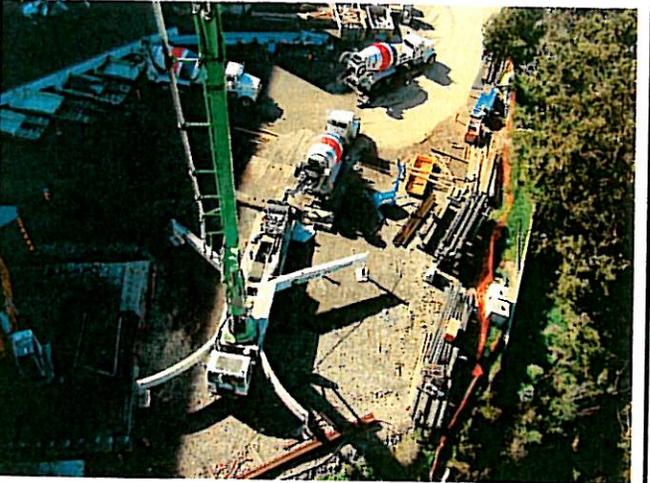
File Name:	DSC009
Date:	02-08-08
By Int:	M Bruce

Description: Concrete pump was located on the northwest side of the W2 cap beam. Crane mats and gravel were used to construct a level surface for the concrete trucks.

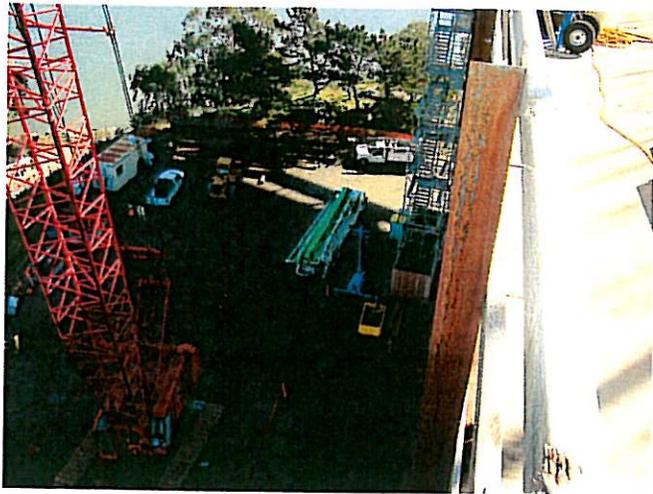
File Name: DSC011
 Date: 02-08-08 By Int: M Bruce
 Description: Back-up concrete pump was located on the southeast side of the W2 cap beam.

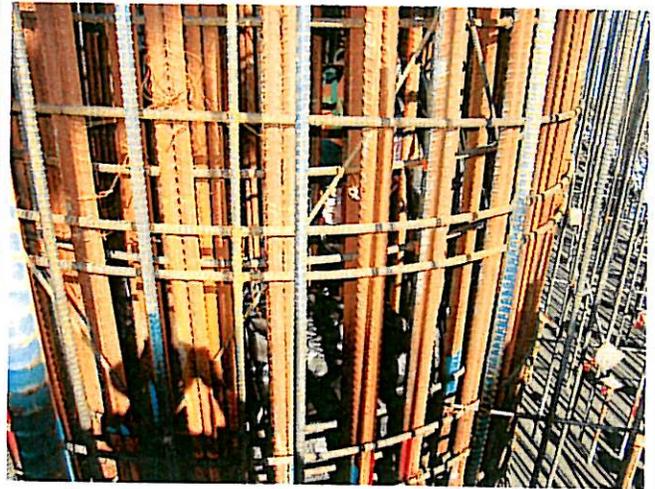
File Name: DSC013
 Date: 02-08-08 By Int: M Bruce
 Description: Curing mat placement inside the southwest cage at W2W on top of the L & T-bars looking east. This task started at 2:50pm.

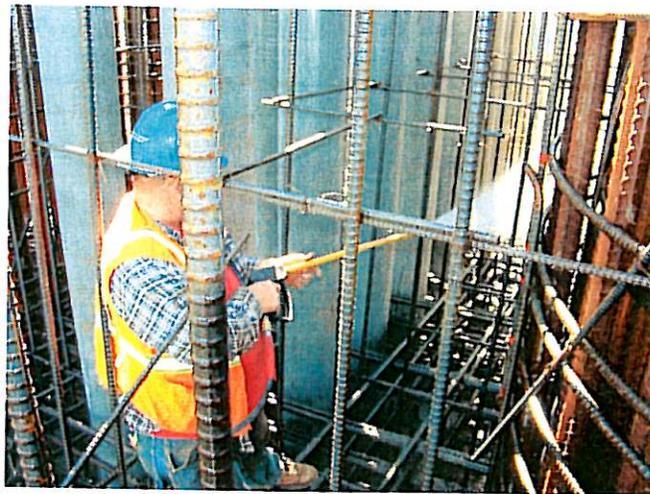
File Name: DSC014
 Date: 02-08-08 By Int: M Bruce
 Description: Water spraying was done every 20-30min until curing mats were placed.

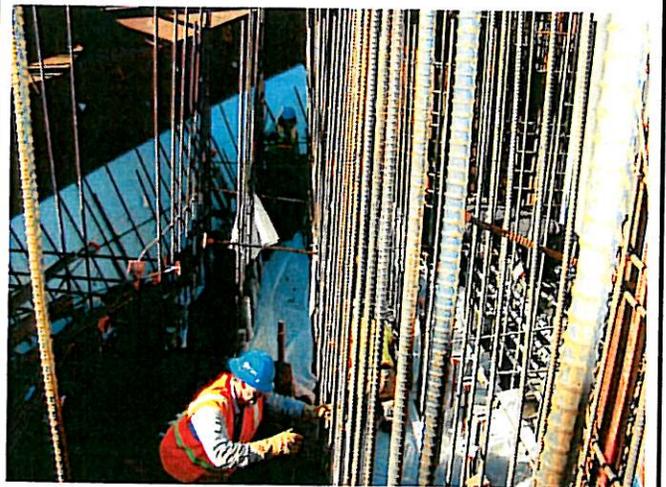
File Name: DSC019
 Date: 02-08-08 By Int: M Bruce
 Description: Concrete placement ended at 4:00pm with no significant problems during this operation. ABF began placing curing mats approximately around 4:10pm.
