Job Stamp  
04-0120F4  
SFOBB SAS

**Description of Operations @ W2 Cap Beam:**

EA	04-0120F4
Co-Rte-KP (PM)	SF-080-13.2/13.9 (8.2/8.7)
Structure Rep.	Rick Morrow

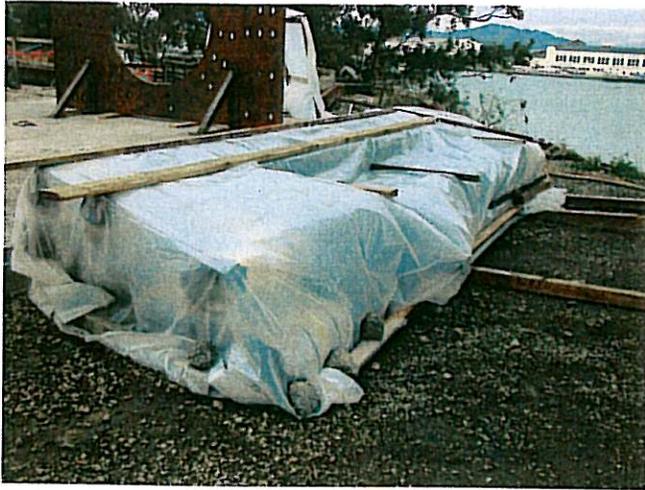
File Name:	DSC00911
Date:	02-23-08
By Int:	M Bruce
Description: Macalloy rods covered with plastic, which was secured down with rocks, rebar, and lumber.

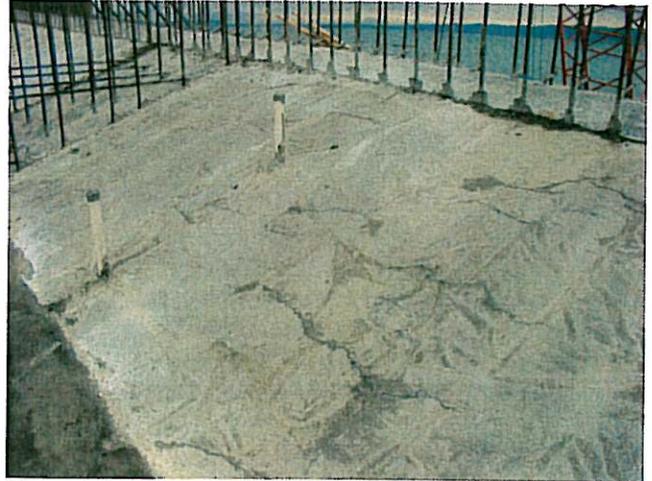
File Name:	DSC00999
Date:	02-23-08
By Int:	M Bruce
Description: Surface cracks on the east sloped portion of the center base slab.

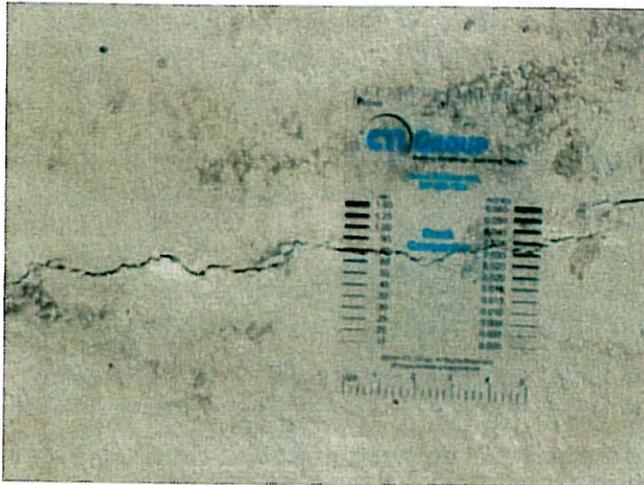
File Name:	DSC01001
Date:	02-23-08
By Int:	M Bruce
Description: Crack found on the east slope which was 0.80mm using a crack comparator.

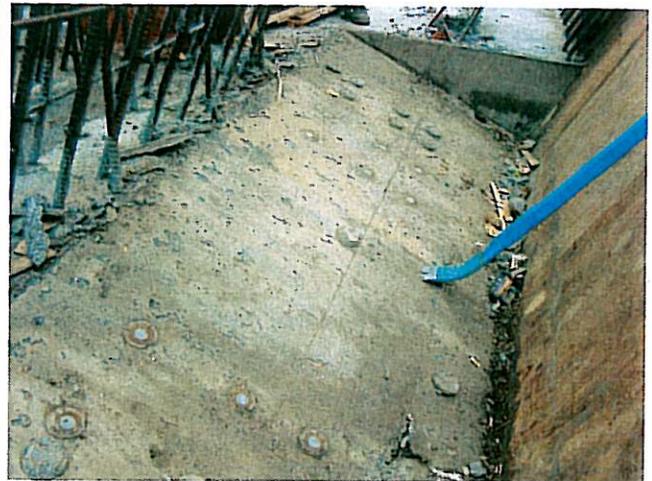
File Name:	DSC01005
Date:	02-23-08
By Int:	M Bruce
Description: Removal of the jacking saddle forms.
