Job Stamp
04-0120F4
SFOBB SAS

Assistant Structure Rep.'s Daily Report

Location & Description of Operation	SAS-Temporary towers, Tower A & B foundation
Weather	HI: 63 F Low: 45 F Partly cloudy

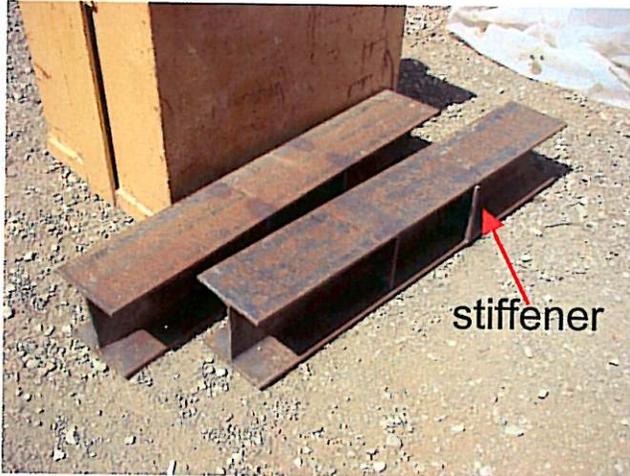
Fig 1. Beam with stiffeners

- Daily activity of contractors
 - Drill tech cleaned A1 footing
 - Drill tech prepared a testing beam with stiffeners and a dial gage for testing, which will be held on Monday (Fig 1).
 - See Art Pannu, Damon Brown, Gina Rizzardo, Thanh Le and Abdikarim Ali's diaries for additional contractors' activities and comments.

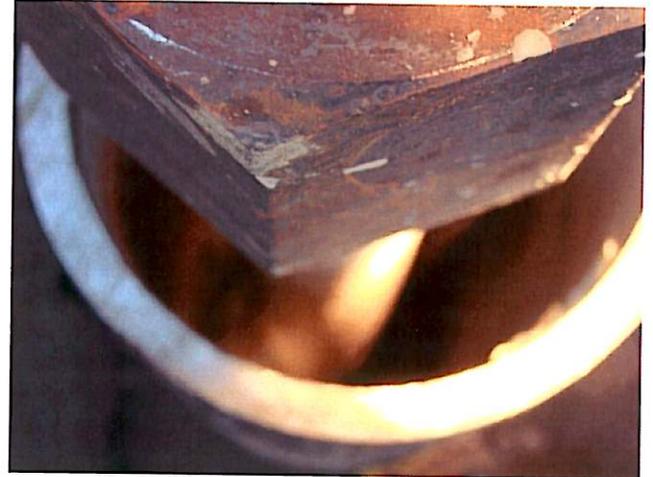
Fig 2. Checked recession after grouting

- Checked recession after grouting (see Fig 2). #2 hole has 50" from top of the casing (see Attachment #1). Let Brad and Art know about it.
- Checked the angle of the battered pile (see Attachment #2).
- Drill Tech crews left early.
- Parts of scaffold are on-site, which will be used for the access between W2 footing and A1 (see Fig 3)
- Steel parts for B1 working platform are on-site (see Fig 4).
- 2 hours O.T. due to preparation of the testing.

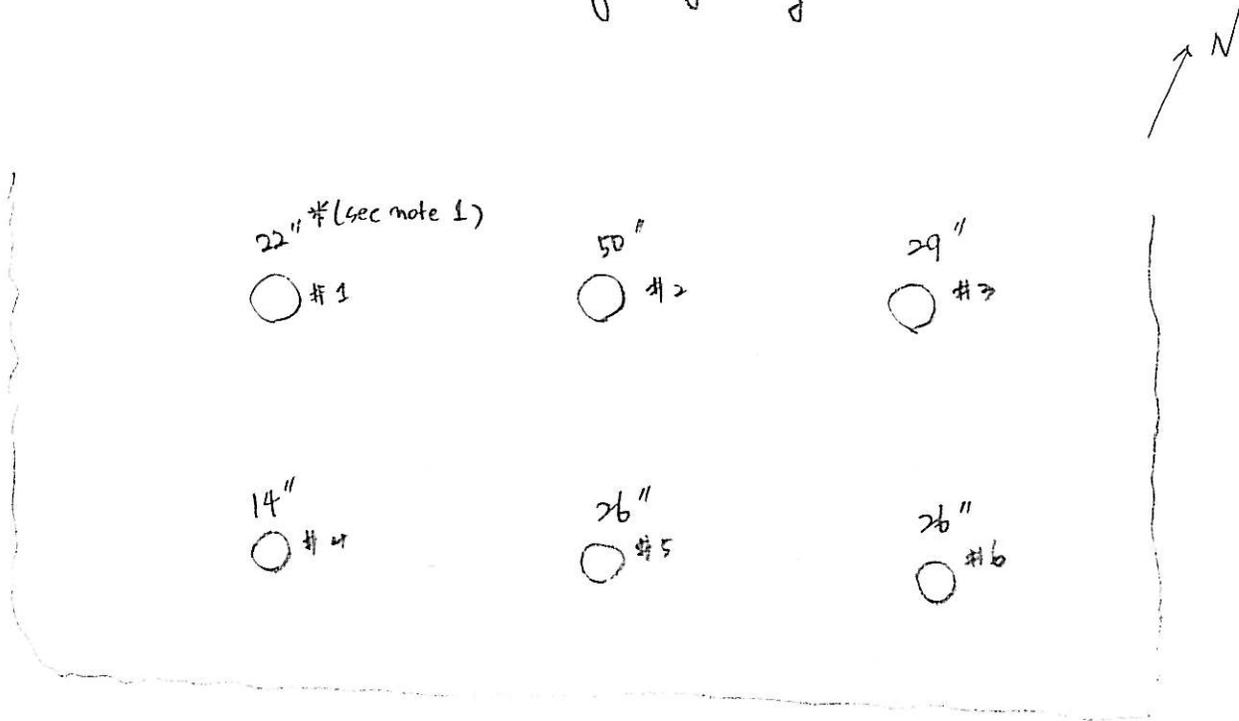
Attachment #1 : Recession check after grouting

* Number indicated is the distance between top of casing and top of grout
