Job Stamp 04-0120F4 SFOBB SAS

Const. Calendar:	502			
Project Work Day No.:	712			
Date	04/28/2008			
Inspectors	Start	12:15	Stop	14:10
Hours				
Shift Hours		07:00		15:30

Description of Operations @ W2 Cap Beam:

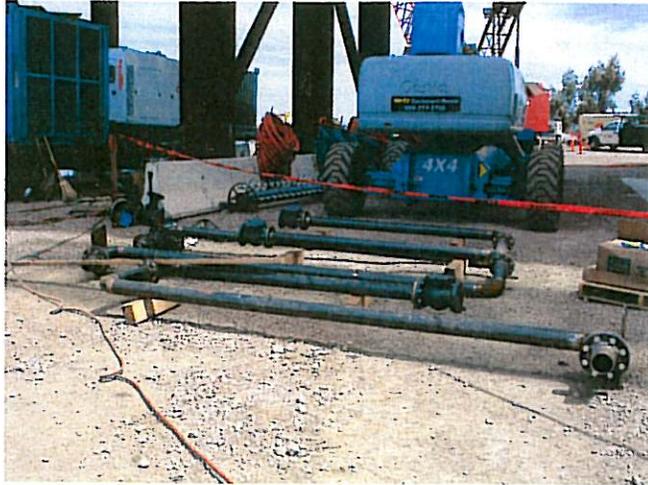
File Name:	DSC01550		
Date:	04-28-08	By Int:	D Chung

Description: Pipes used for the water cooling system.

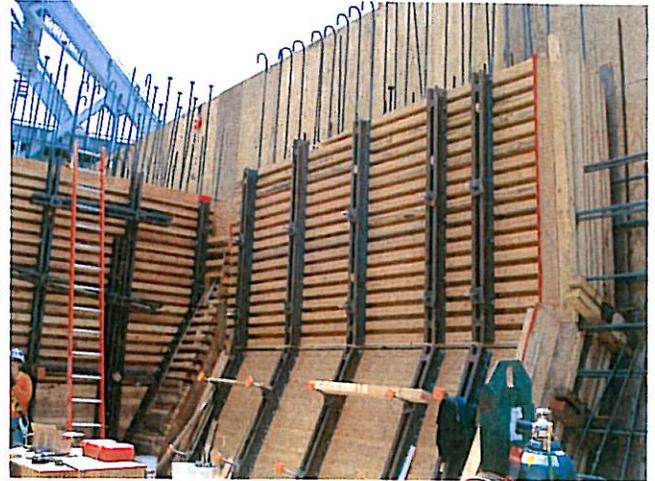
File Name:	DSC01551		
Date:	04-28-08	By Int:	D Chung

Description: Erected the vertical northwest wall forms today.

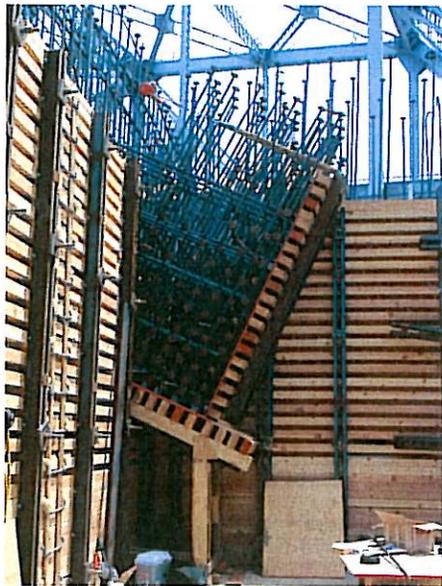
File Name:	DSC01554		
Date:	04-28-08	By Int:	D Chung

Description: Placement of 29JL bars in the jacking saddle support blocks completed today.

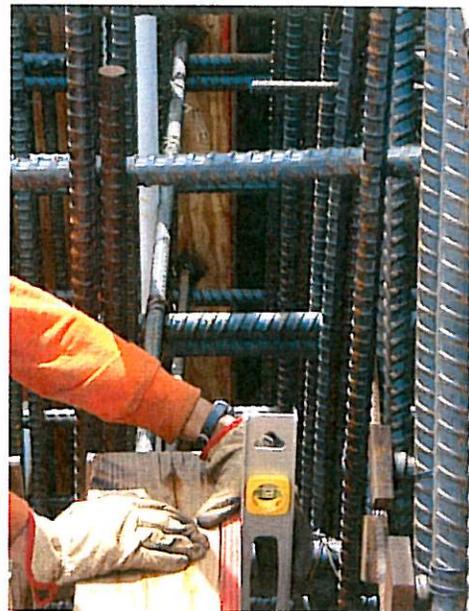
File Name:	DSC01555		
Date:	04-28-08	By Int:	D Chung

Description: Excessive gap between the jacking saddle support block steel and the forms. Cover was found to be over 6" in many locations. This is due to the forms being skewed and the rebar being placed along the longitudinal diaphragm.
