STATE OF CALIFORNIA	Job Stamp	7-day Const. Calendar	Day No. 483
DEPARTMENT OF TRANSPORTATION	SFOBB SAS	Project Work Day No.	Day No. 683
Form HC-10A (Rev. 6/80)	04-0120F4	Date	04/09/2008

ASSISTANT RESIDENT ENGINEER'S

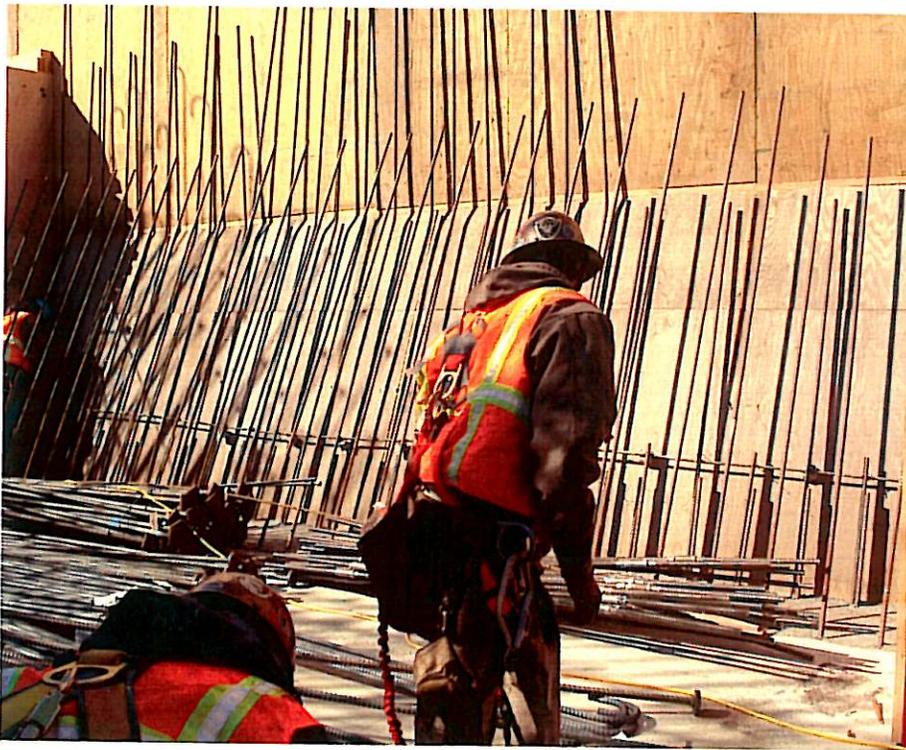
Started installing internal (#36L15-L8Txx) and external (#36L15-L8Txx) rebar in west wall.  
 Started installing east transverse wall jacking saddle horizontal/vertical t-heads #29HT01/#29HV06-08 see sheet 49S7R1.  
 Started installing #25 and #29 vertical bars in transverse diaphragm based on vertical height surveyed by ABF

- Provided Lance with access opening rebar layout.
- Lance installed west wall #36L15-L8 interior and exterior bars with the incorrect couplers at own risk. Is requesting thru RFI to splice correct coupler in for these bars.

West wall rebar.

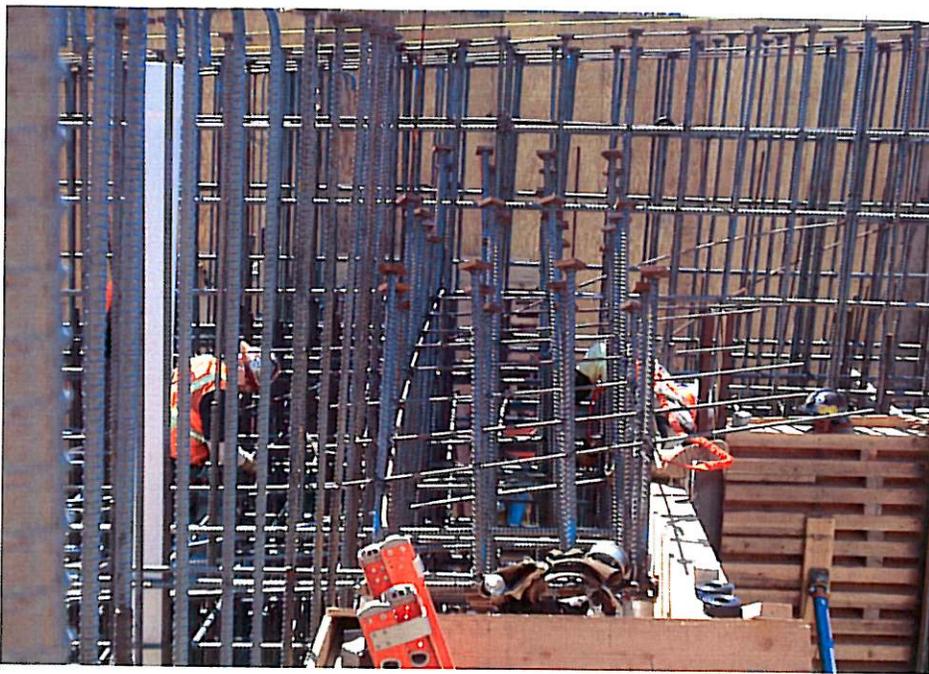
Started installing northeast jacking saddle rebar designated as #29HV03-02 plan allow RSC to use 6 #29HV03 or as an alternative use 4 #32HV03 bars and 6 #36HV02 as oppose to 9 #29HV02. RSC chose to use 4 #32 and 6 #36 HV03 and HV02 respectively. See sheet 497S8R1.  
See M. Bruce & D. Chung diaries for additional comments.

#32HV bar northeast jacking saddle block.

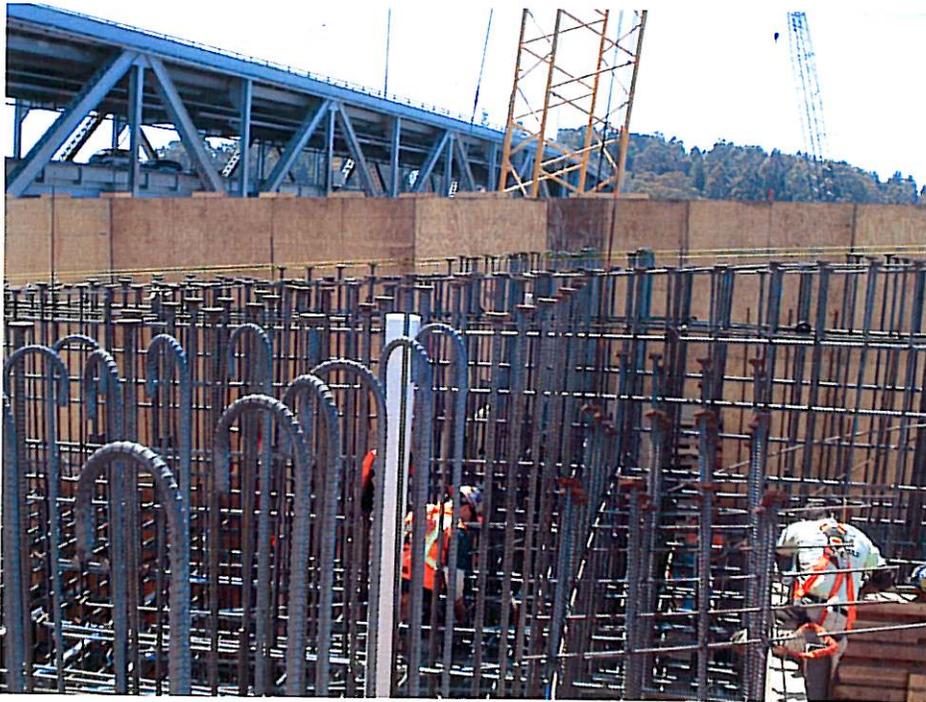
#25 & #29 vertical transverse rebar (from left to right) showing yellow string line surveyed by ABF.
