STATE OF CALIFORNIA	Job Stamp	7-day Const. Calendar	Day No. 490
DEPARTMENT OF TRANSPORTATION	SFOBB SAS	Project Work Day No.	Day No. 690
Form HC-10A (Rev. 6/80)	04-0120F4	Date	04/16/2008

ASSISTANT RESIDENT ENGINEER'S

CONTRACTOR – ABFJV

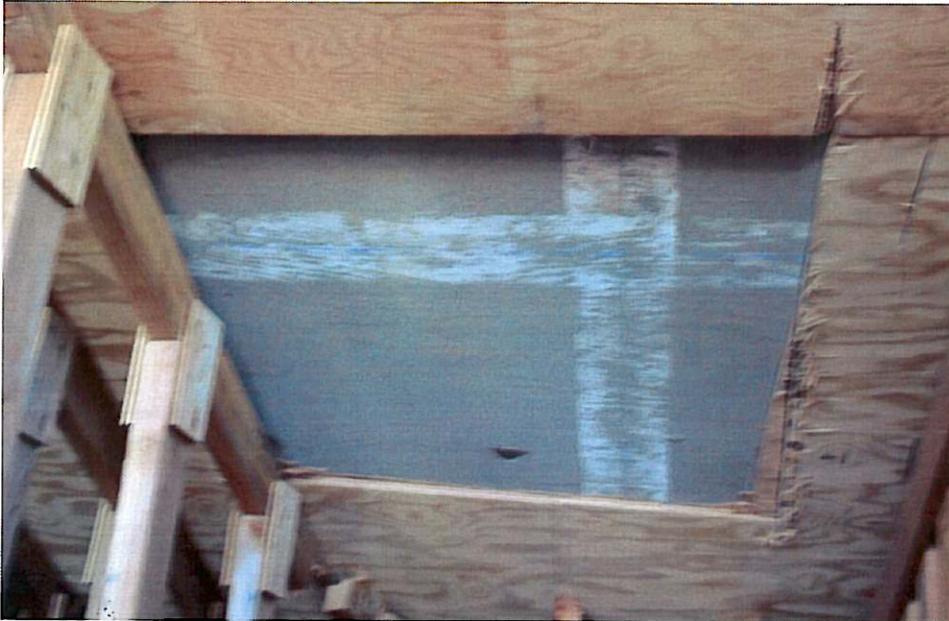
- See L. Mathur's diary for labor, equipment and daily activities. Also see M. Bruce's diary for additional comments.
- Checked opened form on eastside for cracking in soffit concrete. No visible cracking but a dimple in concrete observed. See photo below.

Exposed soffit concrete.

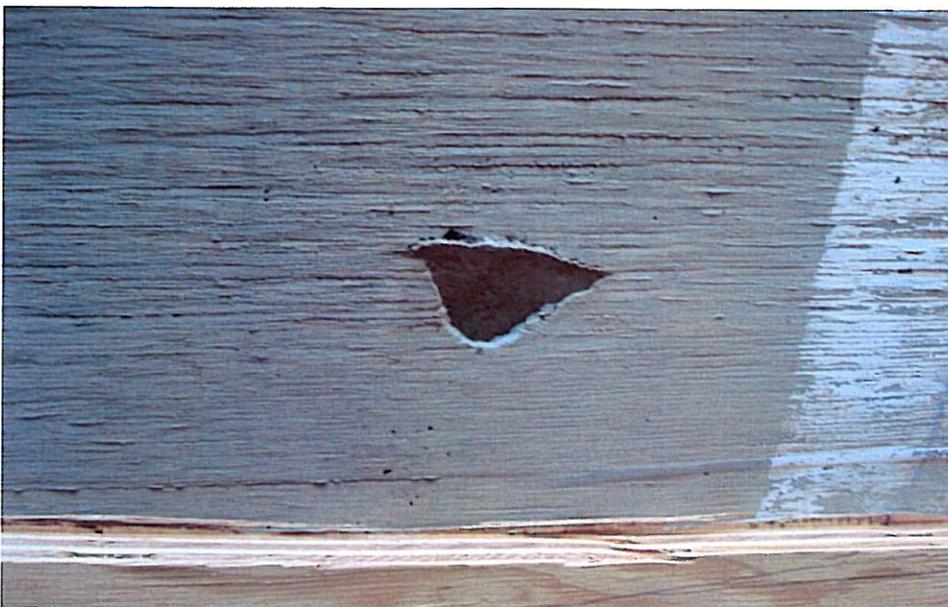
Dimple in soffit concrete.
