Job Stamp
04-0120F4
SFOBB SAS

Assistant Structure Rep.'s Daily Report

Location & Description of Operation	SAS-Temporary towers, Tower A & B foundation
Weather	HI: 61 F Low: 48 F cloudy & windy

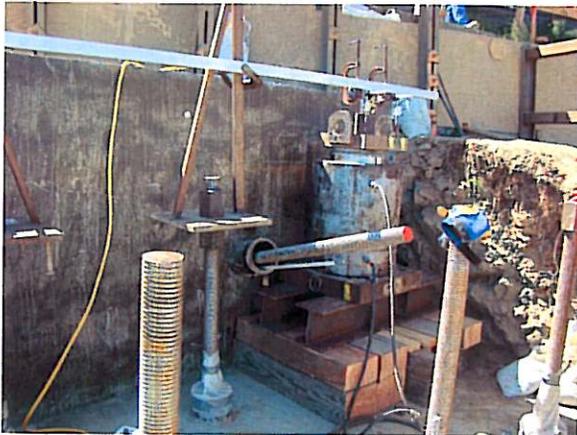
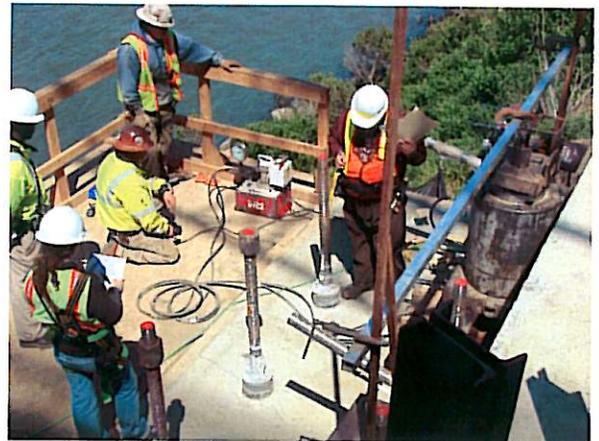
- Daily activity of contractors
 - Drill tech tested vertical micropiles #5, 6 and 7 of B2 foundation (see Figs 1 and 2). See Gina Rizzardo's diary for the testing results and more detailed information.
 - T.D. installed B1 platform (see Fig 3).
 - Three Patent crews started to assemble scaffold (see Fig 4).
 - See Art Pannu, Damon Brown, Gina Rizzardo, Thanh Le and Abdikarim Ali's diaries for additional contractors' activities and comments.

Figs 1 and 2. Micropile testing

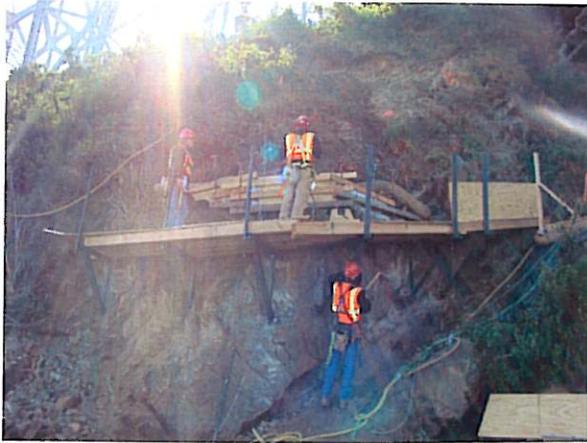
Fig 3. B1 platform

- On site from 10:00 to 14:30.
- Measured the spacing of the steel frame, which consists in B1 platform. See Abdikarim Ali's diary for detailed information.
- Considerable cracks occur when testing #7 micropile (see Fig. 5)
- Conversation with Gil regarding maximum and minimum elongation of micropiles allowed.

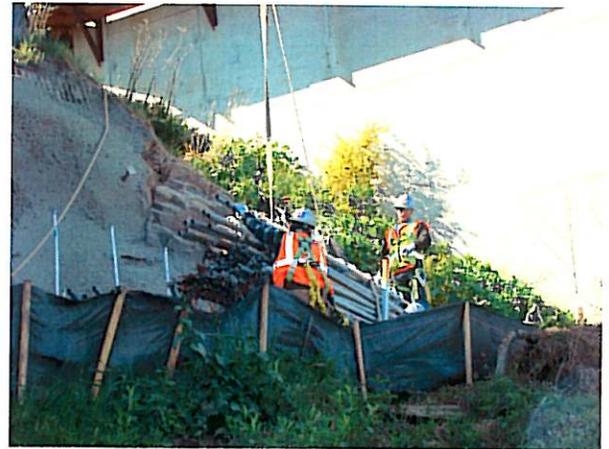
Fig 4. Patent crews start to assemble scaffold

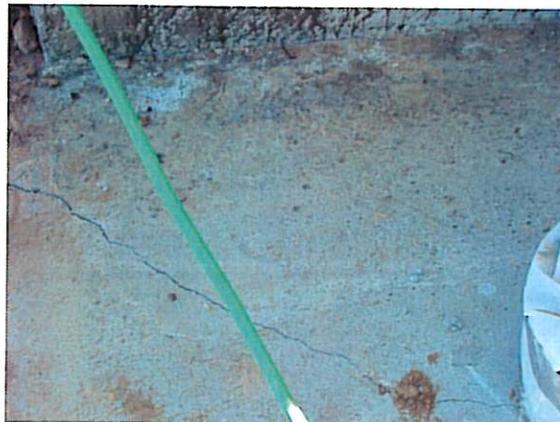
Fig 5. Excessive cracks when testing micropile #7
