Job Stamp
04-0120F4
SFOBB SAS

Const. Calendar Day No. 527
Project Work Day No. 737
Date 05/23/2008
Shift Hours Start 0630 Stop 15:00
Inspector Shift 7:30 AM to 5:30 PM

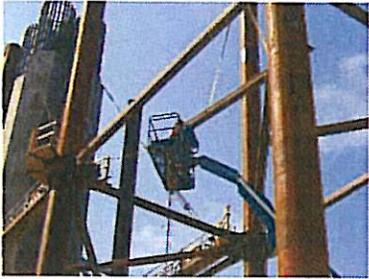
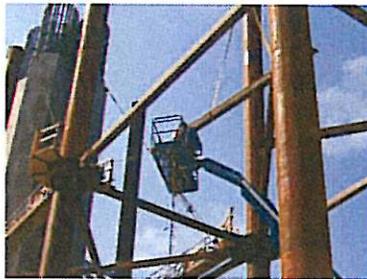
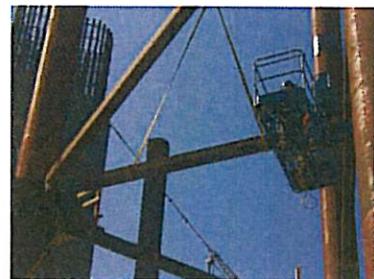
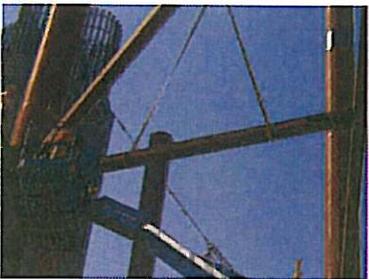
- Following two windy days, the crew finally had an opportunity to get back to work. By 10:30, all the remaining four pieces of HSS were attached. The one connecting the center of the frame to the stiffener ring around falsework post #6 was the last piece to go in. Right prior to my departure, the bolts had been sunnged around FW post #6 but were not lining up at the center connection. Talking to Ben, he said that he would ream the holes to make this happen. I left the site, but asked Ben to let the QC know that we CT had been waiting for him for a long time and that the inspection has to be re-scheduled.

- I spent the rest of the day studying plans and searching PMIV for more documents;
- The following photos were taken today at Pier E2 while the crew were placing the last connection of the lower bracing (HSS 10"x10"x1/2") in to place;

- Once at the office, Gil told me that hr got on the footing shortly following my departure and saw that the connection to the middle bracing was not bolted, rather welded. It is apparent the reaming of the bolt holes would

have been more time-consuming to say the least; hence welding of the middle connection. Gil emphasized that we need to remind the Contractor that they need to revise their falsework plan to reflect this change and provide us with the calculations that justifies the soundness of this connection. I mentioned that such revision should also include the cutting of the knife plates leading ABF to depart from the original plan by not using the 1"x1"x6" bars that connect the knife plates to the stiffener rings. Instead, I added, they used 12"x12" plates where the knife plates were cut. He agreed.
