Job Stamp  
**04-0120F4**  
**SFOBB SAS**

Const. Calendar Day No. 531  
Project Work Day No. 741  
Date **05/27/2008**  
Shift Hours Start 0630 Stop 15:00  
Inspector Shift 7:30 AM to 5:00 PM

Assistant Structures Representative **CONTRACTOR – ABFJV**

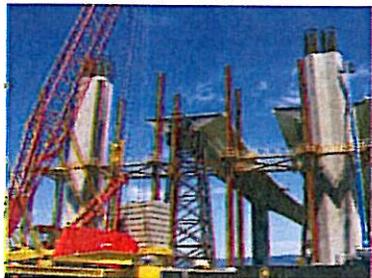
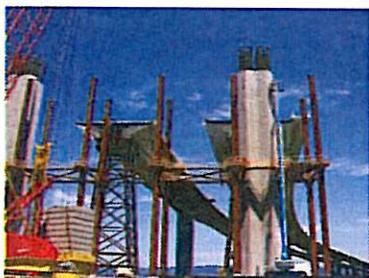
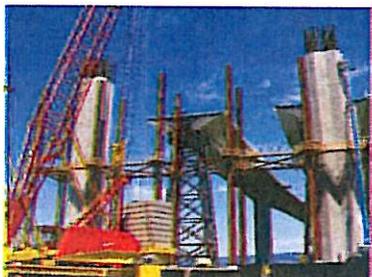
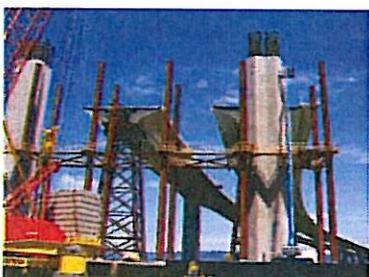
- I continued with the review and downloading of the RFIs pertinent to the E2 x-beam through the PMIV. I am making copies available to Massoud as well. The submittals will be reviewed once I complete organizing these RFIs in a binder.
- Overtime Hours: 1
- The following photos were taken today at Pier E2 while ABF was wrapping-up all the lower bracing work at this location at the conclusion of the day:
