Job Stamp 04-0120F4 SFOBB SAS
-------------------------------------

**ASSISTANT RESIDENT ENGINEER'S CONTRACTOR – ABFJV, Sub RPS**

**Description of Operations @ W2 Cap Beam:**

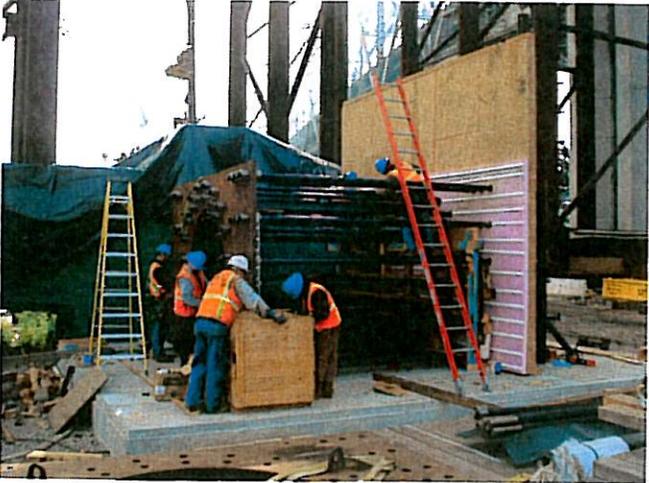
File Name:	DSC01890	File Name:	DSC01892
Date:	06-03-08	Date:	06-03-08
By Int:	M Bruce	By Int:	M Bruce
<p>Description: Removing formwork used to support the Macalloy rods in the vertical direction. Also tightening nuts on the 60mm anchor plate. 14 trapezoidal shear keys were placed on the grout pad blockout with <math>w_1 = 20\text{mm}</math>, <math>w_2 = 55\text{mm}</math>, and <math>h = 20\text{mm}</math>.</p>		<p>Description: Damaged Denso tape on the Macalloy rods found near the bottom of the template.</p>

Time	Operation	Comments
08:30	Began to remove formwork used to support the Macalloy rods in the vertical direction only. Also tightening nuts on the 60mm anchor plate.	As I was checking the nuts on the back plate to see if the proper torque was achieved, ABF foreman Nigel Lohse informed me I couldn't use the specialized wrench to check the nuts. He said that ABF superintendent Steve Marko said Caltrans has to get own tools. I mentioned to Nigel that the nuts need to be tightened prior to concrete placement.

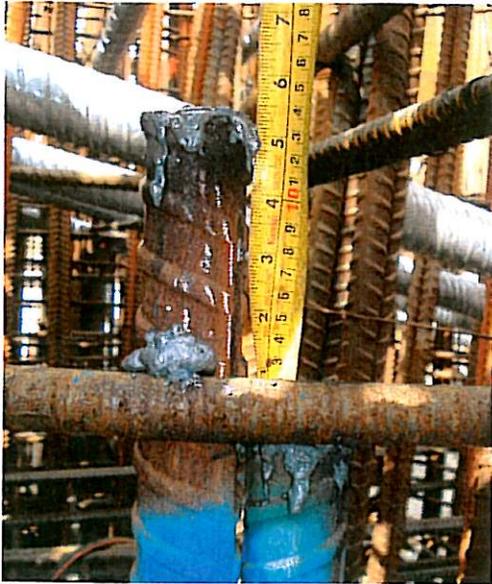
File Name:	DSC01896		
Date:	06-03-08	By Int:	M Bruce
Description: Prepping previously cut #43 vertical bars at W2W NE column cage for T-Head installation.

- Continued to remove #43 vertical bars at W2W column cages.
- Prepped previously cut #43 vertical bars at both W2E and W2W column cages for T-Head installation, see photos below.

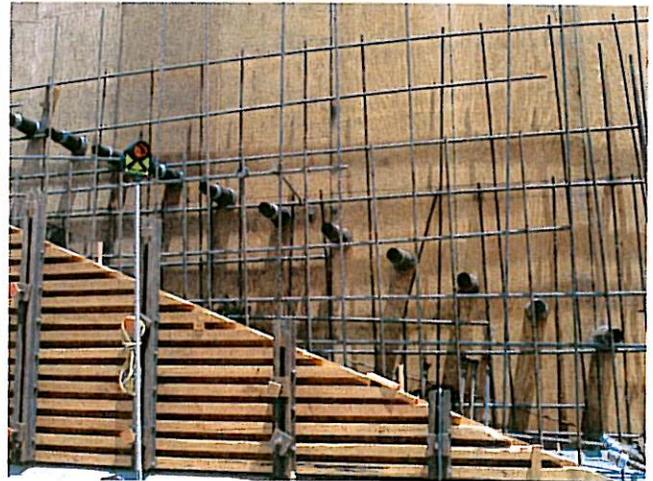
File Name:	DSC01927		
Date:	06-03-08	By Int:	M Bruce
Description: Trumpets installed for continuity tendons E-1B through E-14B.

- Continued to build and mobilize pour number 3 formwork (posts + cap beam frames).
- Installed trumpets in the bearing plates for continuity tendons W-15B to W-18B and W-23B to W-29B and on the bulkhead (east side) for E-1B to E-14B.
- Continued to clean Sandblasting debris for pour 2 construction joint.
- Resumed construction of formwork in the southeast quadrant of the void area.
- Erected South Hinge K assembly (three of four assemblies) near W2W see comments below for details:

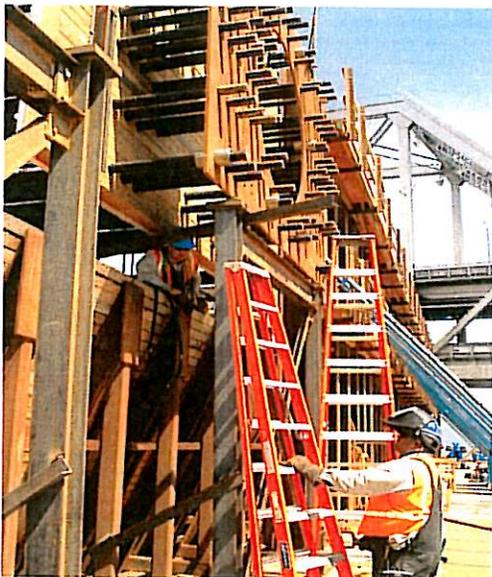
File Name:	DSC01933		
Date:	06-03-08	By Int:	M Bruce
Description: Welding the temporary angles braces (which were spliced in two locations) to the support frames.

15:00	Angles were used to provide additional bracing between the support frames due to high wind speeds and frame stability.	The carpenters level (attached to anchor plate) bubble was moving from left to right.

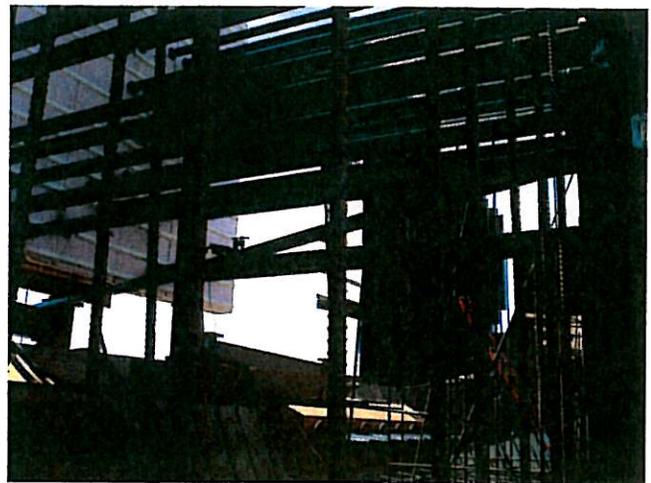
File Name:	DSC01935		
Date:	06-03-08	By Int:	M Bruce
Description: Photo taken of temporary angle braces from inside W2 cap beam.
