Job Stamp
04-0120F4
SFOBB SAS

ASSISTANT RESIDENT ENGINEER'S CONTRACTOR – ABFJV, Sub RPS

Description of Operations @ W2 Cap Beam:

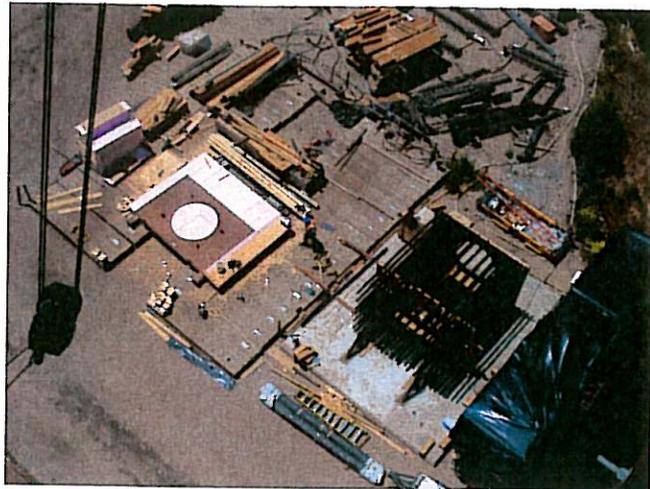
File Name:	DSC01956		
Date:	06-09-08	By Int:	M Bruce

Description: Photo taken of Hinge K assembly construction in the afternoon. Rod placement was complete and the piledrivers were drilling holes in the Styrofoam using the 25mm template. This morning when I arrived onsite the Styrofoam wasn't placed on the formwork, which was already completed.

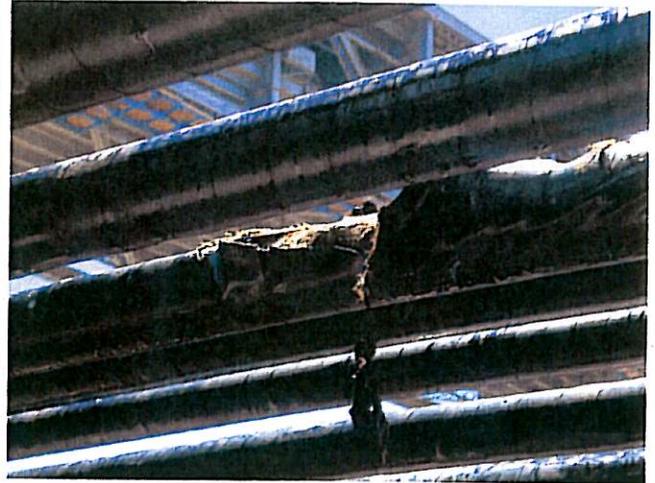
File Name:	DSC01952		
Date:	06-09-08	By Int:	M Bruce

Description: Tear in the Denso tape wrapped around the Macalloy rods in the last Hinge K assembly.

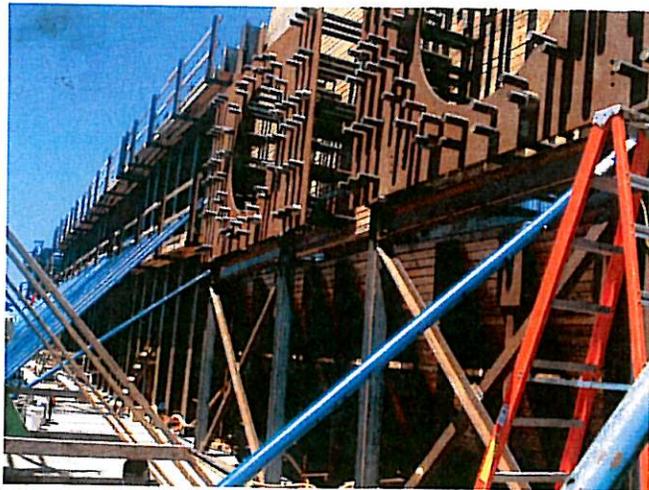
File Name:	DSC01953		
Date:	06-09-08	By Int:	M Bruce

Description: Two Dayton braces placed on the exterior frames of the W2E Hinge K assemblies. The elevator conflicts with placing the remaining braces.

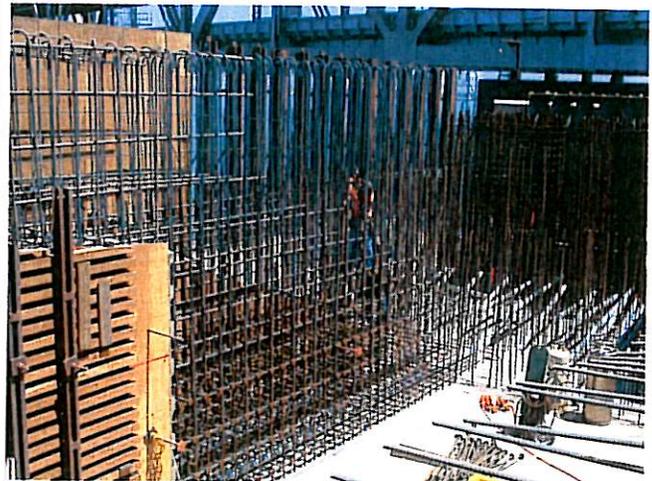
File Name:	DSC01954		
Date:	06-09-08	By Int:	M Bruce

Description: South transverse diaphragm rebar placement completed today.
