Job Stamp
04-0120F4
SFOBB SAS

ASSISTANT RESIDENT ENGINEER'S CONTRACTOR – ABFJV, Sub RPS

Description of Operations @ W2 Cap Beam:

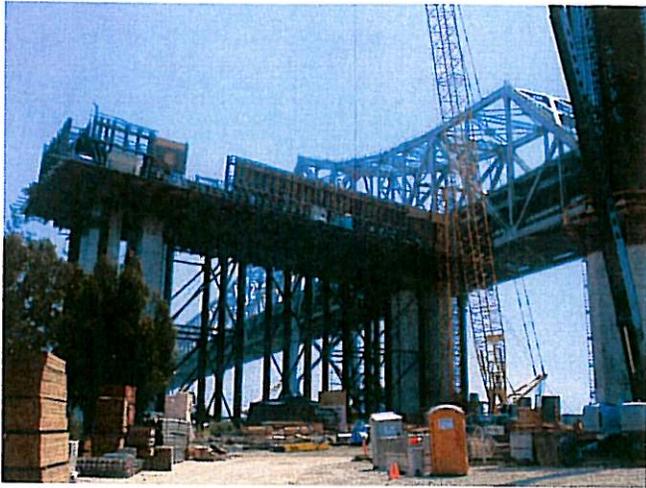
File Name:	DSC01978
Date:	06-13-08
By Int:	M Bruce

Description: Photo taken at noon as the W2W-South Hinge-K assembly was placed on the working slab in the morning.

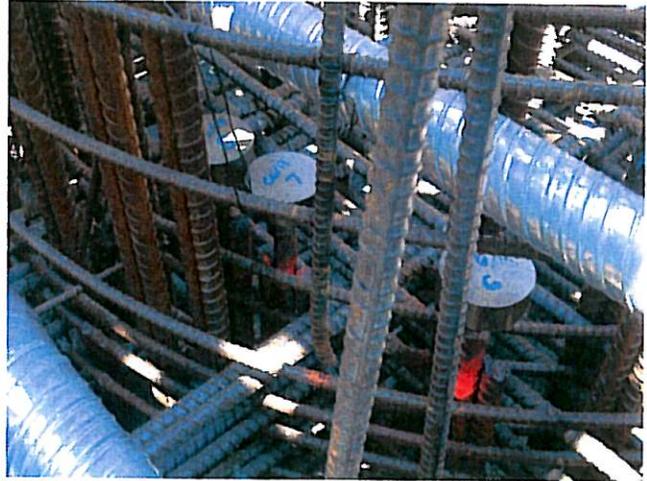
File Name:	DSC01982
Date:	06-13-08
By Int:	M Bruce

- Circular T-Heads were installed on the vertical #43 column rebar at W2E in the following cages; 20 in the northwest, 17 in the northeast, and 3 in the southwest. All torqued couplers that I witnessed were acceptable as the wrench was set to 400lb-ft, two clicks were achieved, and there was a 1/16" to 1/2" visible gap between the male and female coupler sleeve. I used a blue paint pen to mark the date in which the coupler was torqued and the sequence in the particular cage in which it was torqued. Joe Bell was the operator of the torque wrench (Serial No. 2007-253086) and torqued the male coupler. Lucino Ortiz used the wrench on the female coupler.

Description: Circular T-Head installation at W2E northwest column cage.

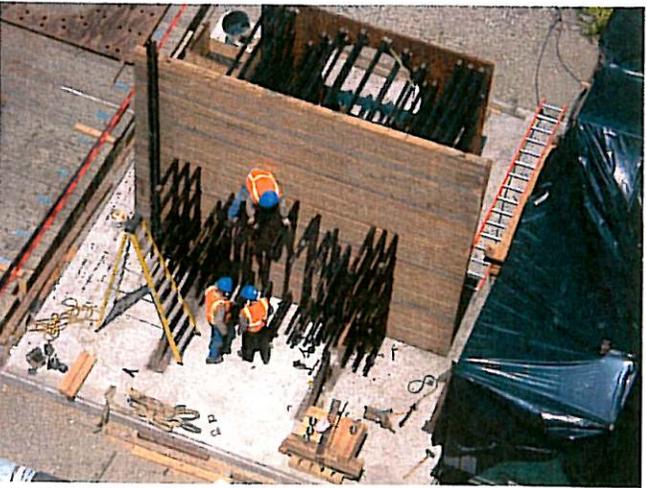
File Name:	DSC01986
Date:	06-13-08
By Int:	M Bruce

Time	Operation
07:40	In the process of removing welds on the template and the support frames.
08:15	Rigged the spreader beam/Hinge K plates. Removed bolts used to connect the "shoes" on the 60mm plate to the internal support frames.
08:20	Removed W2W-South Hinge K assembly from the support frames and lowered onto the working slab.
08:30	Rigging was unhooked from Hinge K plates. Put shims underneath the assembly formwork and began to remove nuts on the front side of the template.
10:00	Approximate time when ABF piledrivers Andy Adam and Jesse Johnassen began testing the threads by running a nut along the stressing end of the Macalloy rod.
14:20	Testing the Macalloy rod threads is completed as no rods need to be replaced in the Hinge K assembly. Two rods needed a wrench to advance the nut along the threads, see David's diary for details.

Description: ABF piledrivers testing the Macalloy rod threads in the afternoon.

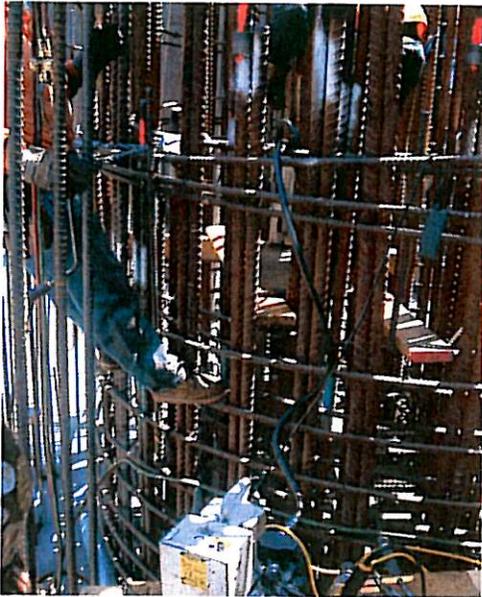
File Name:	DSC01997
Date:	06-13-08
By Int:	M Bruce

- Continued to "mushroomhead" the vertical #43 bars in the south W2E column cages. I observed the ironworkers perform this operation for 7 vertical bars in the southeast cage. Daniel Gomez heated the vertical bar, then Tim Greenlee installed the Xtender machine over the heated bar while Victor Quiroz operated the hydraulic pump to 8,000psi per the procedure. I was unable to observe the "mushroomheading" operation in the southwest cage due to the coupler installation in the north cages and the W2W-South Hinge-K assembly removal.

Description: Vertical #43 column rebar "Mushroomheading" operation.
