Job Stamp	
04-0120F4	
SFOBB SAS

Description of Operations @ W2 Cap Beam:

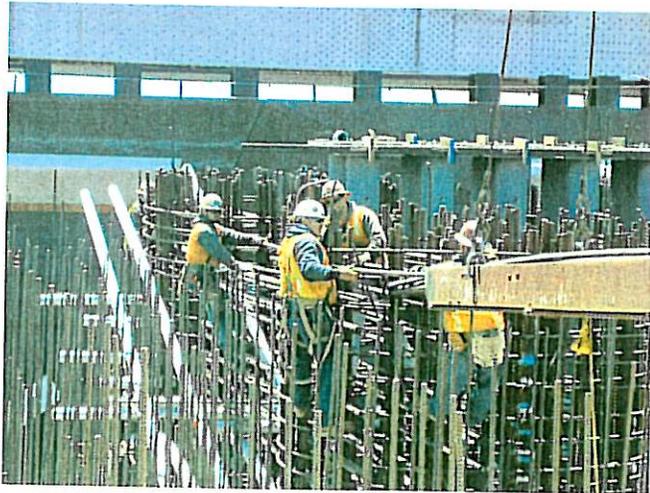
File Name:	July-02-2008 W2 Cap 002
Date:	07-02-08
By Int:	M Bruce

Description: Installation of the T bars in the east column cages at W2E.

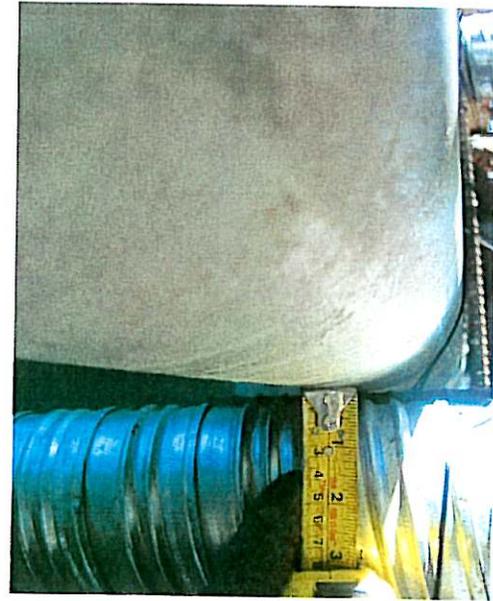
File Name:	July-02-2008 W2 Cap 005
Date:	07-02-08
By Int:	M Bruce

Description: Per the Special Provisions section 20-1.42 under "Ducts" the minimum clear spacing is 25mm between ducts. The continuity tendon shown is E-30B with the strong pipe above. The photo taken above is typical of the clearance between E-30B and the transverse tendons through the W2E column cages.

- a) Continuity tendons E-30B through E-37B need to be straightened out, see photo below.
 - b) There needs to be adequate spacing (25mm minimum) between E-30B and the transverse tendons directly underneath, see photo below. I suggested placing a 25mm dobbie in between the tendons and tying both ducts together.

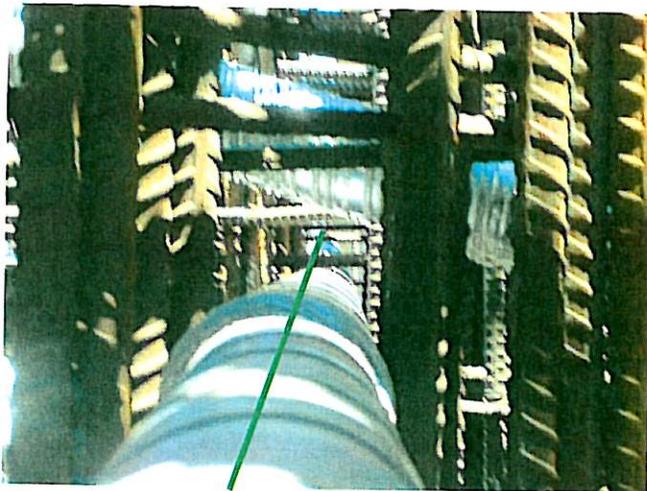
File Name:	July-02-2008 W2 Cap 008
Date:	07-02-08
By Int:	M Bruce

Description: Photo taken of continuity tendon E-35B from the southwest column cage looking east. The green line denotes the center of the duct/tendon through the south W2E column cages. The tendon is not straight as called out in Submittal 150.

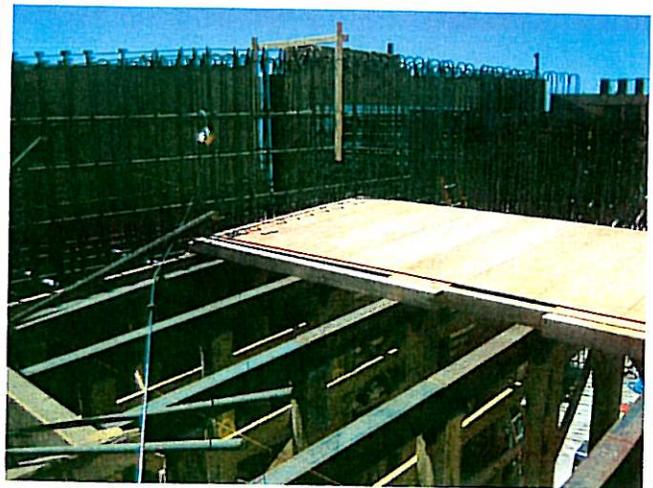
File Name:	July-02-2008 W2 Cap 010
Date:	07-02-08
By Int:	M Bruce

Description: Pour 3 soffit/ceiling formwork in the northeast quadrant.
