STATE OF CALIFORNIA
DEPARTMENT OF TRANSPORTATION
Form HC-10A (Rev. 6/80)

Job Stamp 04-0120F4 SFOBB SAS

Description of Operations @ W2 Cap Beam:

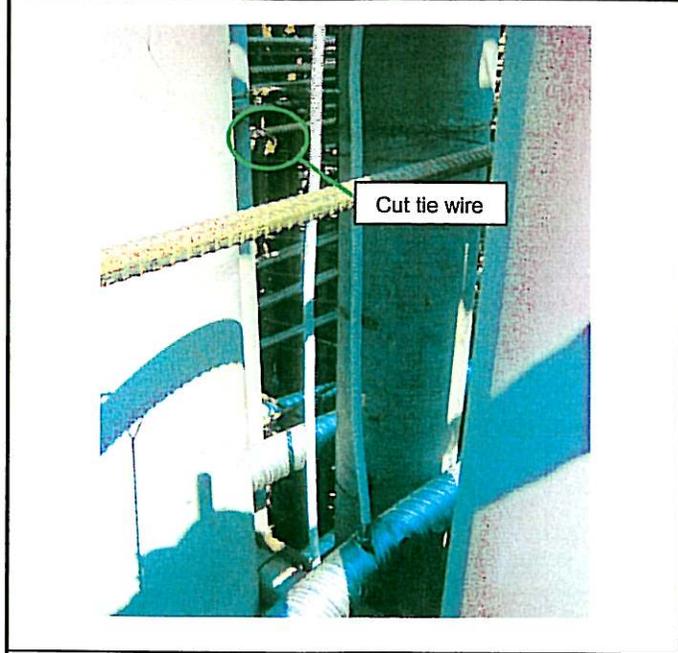
File Name:	July-07-2008 W2 Cap 003
Date:	07-07-08
By Int:	M Bruce

Description: Grout tubes placed for CBT-23, 24, 30, and 31 at pier W2E centerline. Tie wire used to support/plumb the cable tie down pipes (approximately 1/3 from the top) were cut as seen in the photo above. ABF foreman Terry Cronk was notified that the tie wire shouldn't be cut and that the pipes may go out of plumb.

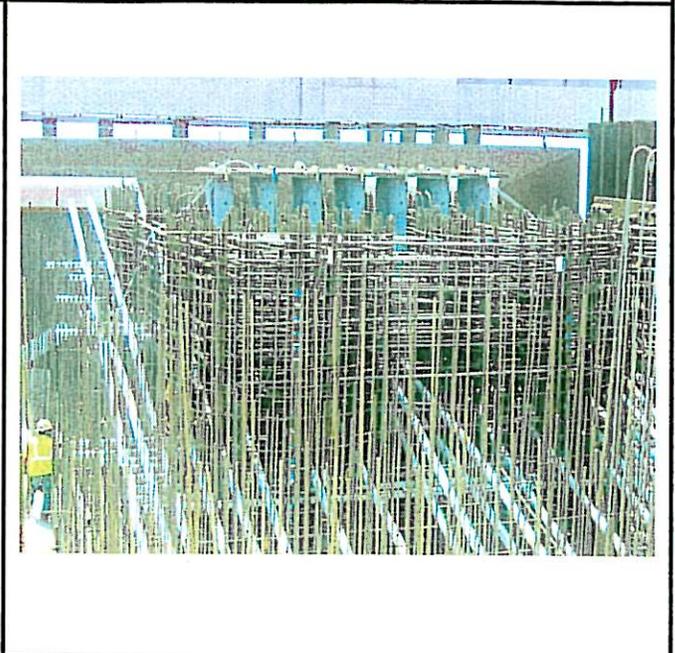
File Name:	July-07-2008 W2 Cap 007
Date:	07-07-08
By Int:	M Bruce

Description: L-bar placement in the north cages at pier W2E completed today.

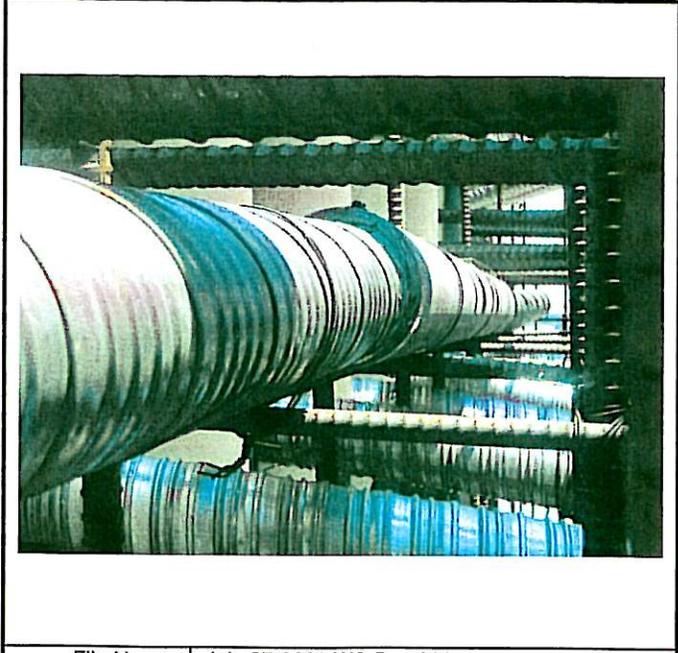
File Name:	July-07-2008 W2 Cap 008
Date:	07-07-08
By Int:	M Bruce

Description: I verbally mentioned to RPS foreman Joe Bell that continuity tendons E-30B through E-38B need to be straight. E-31B is seen in the photo above. The tendons with strong pipes generally look like the photo above. It is at the option of the ironworkers when to fix the tendons, however it is easier to fix/inspect before L-bar placement.

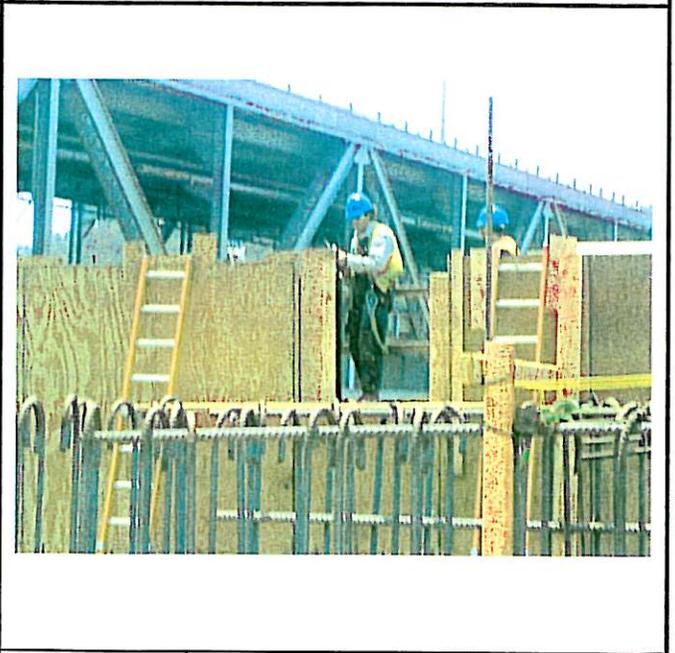
File Name:	July-07-2008 W2 Cap 011
Date:	07-07-08
By Int:	M Bruce

Description: Access opening for pour 4 on the southwest side of W2 cap beam.
