Job Stamp  
04-0120F4  
SFOBB SAS

ASSISTANT RESIDENT ENGINEER'S **CONTRACTOR – ABFJV, Sub RPS**

**Description of Operations @ W2 Cap Beam:**

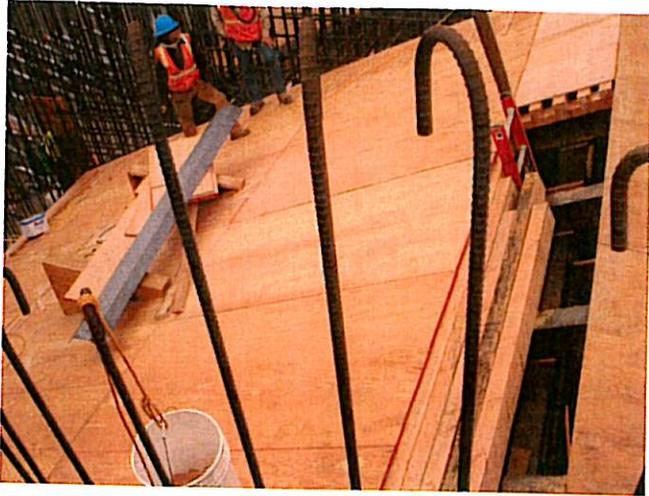
File Name:	DSC02154
Date:	07-28-08
By Int:	D Chung

Description: Chamfer work on the sloped portion in the northwest quadrant void area. There still is an opening in the forms with a ladder going into this confined space. This also is a fall hazard as there is nothing around the opening denoting the hazard. A piledriver was seen going into the space at the time of the photo. I confronted him and mentioned the potential hazards of entering the confined space. ABF foreman could be found to inform them of this situation.

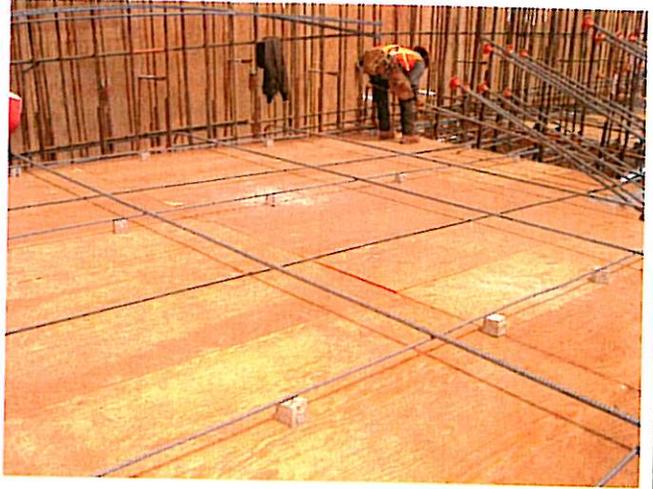
File Name:	DSC02160
Date:	07-28-08
By Int:	D Chung

- Began to place a few 25L5L01 bars on berry bars in the pour 3 east quadrant with the wrong size (3") dobbies. The ironworkers are aware that they are using the wrong dobbies however they are setting up the bottom mat reinforcement until they get the right size dobbies; see sheets 478R1, 480R1, 481R1 for details.
- Placed #25 Horizontal T-head bars in the longitudinal diaphragm; see sheets 497S4R1 and 497S5.
- Placed 4-25L6L20 and 4-25L7L20 (hooked bars) in the longitudinal diaphragm; see sheets 497S4R1, 497S5, and 497S16R1 for details.
- Began to place #36 exterior and interior bars in the west wall; see sheets 492R2 and 493R2 for details.

Description: Placement of a few 25L5L01 bars on berry bars on top of 3" dobbies in the pour 3 east quadrant.
