Job Stamp 04-0120F4 SFOBB SAS

Description of Operations @ W2 Cap Beam:

EA	04-0120F4
Co-Rte-KP (PM)	SF-080-13.2/13.9 (8.2/8.7)
Structure Rep.	Rick Morrow

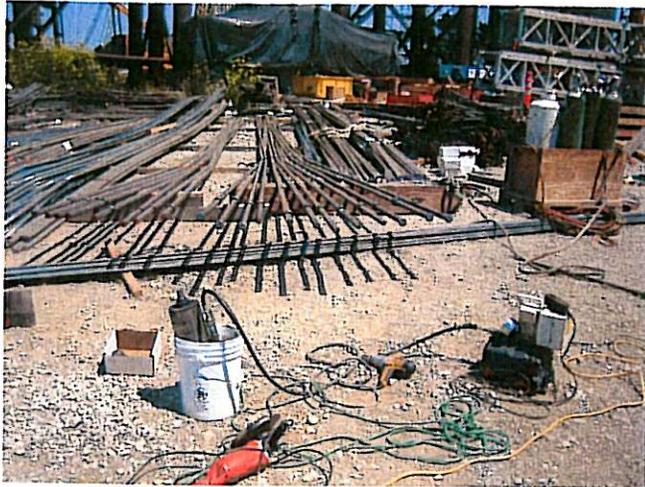
File Name:	Aug-12-2008 W2 Cap 001		
Date:	08-12-08	By Int:	M Bruce

Description: Photo of the #43 transverse top mat bars being mushroomheaded/prepared for testing. General foreman Bob Bogneas was heating the bars and Tim Greenlee was placing the jack over the bars, while another ironworker was operating the hydraulic pump. The operation in the horizontal position appeared to be more difficult than in the vertical position.

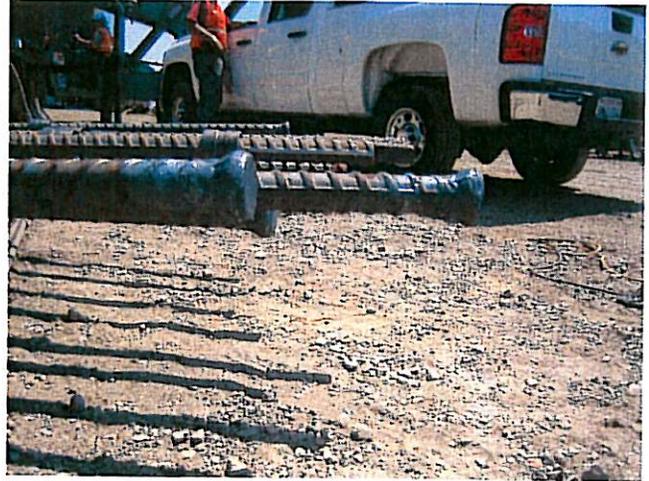
File Name:	Aug-12-2008 W2 Cap 002		
Date:	08-12-08	By Int:	M Bruce

Description: Completed #43 bars that were mushroomhead in the field for QC/QA testing.

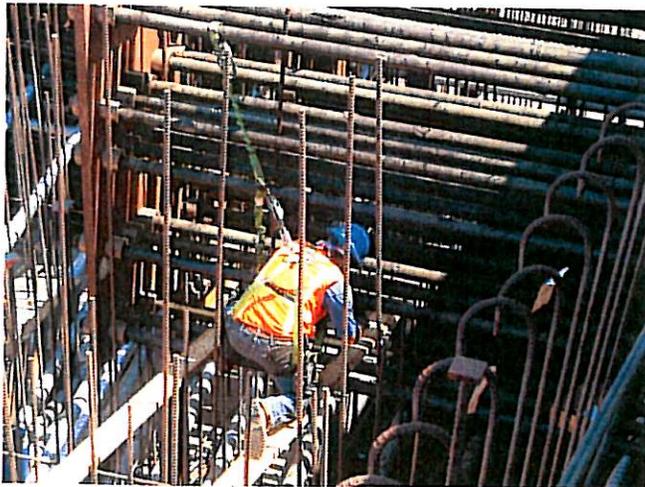
File Name:	Aug-12-2008 W2 Cap 004		
Date:	08-12-08	By Int:	M Bruce

Description: In this photo a piledriver was placing additional denso tape on a Macalloy rod in the W2E North Hinge-K assembly.

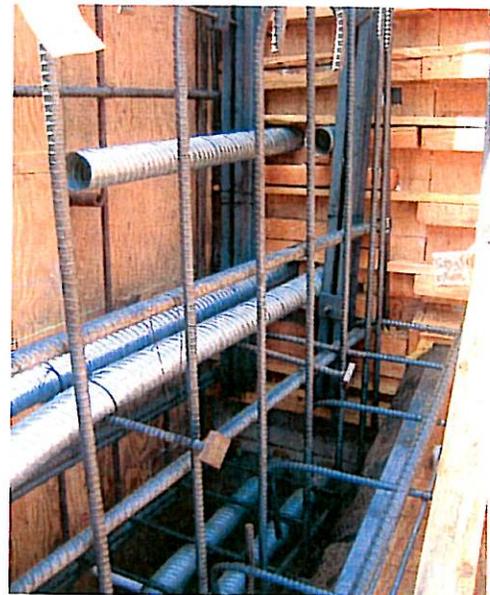
File Name:	Aug-12-2008 W2 Cap 005		
Date:	08-12-08	By Int:	M Bruce

Description: West wall bulkhead on the south side of the W2 cap beam. CBT-3 and CBT-7 are still butting against the forms.
