Job Stamp 04-0120F4 SFOBB SAS

ASSISTANT RESIDENT ENGINEER'S **CONTRACTOR – ABFJV, Sub RPS**

Description of Operations @ W2 Cap Beam:

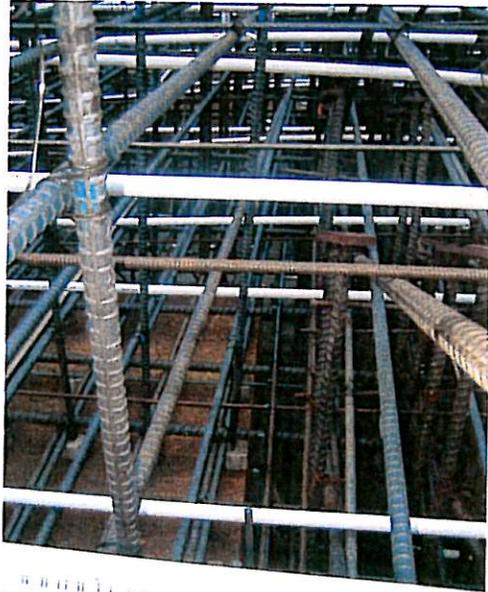
- The ironworkers placed #16 vertical rebar in the southeast jacking saddle block which has excessive cover of approximately 200mm on the south side, see photo below.

Date:	08-16-08	By Int:	M Bruce
Description: The ironworkers placed #16 vertical rebar in the southeast jacking saddle block which has excessive cover of approximately 200mm on the south side.			
Date:	08-16-08	By Int:	M Bruce
Description: Overview of the ironworkers operations for the day. In this picture the crane is raising the #43 transverse bars on the left and #25 vertical hairpin placement is also seen.

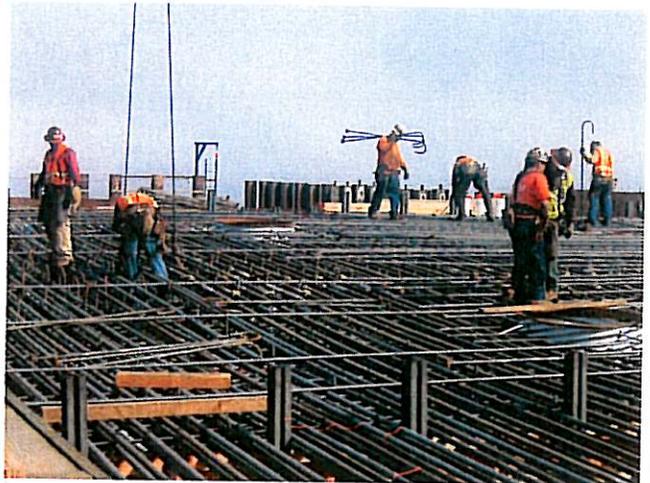
- Began to raise the top mat 2x7 43L1T01*, 2x4 43L1T02*, 2x12 43L1T04*, and 2x3 43L1T06* bars on the west end of the W2 cap beam, see photo below for details.
