Job Stamp 04-0120F4 SFOBB SAS

Description of Operations @ W2 Cap Beam:

EA	04-0120F4
Co-Rte-KP (PM)	SF-080-13.2/13.9 (8.2/8.7)
Structure Rep.	Rick Morrow

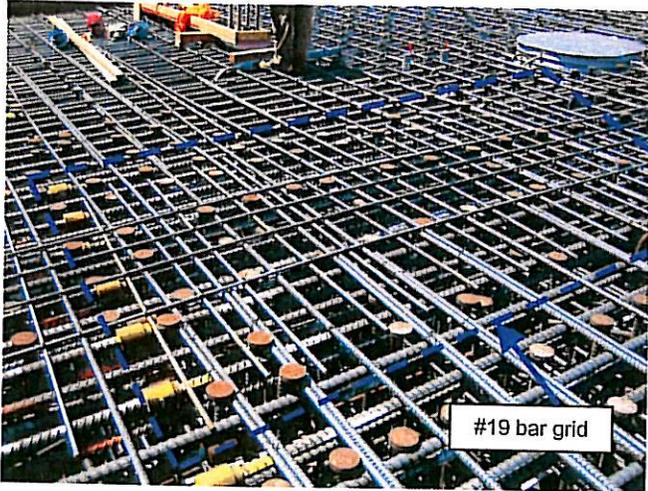
File Name:	Aug-20-2008 W2 Cap 001
Date:	08-20-08
By Int:	M Bruce

#19 bar grid

Description: Placement of the #19 straight bar grid at the intersection of the longitudinal diaphragm and transverse diaphragm looking west.

- Completed items on Pamela's punchlist, see her diary for details.
- Placed #19 straight bars (instead of #13 bars) for the #29 T-heads at the intersection of the longitudinal diaphragm and transverse diaphragm per RFI 1437R00.

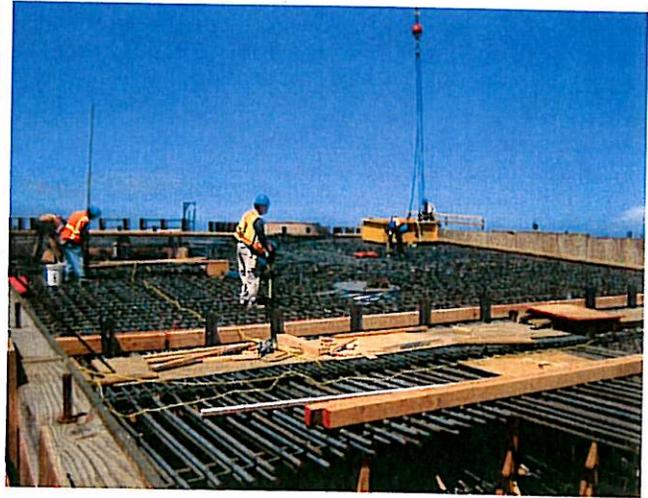
File Name:	Aug-20-2008 W2 Cap 004
Date:	08-20-08
By Int:	M Bruce

Description: Progress photo of ABFs operations prior to placing concrete in a few hours.

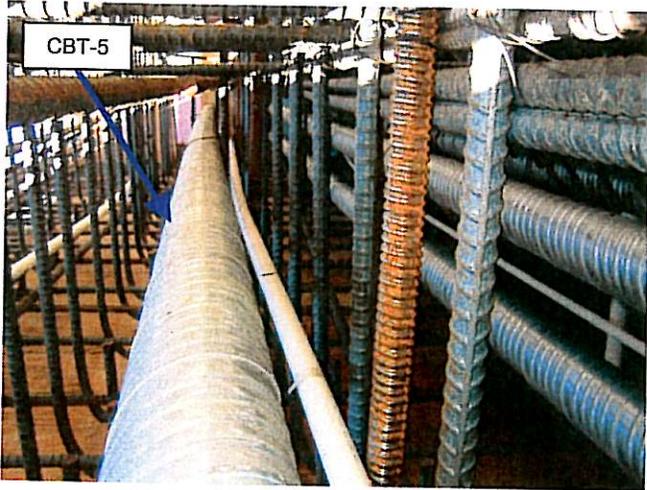
File Name:	Aug-20-2008 W2 Cap 005
Date:	08-20-08
By Int:	M Bruce

CBT-5

Description: CBT-1 through CBT-8 ducts appeared to be properly aligned with no noticeable damage. While down in the rebar I noticed a few water bottles and miscellaneous debris. I mentioned this to the laborers and ABF foreman Nigel Lohse. They removed the water bottles and a tie rod. It is difficult to see the concrete surface in the west wall due to the congestion of rebar and ducts.

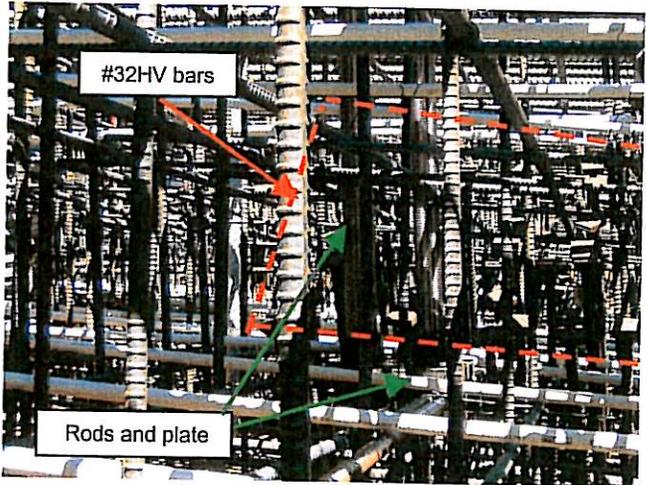
File Name:	Aug-20-2008 W2 Cap 007
Date:	08-20-08
By Int:	M Bruce

#32HV bars

Rods and plate

Description: Jacking saddle erection rods and plate are within a foot of the first row of #32HV bars on both sides.
