Job Stamp 04-0120F4 SFOBB SAS
-------------------------------------

ASSISTANT RESIDENT ENGINEER'S **CONTRACTOR – ABFJV, Sub SDI**

EA	04-0120F4		
Co-Rte-KP (PM)	SF-080-13.2/13.9 (8.2/8.7)		
Structure Rep.	Rick Morrow

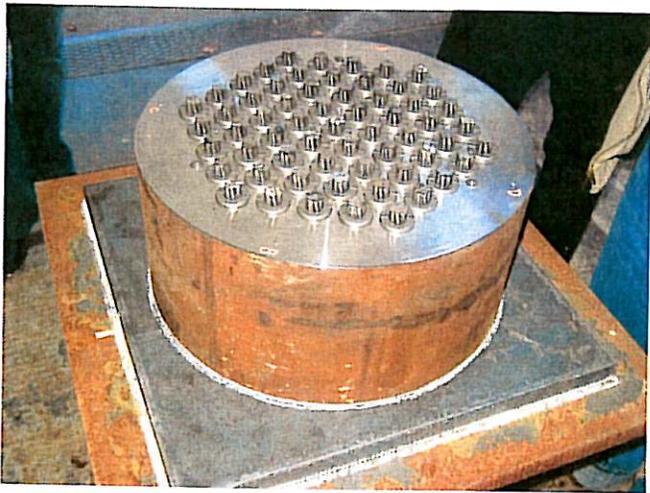
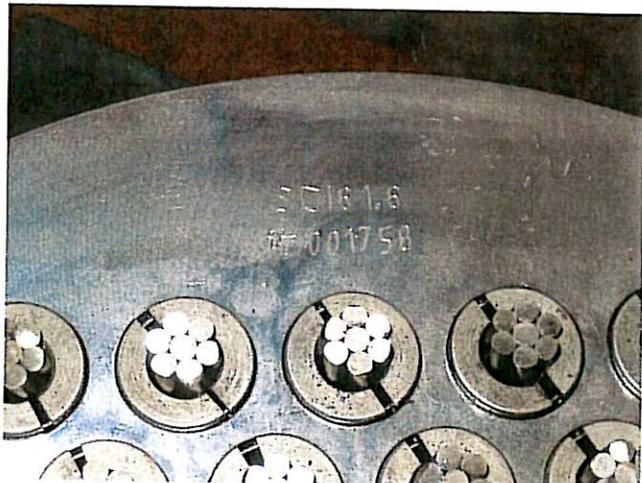
File Name: Aug-28-2008 W2 Cap 001	File Name: Aug-28-2008 W2 Cap 002
Date: 08-28-08	Date: 08-28-08
By Int: M Bruce	By Int: M Bruce
Description: Cable tiedown anchor head sitting on the testing pedestal/bearing plate. Wedges and partial portions of 0.6" strand were installed the previous day prior to testing. The strands were to be cut at a horizontal plane and be level with the load distribution plate. However there were a few strands that were slightly higher or lower in certain areas.	Description: The anchor head tested had a heat number SDI-61.6 TT001758. It is my understanding from talking with Rosme that this anchor head failed to reach the specified yield stress of 51psi (achieved 47ksi). Also the chemical composition of the anchor head hasn't been determined due to the fact that the report is in German.

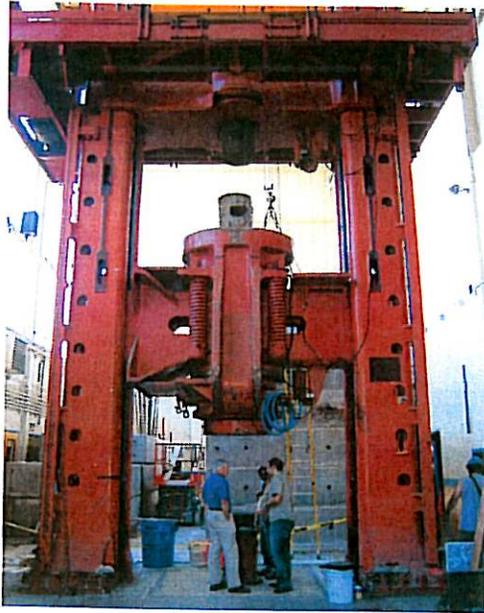
File Name:	Aug-28-2008 W2 Cap 003
Date:	08-28-08
By Int:	M Bruce

Description: UC Berkeley testing facility UTM (hydraulic type), which is rated for 4,000kips in compression and 3,000kips in tension. The anchor head was tested to 3,400kips in compression.

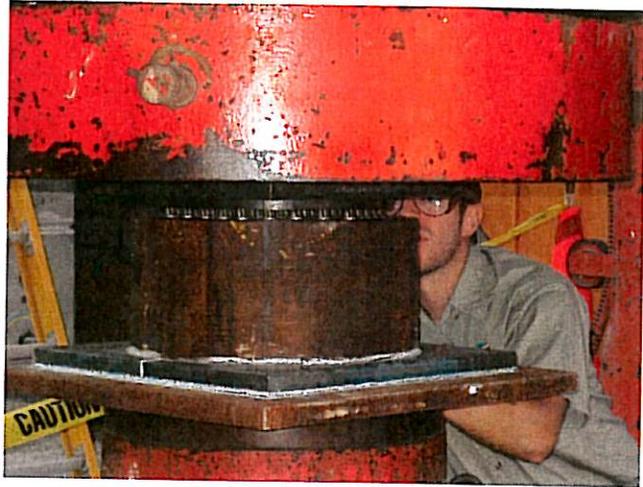
File Name:	Aug-28-2008 W2 Cap 012
Date:	08-28-08
By Int:	M Bruce

Description: Photo taken at 50%GUTS of the test. The strands were checked at this point to see if there were any deformations or splitting of the strands. The higher strands appeared to have split ever so slightly.

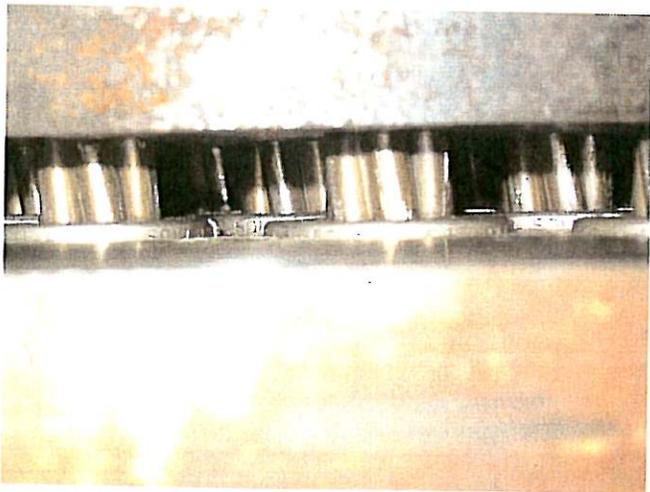
File Name:	Aug-28-2008 W2 Cap 014
Date:	08-28-08
By Int:	M Bruce

Description: Close up view of the strands at 50%GUTS.

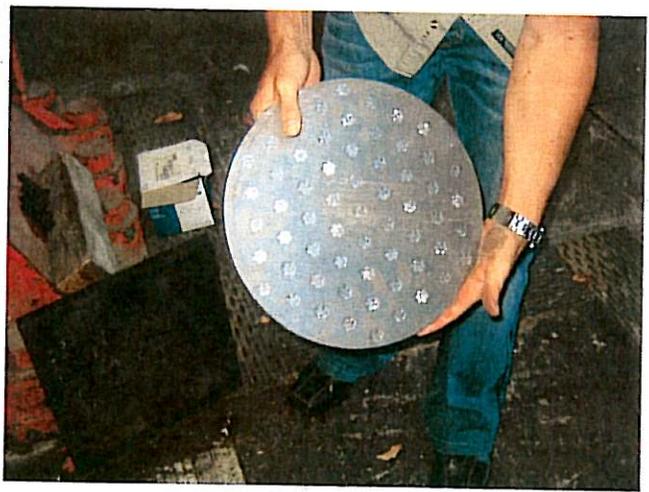
File Name:	Aug-28-2008 W2 Cap 015
Date:	08-28-08
By Int:	M Bruce

Description: Indentations on the load distribution plate after imposing a load of 95%GUTS. There appeared to be no visual damage to the strands after the test. As mentioned above the only noticeable damage was minor splitting of the strands.
