Job Stamp 04-0120F4 SFOBB SAS

Assistant Structure Rep.'s Daily Report

Location & Description of Operation	SAS-Temporary towers, Tower A & B Erection
Weather	HI: 65 F Low: 53 F Partly cloudy

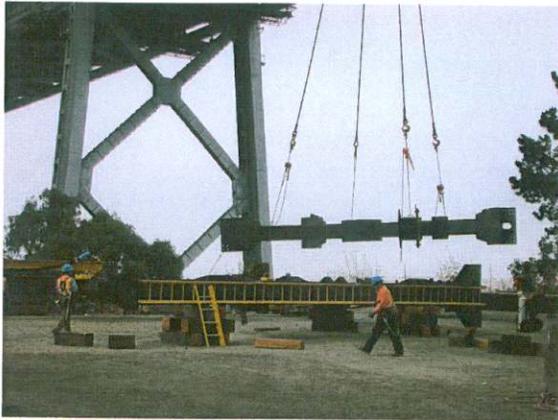
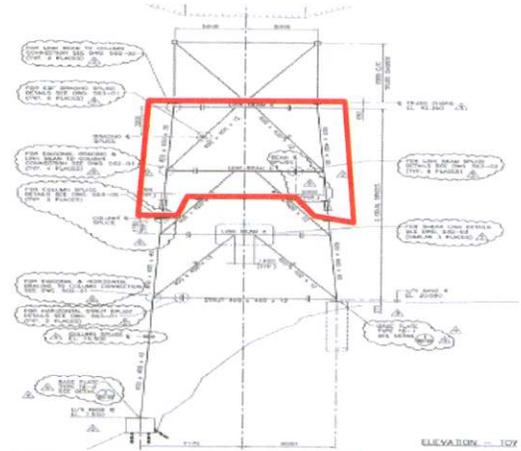
- Daily activity of contractors
 - ABF continued to assemble the second section which contains two link beams (see Figs 1 and 2).
 - ABF installed bolts with the impact wrench. Turn-of-Nut method is used (see Figs 3 and 4).
 - ABF adjusted the elevation of the existing tower A west line and plumbed (see Figs 5 and 6).
 - See Art Pannu's diary for additional contractors' activities and comments.

Figs 1 and 2. ABF continued to assemble the second section which contains two link beams.

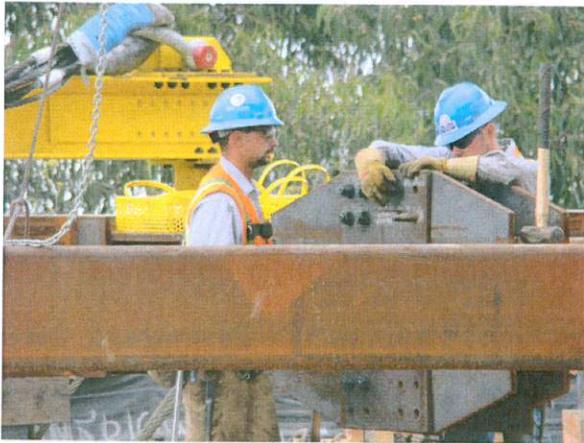
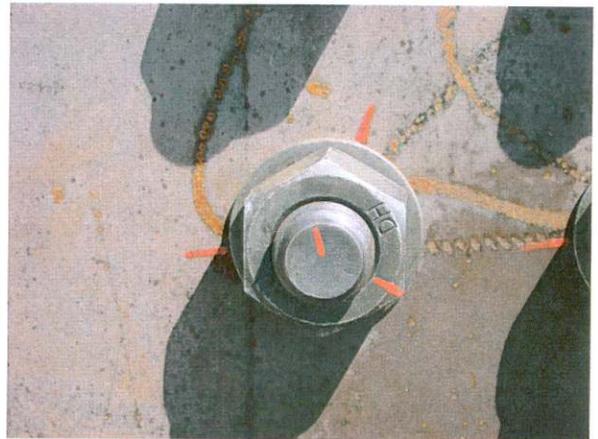
Figs 3 and 4. ABF crews installed bolts using turn-of-nut method.

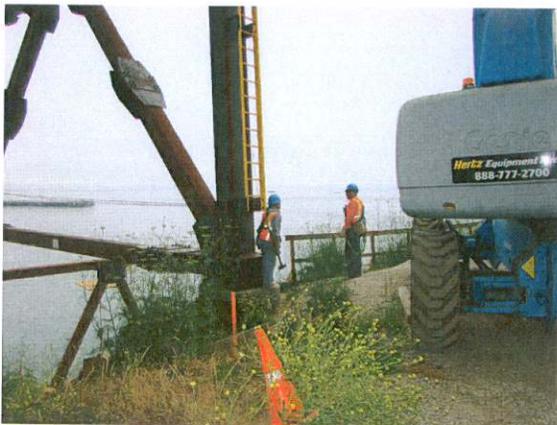
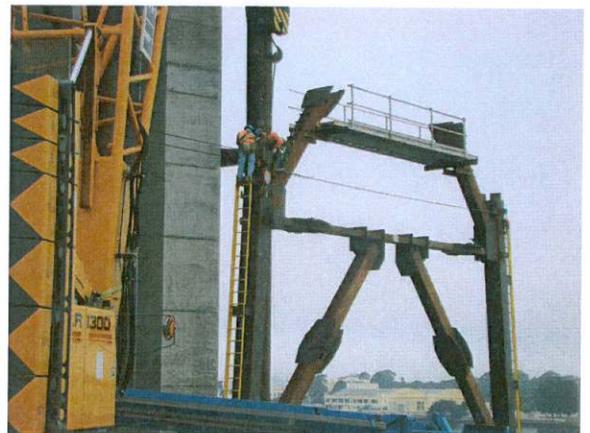
Figs 5 and 6. ABF adjusted the existing tower A west line and plumbed.

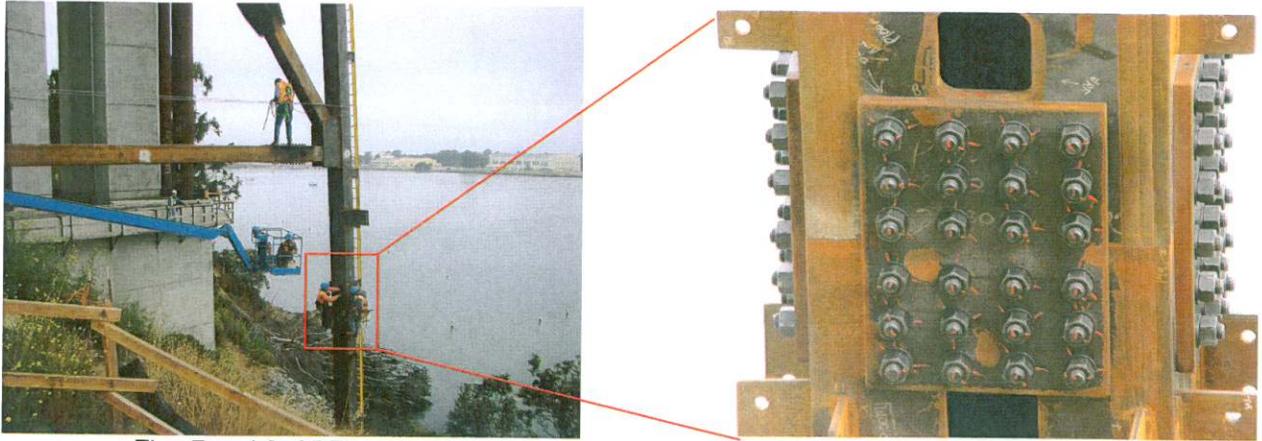
- Note
 - ABF provided an access to the splice which connects one vertical member and first section erected. Checked the bolt pretensioning and mentioned foreman Ed that the right top bolt of the east side plate should be pretensioned more (see Figs 7 and 8).
 - Attend a construction meeting from 12:30 to 14:30.
 - Dan, who is a superintendent, is on-site from 09:10 to 10:00.
 - At 14:30, Art and I visited the site to check the capacity of the bolt using the torque wrench.
 - 2 hours O.T.

Figs 7 and 8. ABF provided an access to the splice and checked the bolt pretension.
