Job Stamp <b>04-0120F4</b> <b>SFOBB SAS</b>
---

### Assistant Structure Rep.'s Daily Report

Location & Description of Operation	SAS-Temporary towers, Tower A & B Erection
Weather	HI: 74 F Low: 55 F Partly cloudy

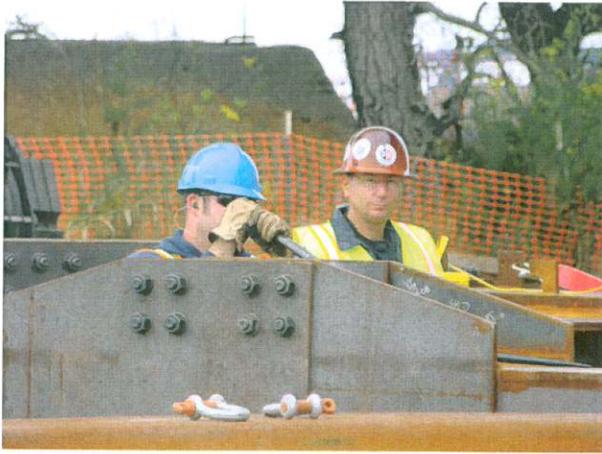
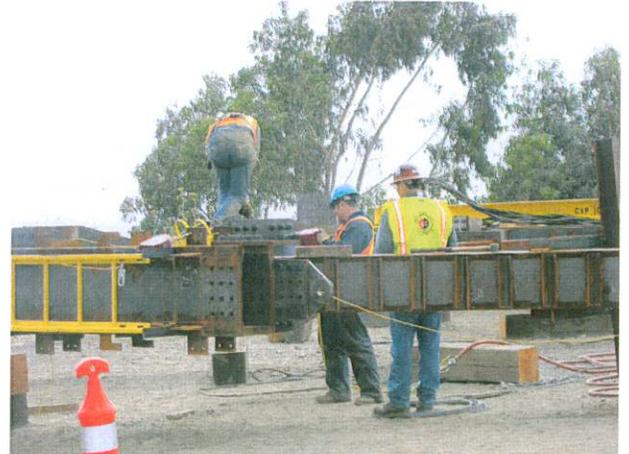
Figs 1 and 2. ABF used a hand-wrench to make snug-tight condition and an impact wrench to pretension bolts.

- Daily activity of contractors
  - ABF used a hand-wrench to make snug-tight condition and an impact wrench to pretension bolts (see Figs 1 and 2). Turn-of-Nut method is used for pretensioning.

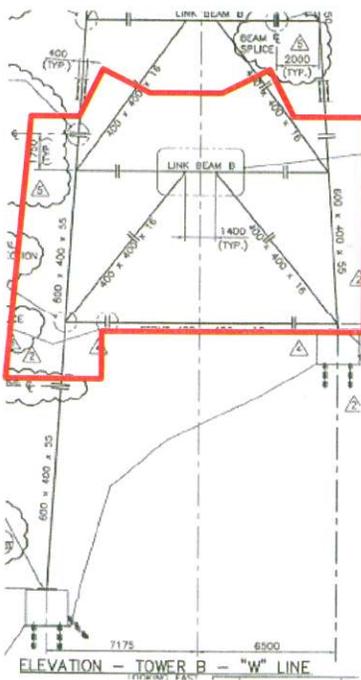
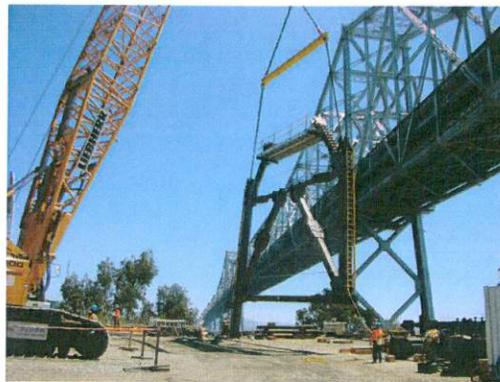
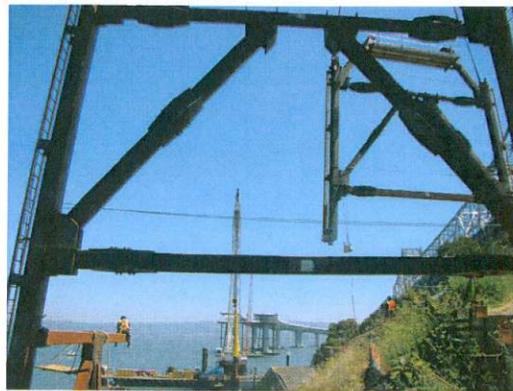
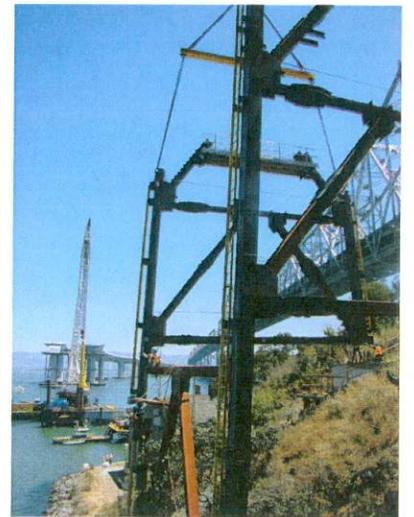
Figs 3 through 6. ABF erected the first section of the tower B west line.

- ABF erected the first section of the tower B west line (see Figs 3 through 6 for the erection). All bolts of the splice zone are pretensioned either on ground or after the erection. Red and blue circles indicate locations where the pretension is done on ground and after the erection, respectively (see Fig 7).

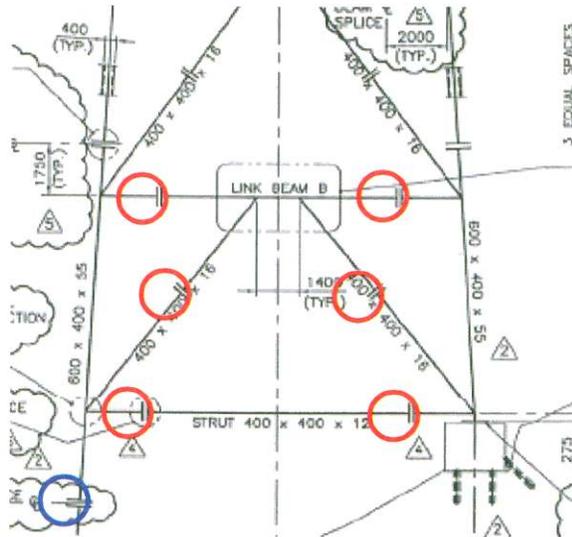
Fig 7. Red and blue circles indicate locations where the pretension is done on ground and after the erection, respectively.

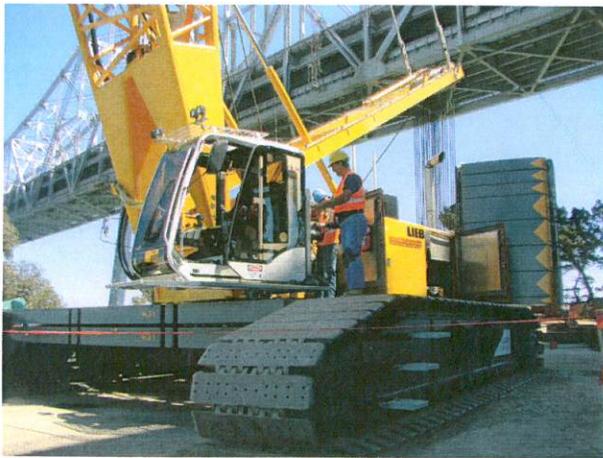
Fig 8. A crane inspector is on-site for a crane annual check-up.

- A crane inspector, ALLCAL equipment service inc, is on-site for a crane annual check-up (see Fig 8).
  - Dan is on-site from 13:00 to 13:50.
  - Marked bolts which turn out shorter (see Fig 9). See Appendix #1 of 07/29/08 diary for the locations.

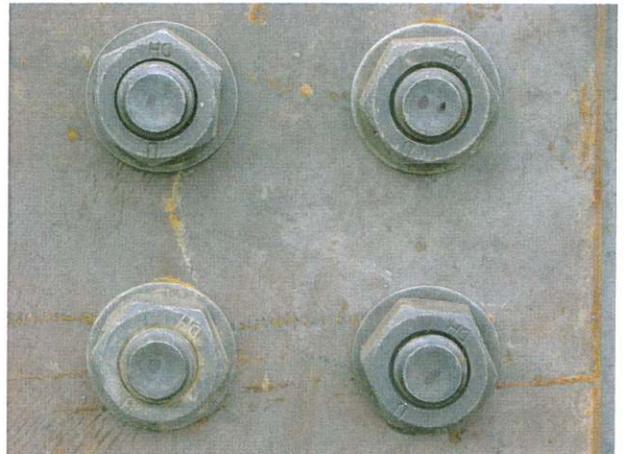
Fig 9. Bolts, which transition area is located at the shear plane are marked.
