Job Stamp 04-0120F4 SFOBB SAS

Assistant Structure Rep.'s Daily Report

Location & Description of Operation	SAS-Temporary towers, Tower A & B Erection
Weather	HI: 76 F Low: 57 F Partly cloudy

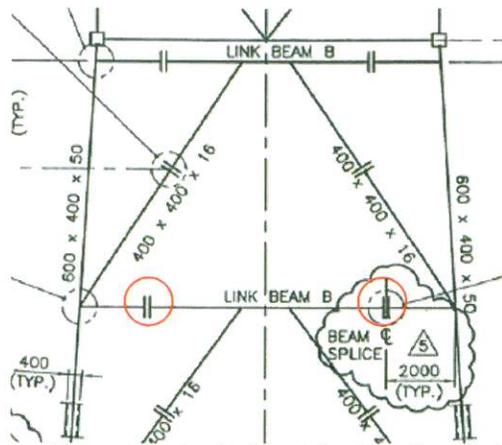
- Daily activity of contractors (ABF)
 - Pretension the bolts at the middle link beam before the erection (see Fig 1 for the location pretensioned today). They are snug-tightened on 07/31/08.

Fig 1. ABF continued to pretension bolts at the location circled on the ground.

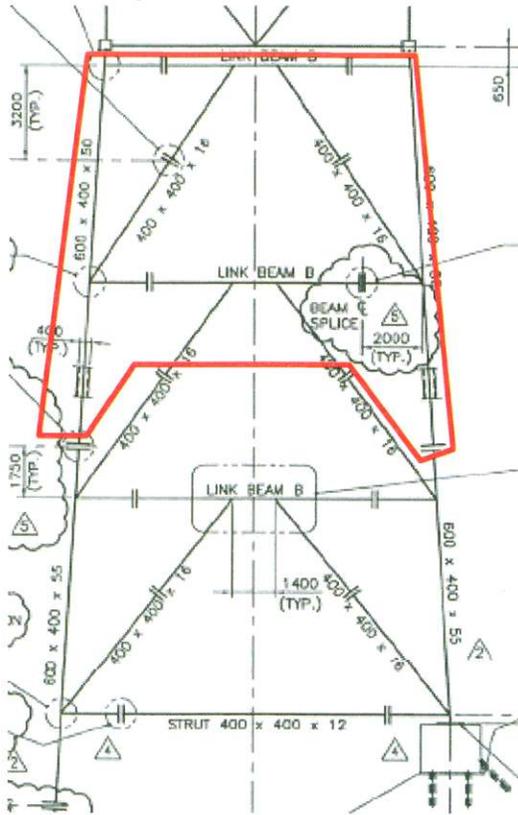
- Erect the assembled section, which contains two link beams (see Figs 2 through 6).
 - Installed and pretensioned bolts after the erection (see Figs. 7 through 10).

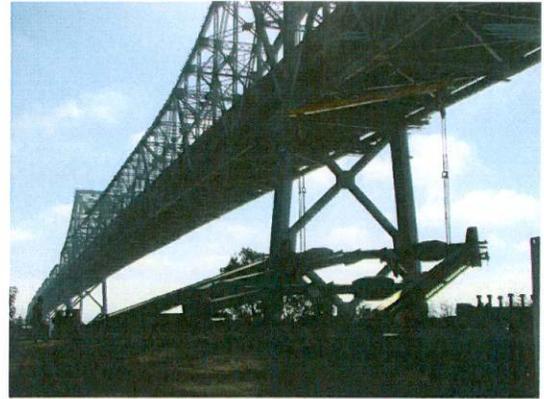
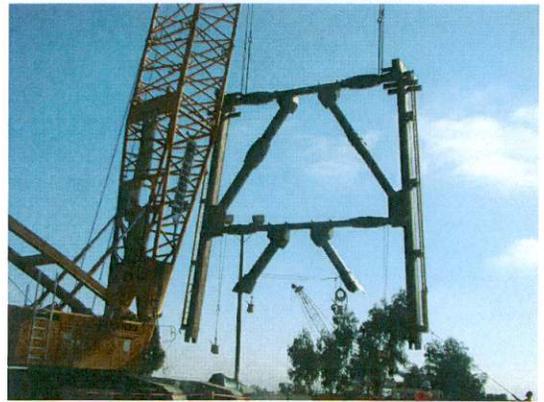
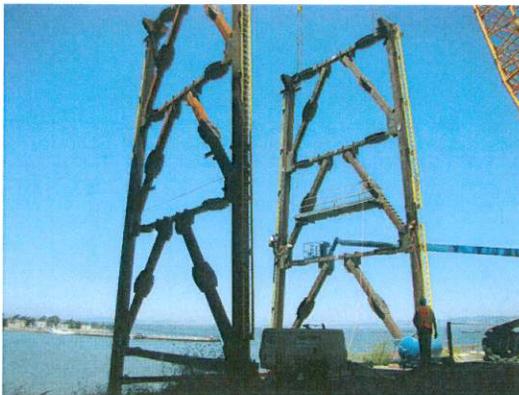
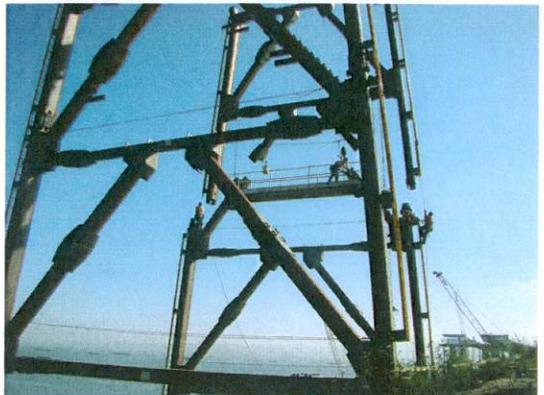
Figs 3 through 6. Erected the second section of the tower B west line.

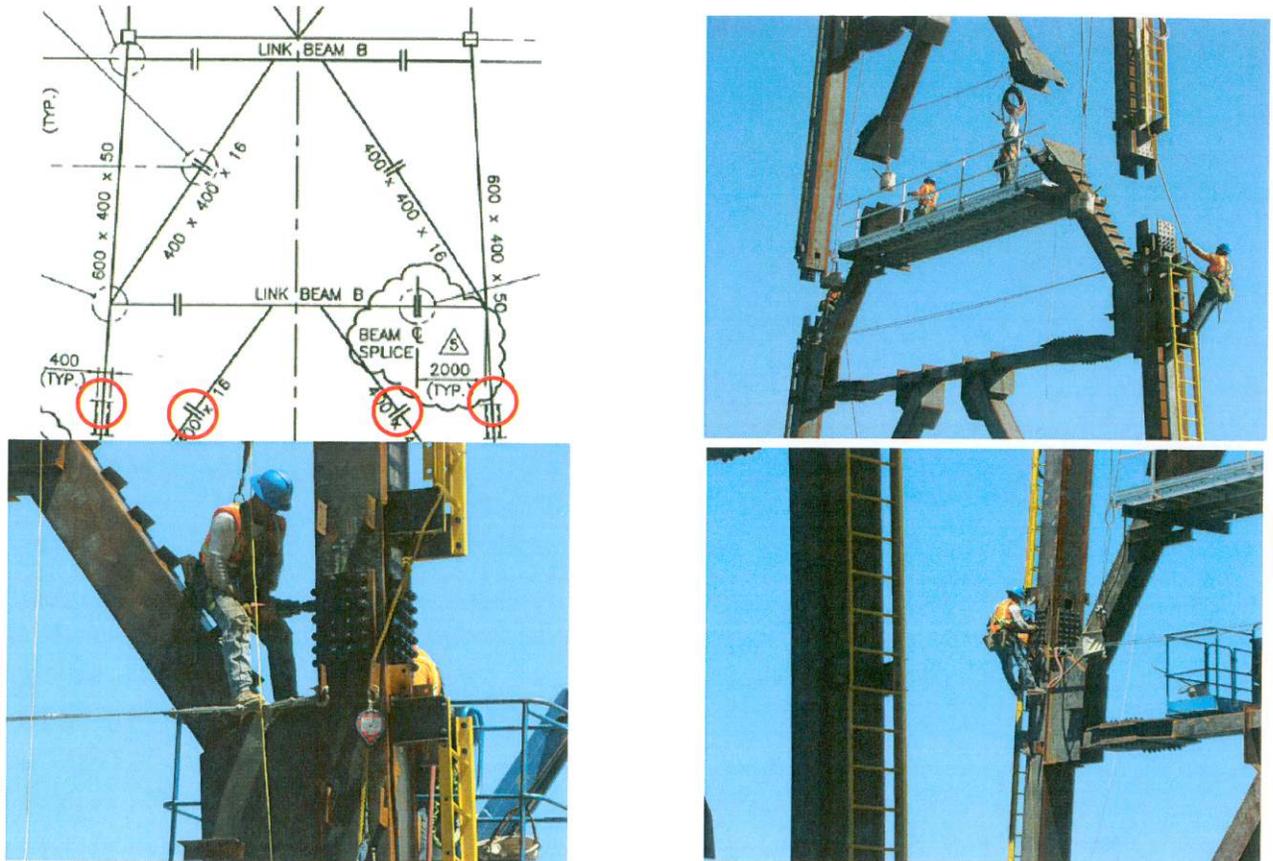
Figs 7 and 10. ABF snug-tight and pretension bolts after the erection. See the red circles for the locations.
