Job Stamp 04-0120F4 SFOBB SAS

Assistant Structure Rep.'s Daily Report

Location & Description of Operation	SAS-Temporary towers, Tower A & B Erection
Weather	HI: 76 F Low: 57 F Partly cloudy

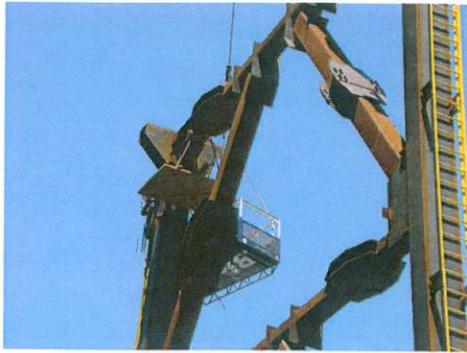
Fig 1. Installed a wood platform for field drilling

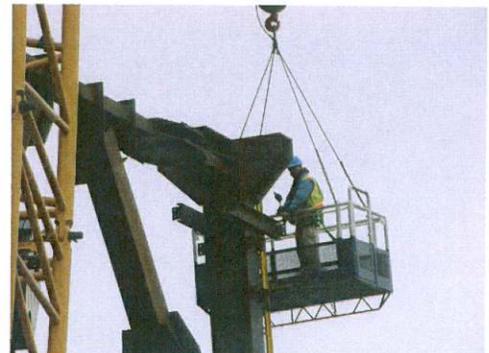
Fig 2. ABF conducted surveying on the final positions of the towers A and B west line

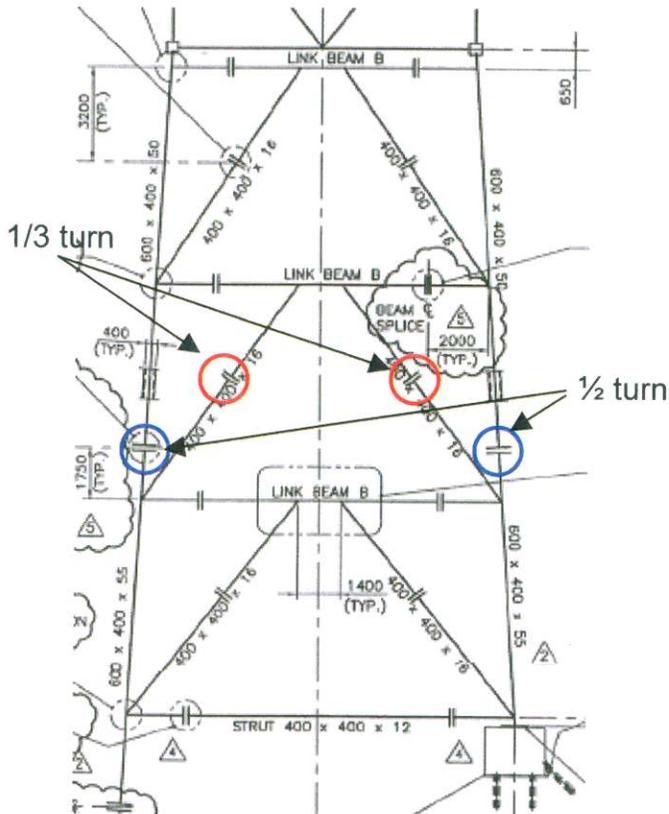
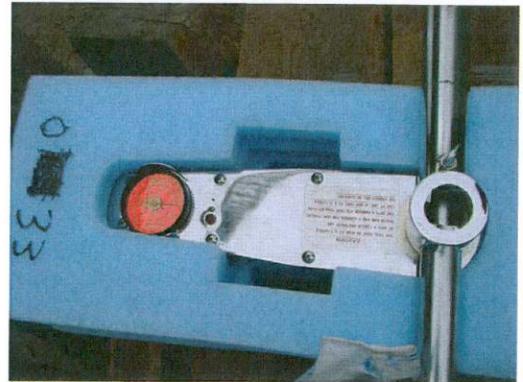
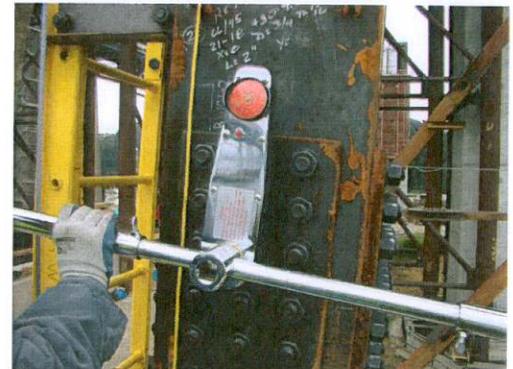
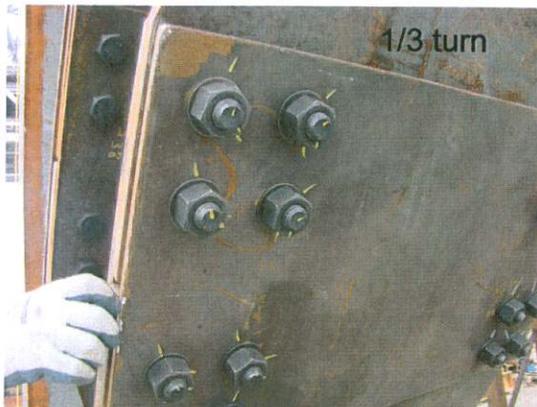
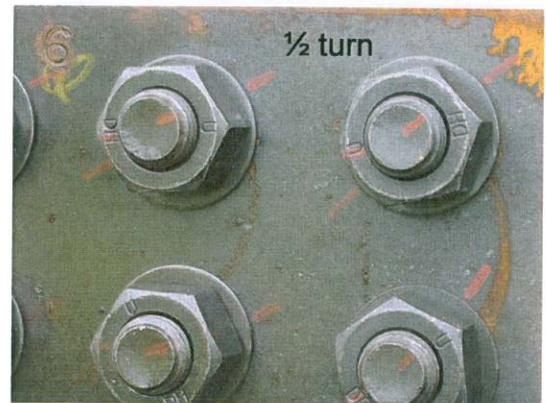
- Note
 - Tony Sherwood from SE company and I inspected bolts pretensioned after the erection visually and using the calibrated torque wrench (see Figs 3 through 7). The torque measured exceeds 1450 lb.ft, which is equivalent to 84 kips for the calibrated wrench.
 - David Bradd and I carried out surveying on the final positions of the towers A and B west line. See David Bradd's diary for the detailed information. Surveying date is attached.
 - The third item of punch list is cleared, because Tony and I checked the capacity of the bolt using the calibrated torque wrench.

Figs 3 through 7. Tony and I checked the bolts pretensioned after the erection either visually or using calibrated torque wrench. Blue and red circles denote bolts which require 1/2 turn and 1/3 turn, respectively.

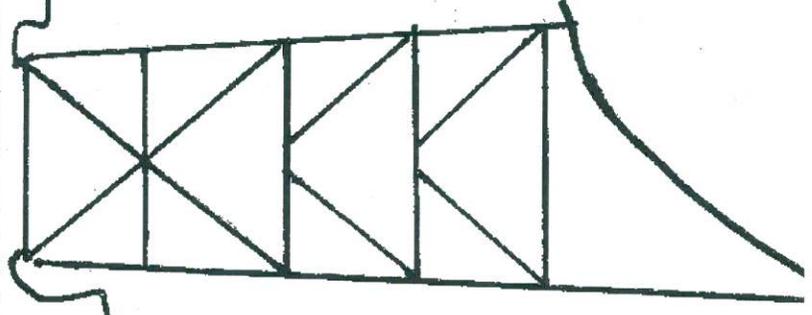
Final Location of Temporary Towers A and B 8-4-2008

ABF 15503
ABF 15507
CT 1
CT 10

ABF 15505
ABF 15508
CT 3
CT 11

Looking East
No Scale
