Job Stamp:
04-SF-80-13.2/13.9 04-0120F4
SFOBB SAS
San Francisco Co. in San Francisco
Fm 0.6 km to 1.3 km East of Yerba Buena
Tunnel East Portal

ASSISTANT RESIDENT ENGINEER'S DAILY

Location: W2 Cap Beam	Weather: partly cloudy
Remark: ironwork/exterior forms	Hi 68F/Lo 55F

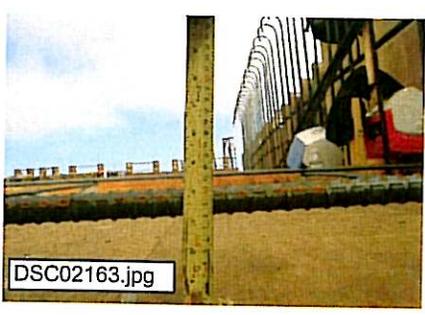
ABF resumed work on exterior formwork - the built-up 4x4s that the Hinge rods have been placed through were not plumb (DSC02165). The series of 4x4s on the left are not in line with the panel you see in the middle of the picture. A few minor adjustments to various formwork items around.
