Job Stamp 04-0120F4 SFOBB SAS

ASSISTANT RESIDENT ENGINEER'S **CONTRACTOR – ABFJV**

EA	04-0120F4
Co-Rte-KP (PM)	SF-080-13.2/13.9 (8.2/8.7)
Structure Rep.	Rick Morrow

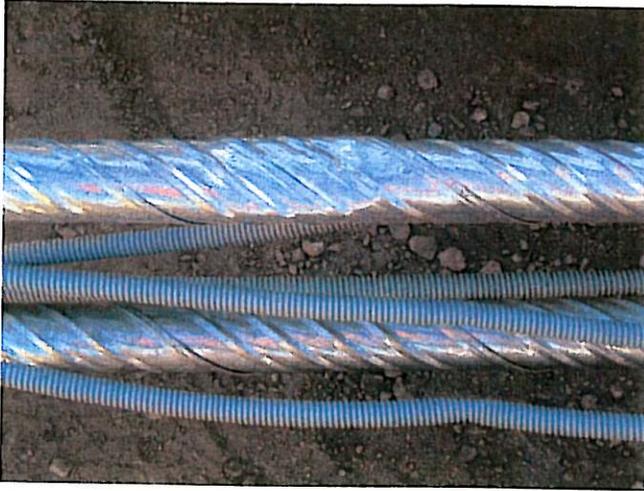
File Name: Sept-4-2008 W2 Cap 002

Description: Dents found in the duct of the first rods in the top row with VB-84W on the grout tubes.

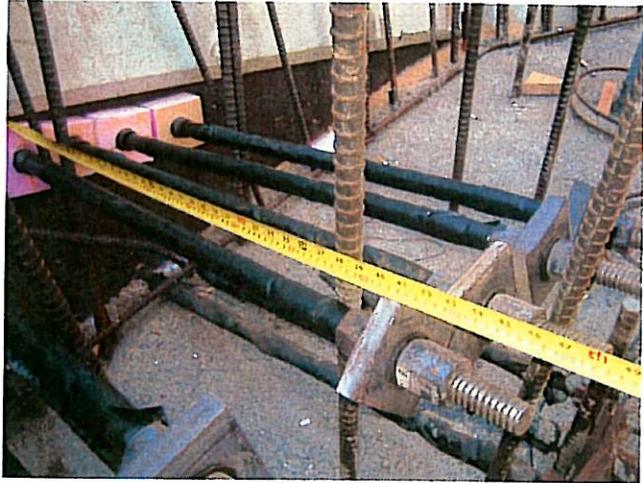
File Name: Sept-4-2008 W2 Cap 014

Description: Top row of deviation saddle erection rods placed today at W2E.

- Installed deviation saddle erection rods near W2E.
- Continued to prepare templates for the vertical PT rod installation, no rods have been placed in the W2 cap beam to date.

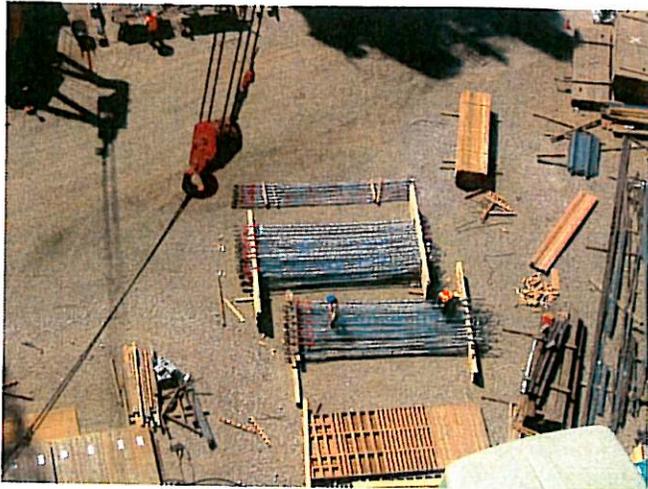
File Name: Sept-4-2008 W2 Cap 015

Description: The top template has the following marks on the grout tubes from the top row to the bottom row of VB-84W, VB-66W, VB-57W, VB-39W, and VB-48W. Similarly the bottom template (where the piledrivers are seen working) has the marks VB-102E, VB-12E and VB-03E.

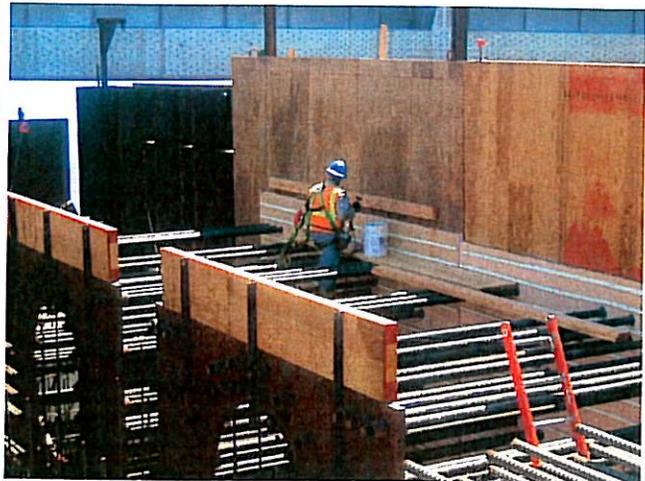
File Name: Sept-4-2008 W2 Cap 016

Description: Vertical PT rod support forms and ledger beams at the W2E Hinge K assemblies.

- Began to install ledger beam for vertical PT rod template starting at the W2E South Hinge K assembly.
- Installed vertical PT rod support forms on the top of the interior Hinge K plates at all four Hinge K assemblies.
Note: ABF was also erecting/securing the second truss section from A2 to B2 today. While watching this operation with Art Pannu the truss section grazed the W2 falsework with no apparent damage to the falsework. The cantilevered portion of this truss section goes underneath the W2 soffit with minimal clearance.
