Job Stamp 04-0120F4 SFOBB SAS

ASSISTANT RESIDENT ENGINEER'S **CONTRACTOR – ABFJV**

EA	04-0120F4
Co-Rte-KP (PM)	SF-080-13.2/13.9 (8.2/8.7)
Structure Rep.	Rick Morrow

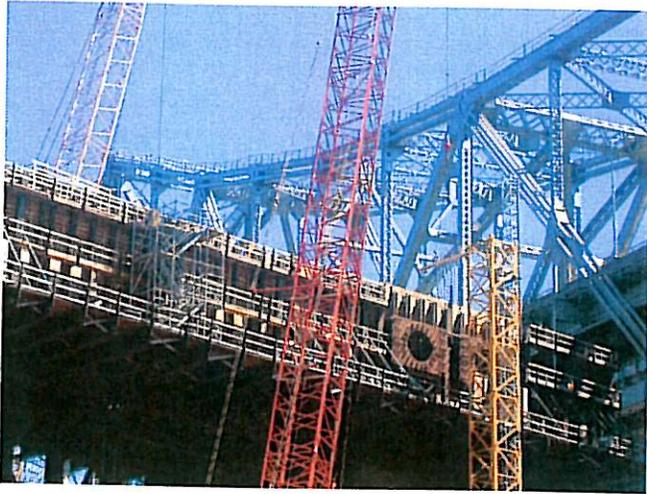
File Name:	Sept-5-2008 W2 Cap 007
Date:	09-05-08
By Int:	M Bruce

Description: Lifting of a single row of 7 vertical bars at the South Hinge K assembly. A total of 56 vertical bars were placed in the W2E Hinge K assemblies today.

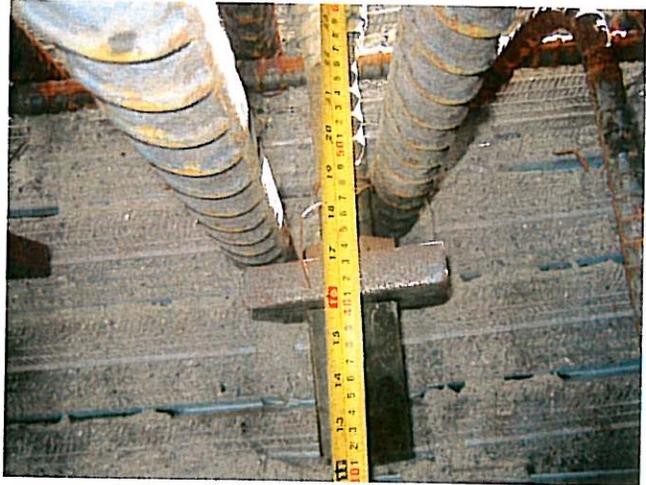
File Name:	Sept-5-2008 W2 Cap 011
Date:	09-05-08
By Int:	M Bruce

Description: Photo of the VB-7 at W2E looking south. The top of the plate is at 435mm opposed to 500mm per sheet 471R2. The placement of the #43 transverse bar (left side of the photo) is preventing the plate from being at the proper elevation. The same bar is touching the plate as well and the 36mm hexnut is at the end of the bar. VB-7 was the only bar found in this condition.

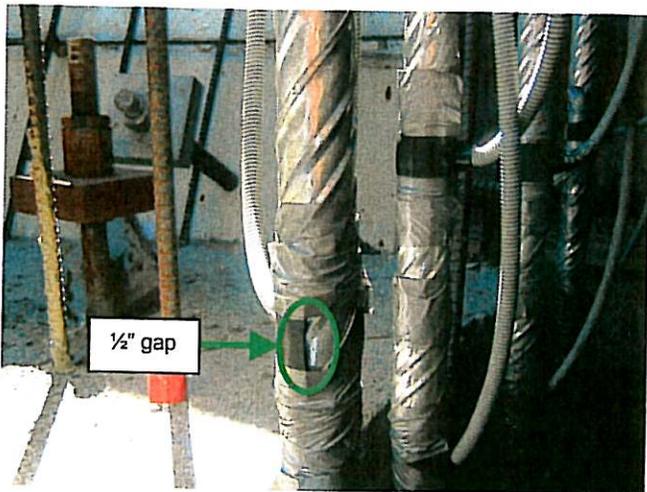
File Name:	Sept-5-2008 W2 Cap 012
Date:	09-05-08
By Int:	M Bruce

Description: Grout saddle (closest vertical rod) where there is a 1/2" gap between the saddle and duct and no duck tape around the gap. I told Nigel about this issue and he told me that as of right now it wasn't going to be covered or sealed. Nigel also informed me that the ducts would be pressure washed after the concrete placement in the blockouts tentatively scheduled for September 15th.

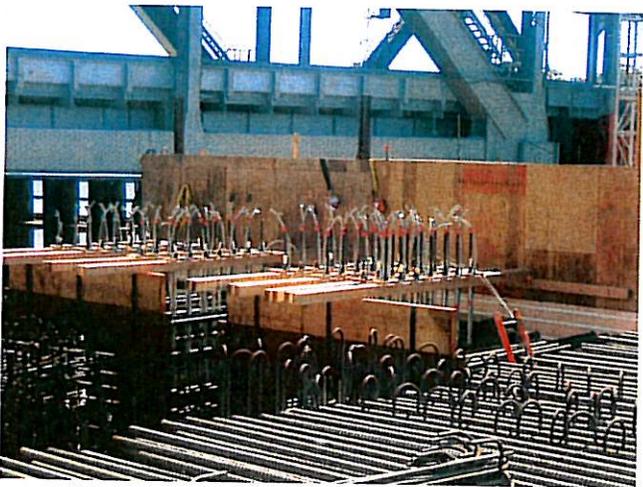
File Name:	Sept-5-2008 W2 Cap 014
Date:	09-05-08
By Int:	M Bruce

Description: Vertical bar placement at the W2E Hinge K assemblies to date. I told Nigel and Branden to move rebar that was in the way of placing the vertical rods in the correct position.
