| Job Stamp<br>04-0120F4<br>SFOBB SAS |

| Date | 09/19/2008 | | |

ASSISTANT RESIDENT ENGINEER'S **CONTRACTOR – ABFJV, Subs Patent**

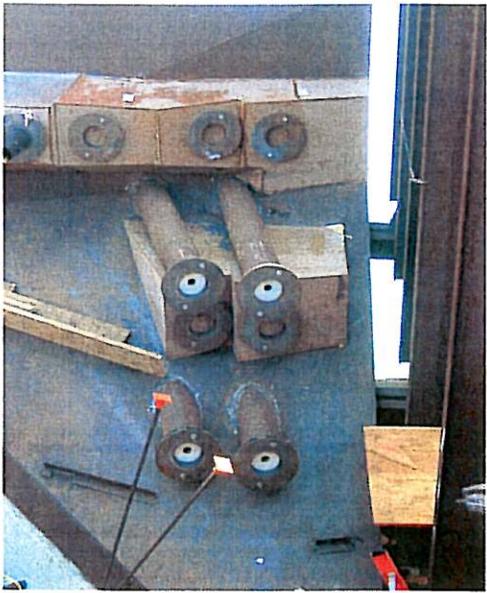
| File Name: Sept-19-2008 W2 Cap 002 | | File Name: Sept-19-2008 W2 Cap 007 | |

| Description: CBT-1 through CBT-8 blockouts near the W2E pier looking south. | | Description: E-2B looking west as some reinforcement will have to be moved to facilitate trumpet/duct installation. | |

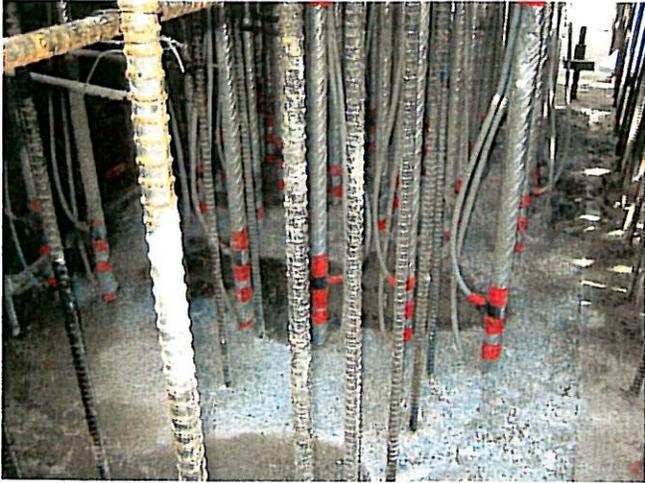
| File Name: Sept-19-2008 W2 Cap 010 | | File Name: Sept-19-2008 W2 Cap 011 | |

| Description: Photo of the W2W vertical bar blockout looking north. At both blockouts it appeared that curing spray was reapplied after Rugasol-S was cleaned from the surface. The surface was rough as the coarse aggregate was exposed. Also no cracks were seen yet at either blockout. | | Description: ABF subcontractor Patent installing scaffolding for the ironworkers on the north side of the pour 3 construction joint. | |

- Removed Rugasol-S from the W2E and W2W vertical bar blockout surface and then reapplied the curing compound. I informed ABF foreman Nigel Lohse that it appeared that more curing compound should be applied to some areas at both blockouts. No cracks were seen on the surface of the concrete thus far.
