EA	04-0120F4
Co-Rte-KP (PM)	SF-080-13.2/13.9 (8.2/8.7)
Structure Rep.	Rick Morrow

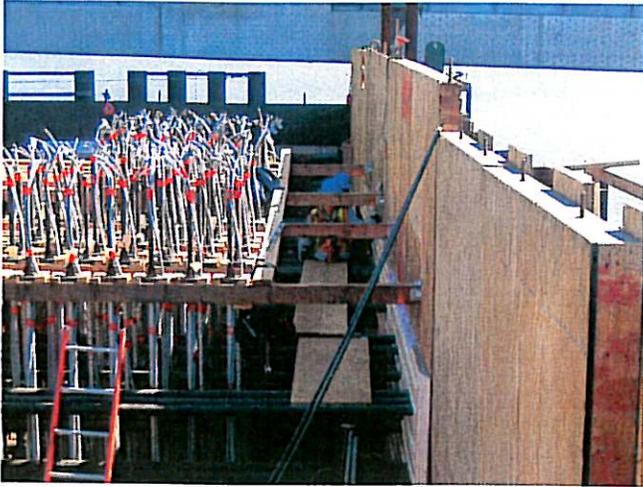
File Name:	Sept-29-2008 W2 Cap 004
Date:	09-29-08
By Int:	M Bruce

Description: Piledrivers cut 4"x6" support beams to facilitate the short vertical PT bar template installation. A 2"x6" ledger beam was used to try and maintain the alignment of the bars at the top. The batter of the long vertical bars should be checked prior to concrete placement.

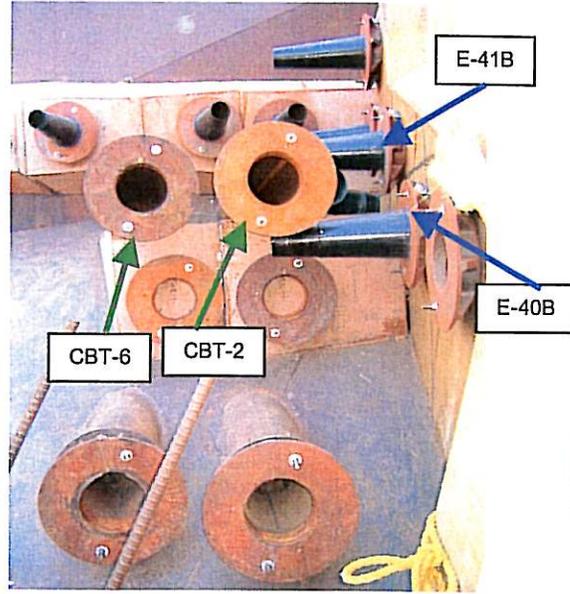
File Name:	Sept-29-2008 W2 Cap 008
Date:	09-29-08
By Int:	M Bruce

Description: Potential conflict with CBT-2/6 and E-40/41B at W2E looking south.

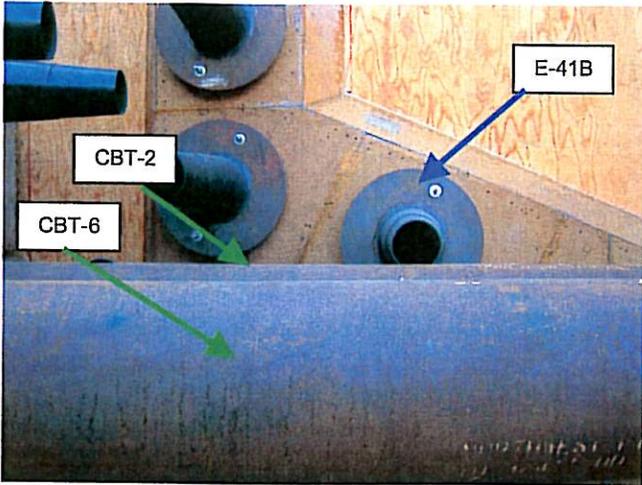
File Name:	Sept-29-2008 W2 Cap 009
Date:	09-29-08
By Int:	M Bruce

Description: Potential conflict with CBT-2/6 and E-40/41B at W2E looking west.

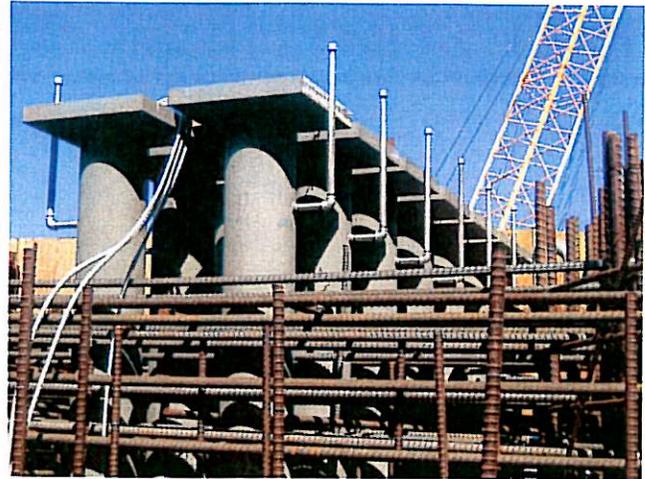
File Name:	Sept-29-2008 W2 Cap 011
Date:	09-29-08
By Int:	M Bruce

Description: Drainage pipes seen connected to the W2E cable tie-down pipes.
