Job Stamp 04-0120F4 SFOBB SAS

Description of Operations @ W2 Cap Beam:

EA	04-0120F4
Co-Rte-KP (PM)	SF-080-13.2/13.9 (8.2/8.7)
Structure Rep.	Rick Morrow

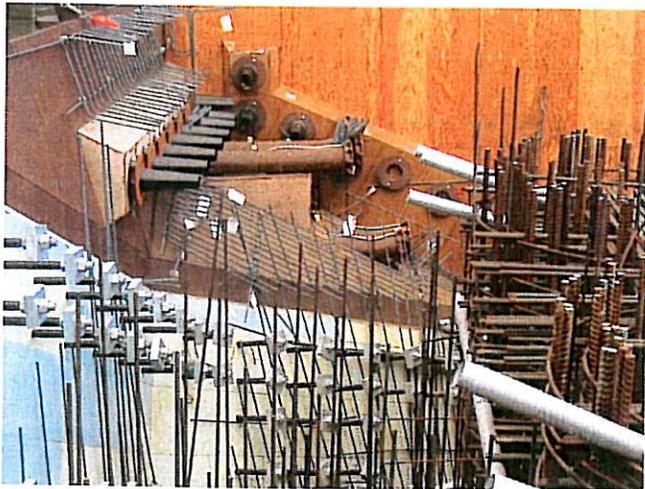
File Name:	Oct-02-2008 W2 Cap 002
Date:	10-02-08
By Int:	M Bruce

Description: Placement of the vertical #19 cap end skin reinforcement for the south end of the W2 cap beam.

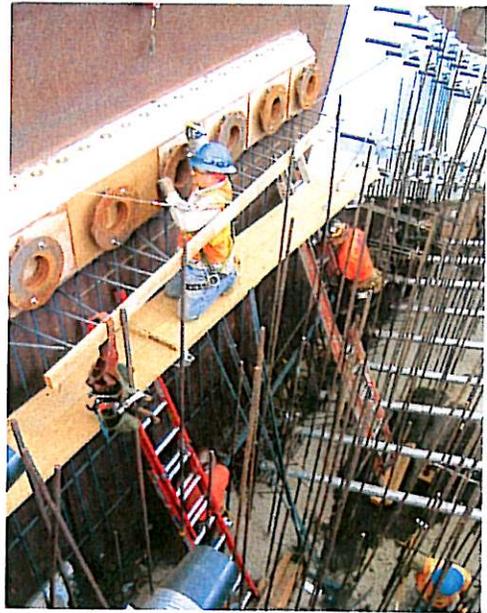
File Name:	Oct-02-2008 W2 Cap 003
Date:	10-02-08
By Int:	M Bruce

Description: Piledrivers fixing washers of the #16 formsavers to the CBT-16 through CBT-22 blockout forms at the south end of the cap near W2E.

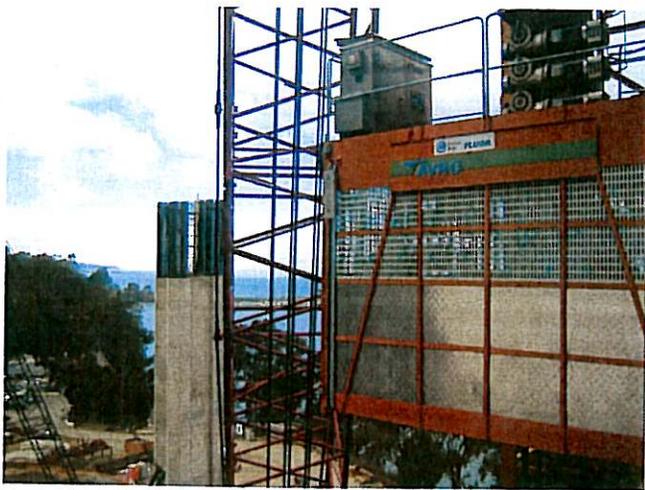
File Name:	Oct-02-2008 W2 Cap 007
Date:	10-02-08
By Int:	M Bruce

Description: Cables from the lifting block of the Manitowoc 4100W crane came within a couple of inches of the elevator while lifting materials. This is a safety issue where the cables could get tangled on the elevator while the boom of the crane is swinging.

Description: Photo taken after I talked to the personnel involved with this operation. In the previous photo the crane was too far to the north on the crane mats. I told the personnel to move the crane to the southern most end of the crane mats before lifting
