Job Stamp 04-0120F4 SFOBB SAS

ASSISTANT RESIDENT ENGINEER'S **CONTRACTOR – ABFJV, Subs CMC-RS**

Description of Operations @ W2 Cap Beam:

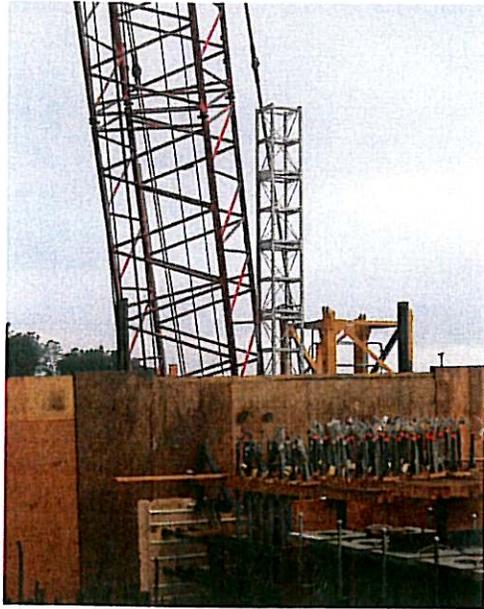
File Name:	Oct-03-2008 W2 Cap 001
Date:	10-03-08
By Int:	M Bruce

Description: The boom of the Manitowoc 4100W crane had more clearance today when I observed lifting operations. I mentioned to ABF foreman Nigel Lohse what happened yesterday regarding the crane and the elevator. He told me that they are aware of the situation and that the standard protocol is to not operate the elevator while swinging the boom of the crane near the elevator.

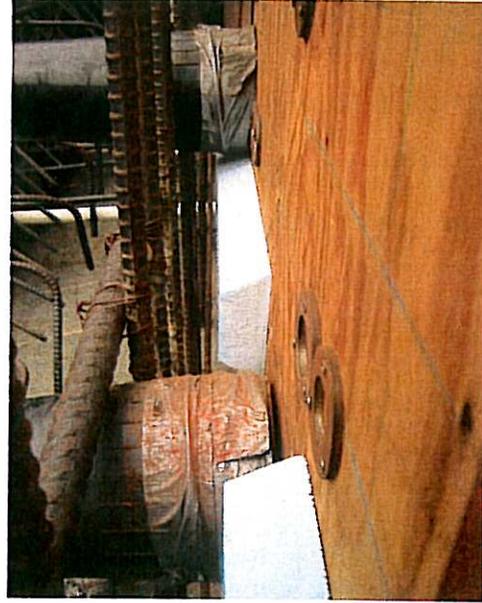
File Name:	Oct-03-2008 W2 Cap 004
Date:	10-03-08
By Int:	M Bruce

Description: While shooting the E-1B to E-15B at the east bulkhead a couple of the trumpets were loose and there appeared to be an opening large enough to allow SCC into the void.

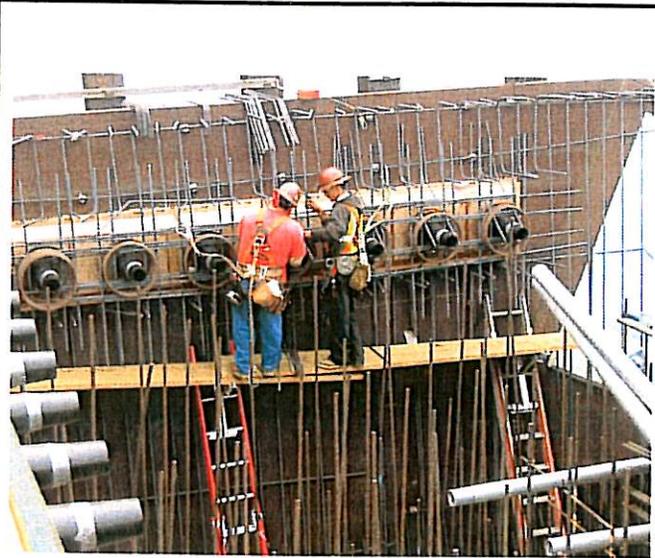
File Name:	Oct-02-2008 W2 Cap 006
Date:	10-03-08
By Int:	M Bruce

Description: Ironworkers placing grillage around the CBT-16 through CBT-22 blackout near W2E.
