Job Stamp 04-0120F4 SFOBB SAS

ASSISTANT RESIDENT ENGINEER'S **CONTRACTOR – ABFJV, Subs CMC-RS**

Description of Operations @ W2 Cap Beam:

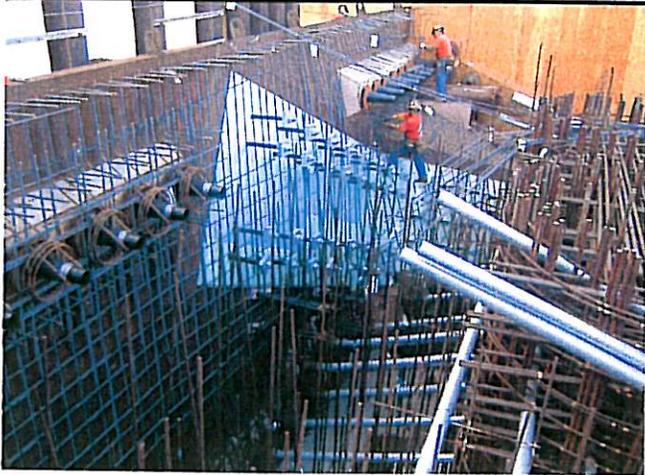
File Name:	Oct-06-2008 W2 Cap 002
Date:	10-06-08
By Int:	M Bruce

Description: Resumed placing the #19 horizontal cap south end skin reinforcement.

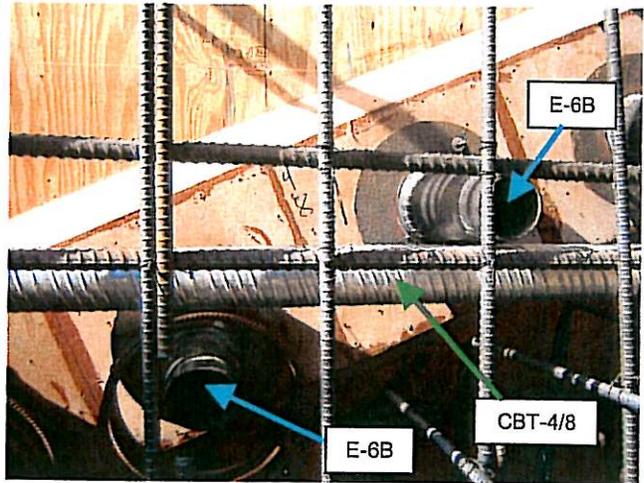
File Name:	Oct-06-2008 W2 Cap 003
Date:	10-06-08
By Int:	M Bruce

Description: Potential conflict between CBT-4/8 and E-6/7B. It appears that it will be extremely difficult to install the spirals of the E-6/7B tendons. The CBT-4/8 ducts will dramatically affect the spiral pitch. Also the clearance between the intersecting ducts may not provide a minimum of 25mm.

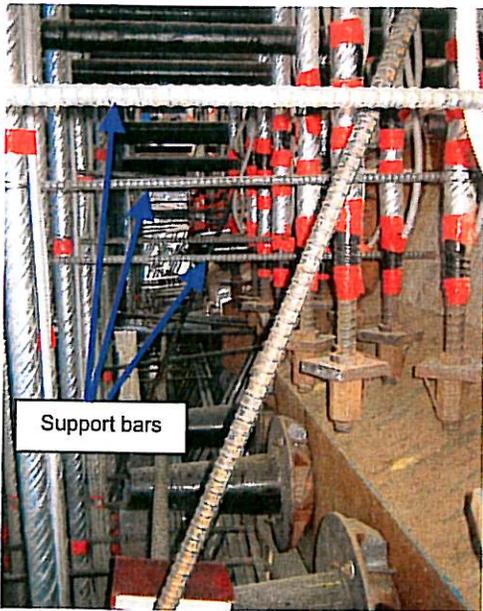
File Name:	Oct-06-2008 W2 Cap 004
Date:	10-06-08
By Int:	M Bruce

Description: Vertical PT bar installation at W2E. A support bar fixes the short bars horizontally. This support bar is connected to the long vertical PT bars where the bottom end is fixed due to the previous concrete placement. Also some of the short bars are touching the continuity tendon blockouts. The elevations or orientation hasn't been checked yet.

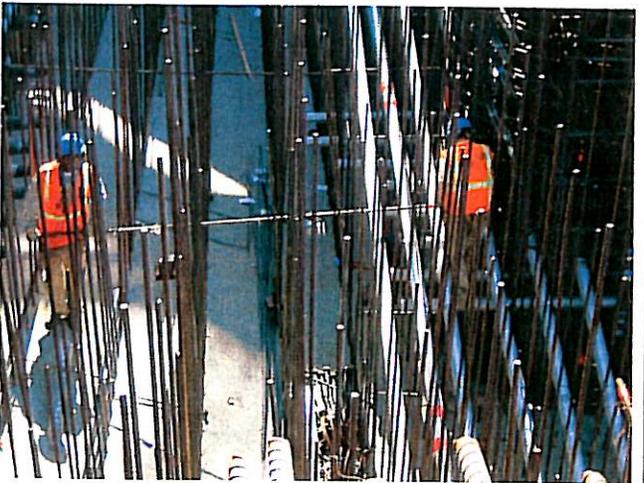
File Name:	Oct-06-2008 W2 Cap 006
Date:	10-06-08
By Int:	M Bruce

Description: Piledrivers installing tie-rods in the pour 4 area.
